**Ratby Conservation Area Appraisal and Management
Plan**

**Photographic Record 2 – Church Lane, Chapel Lane &
Berrys Lane**

**December 2013
(Adopted February 2014)**

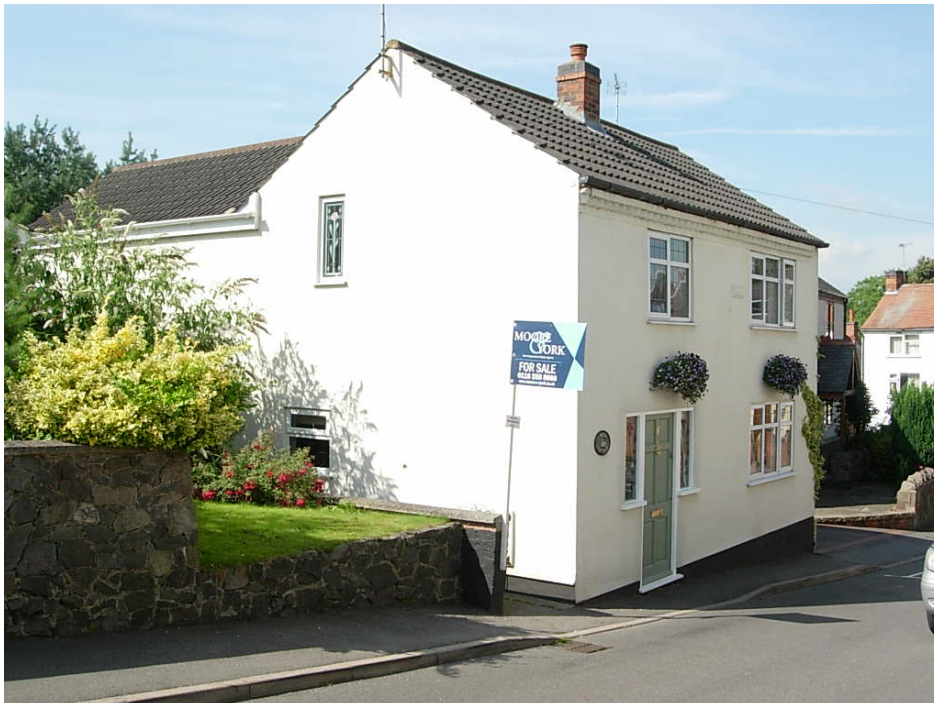
8 Church Lane is a detached cottage that has been considerably modernised with a large rear extension, plastic windows, rendered walls and concrete roof tiles.

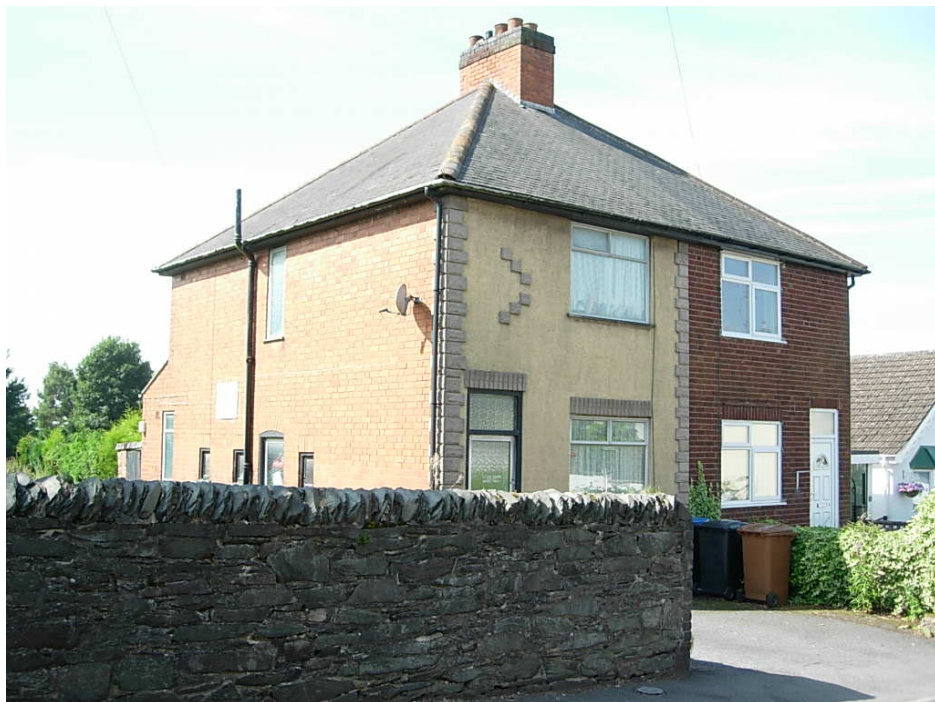
It is unfortunate that the semi-detached dwellings, 14 and 16 Church Lane, have lost their uniformity due to each dwelling being modernised separately.

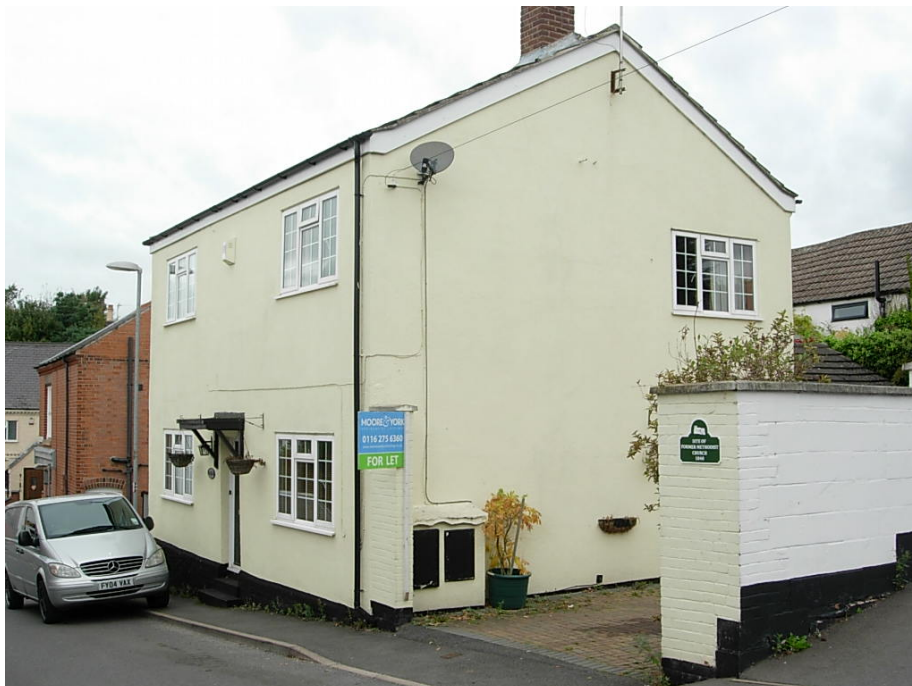
1 Church Lane is one of Ratby's core semi-detached dwellings that have also been considerably modernised and now converted into one dwelling. Its window openings have been enlarged, the front door centralised, walls rendered and re-roofed with concrete tiles.

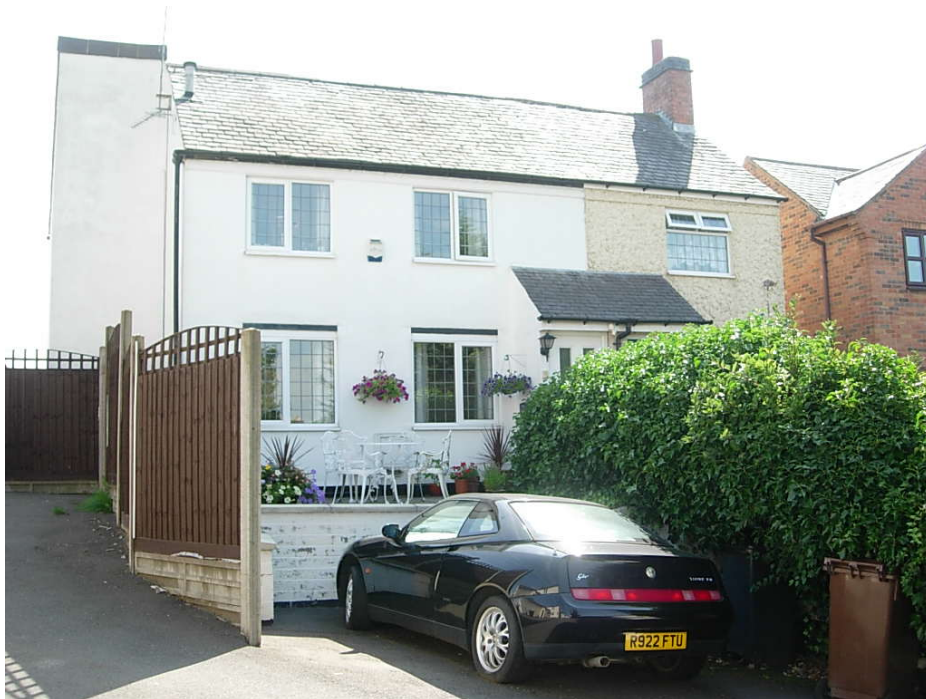
The unity of 9 and 11 Church Lane has been lost due to each dwelling being modernised separately. The two dwellings stand well back from the highway.

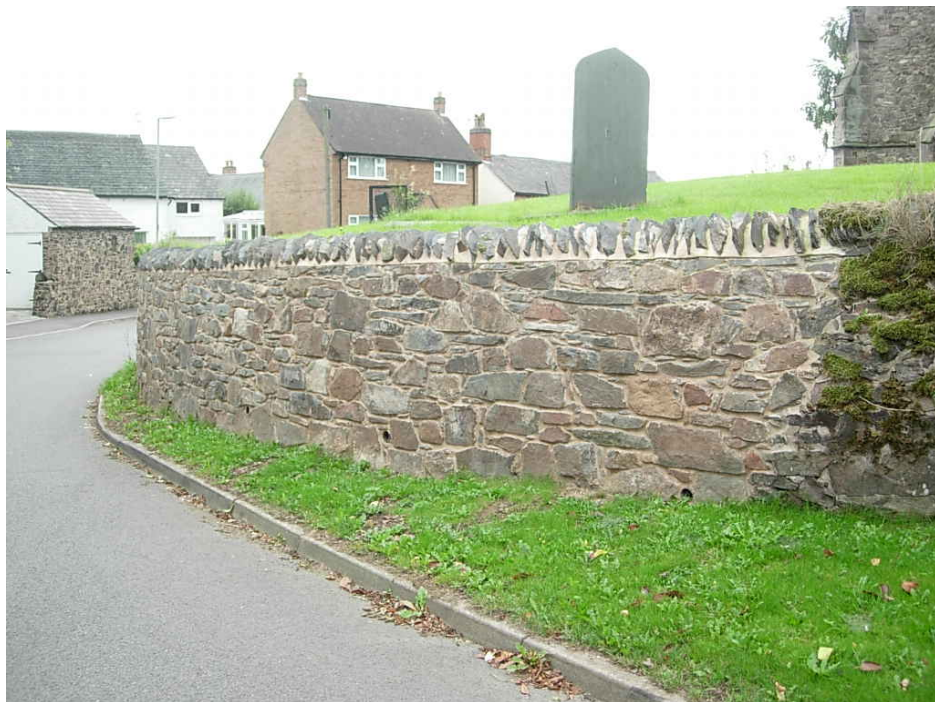
This section of churchyard wall on Church Lane has recently been rebuilt as a project put forward in the previous management plan review. The granite churchyard wall is an important feature in the Conservation Area and every effort should be given to ensure its retention.

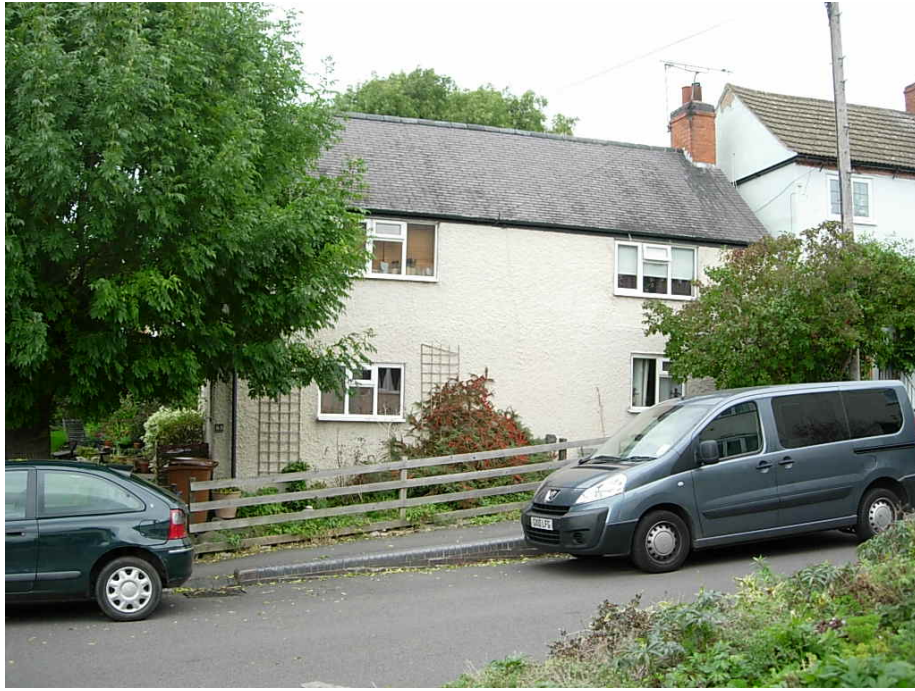
68 Church Walk is a rendered property that has had its window openings enlarged. However, the dwelling still retains its slate roof and gable chimney stacks.

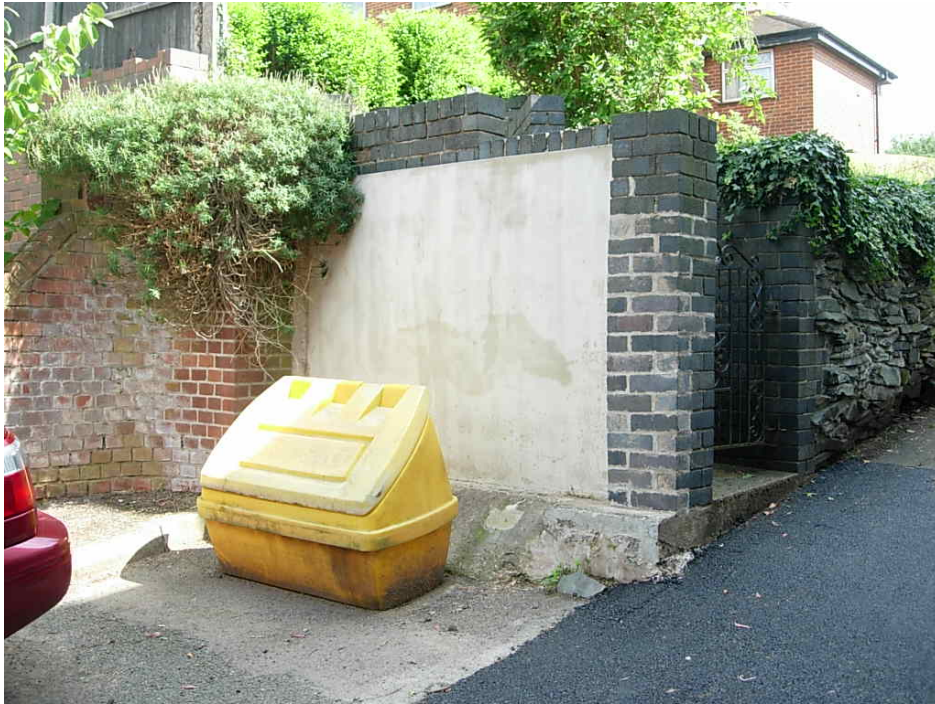
This brick wall on Berry's Lane was recently improved by the Borough Council as a project identified in the previous Conservation Management Plan.

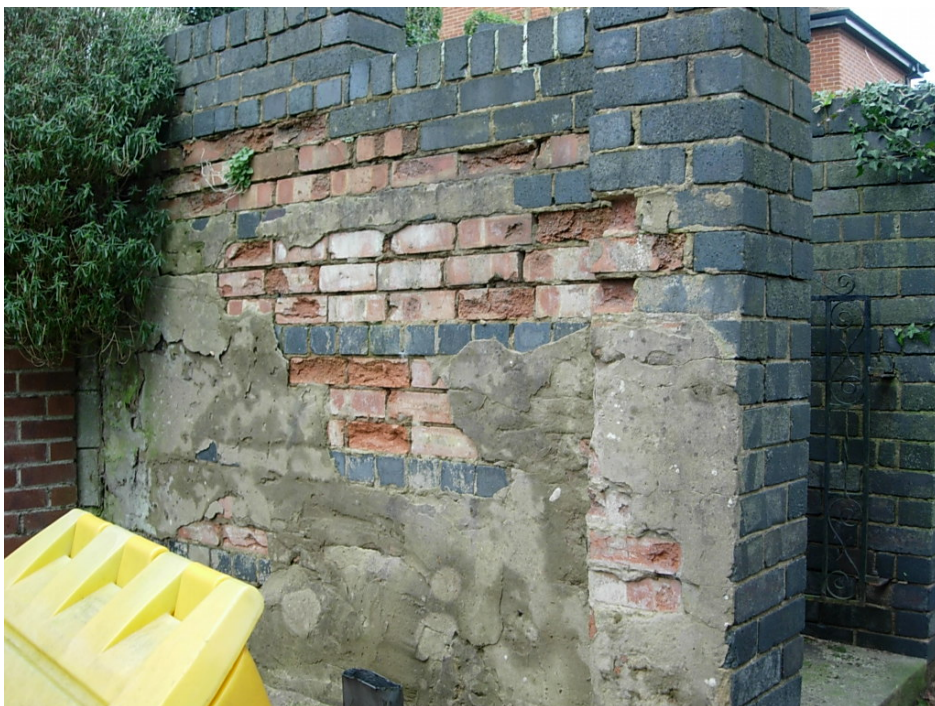
A picture of the brick wall on Berry's Lane before its improvement.

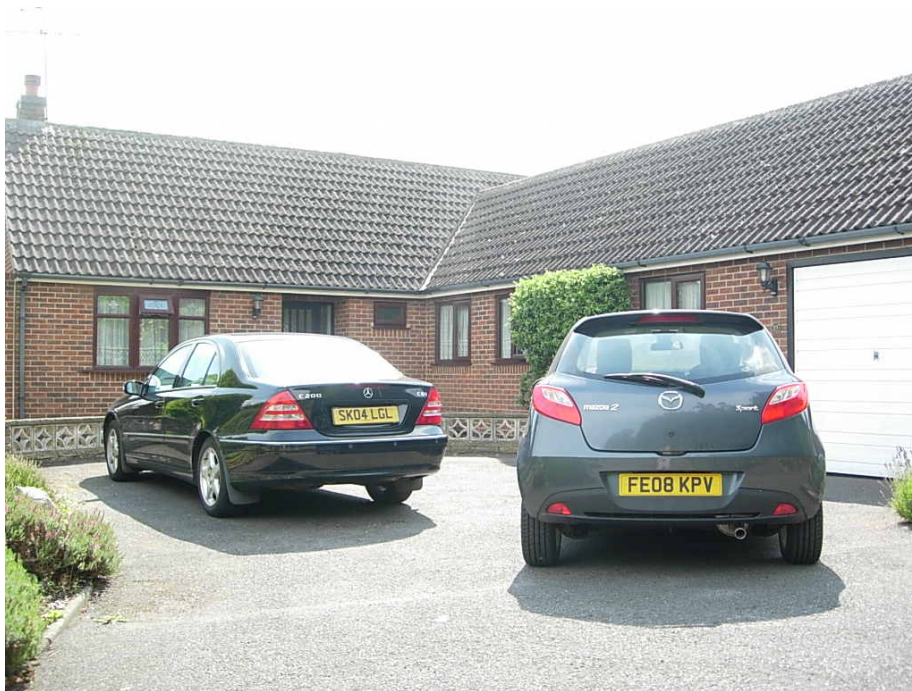
The form, materials used and detail design of these two bungalows are contrary to the traditional qualities of the Conservation Area.

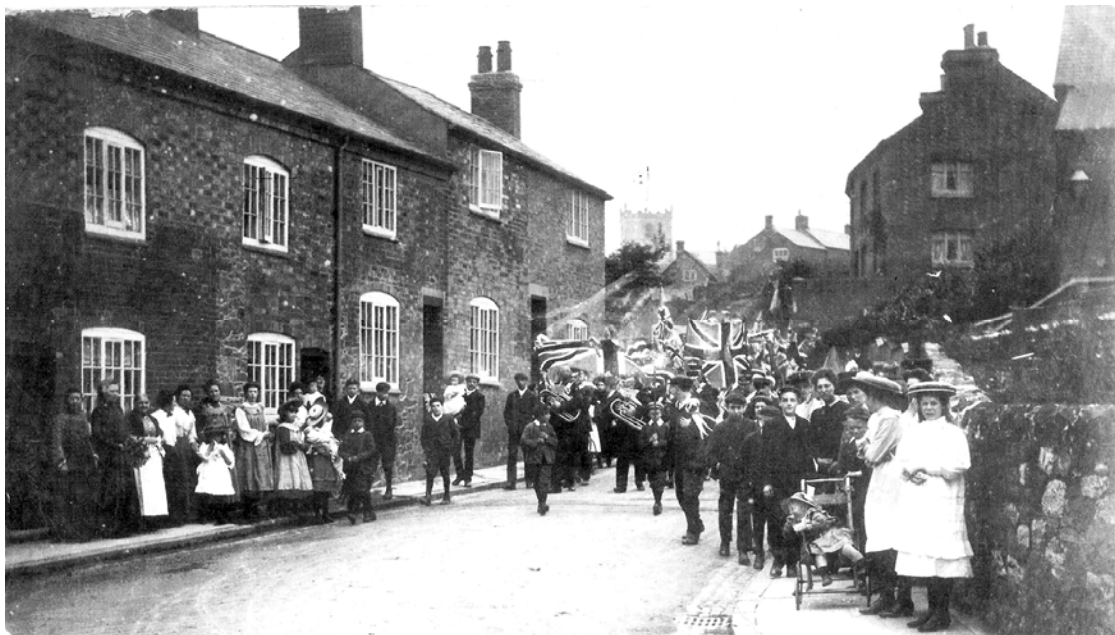
Unfortunately this terrace has lost some chimneys, had others truncated and the segmental heads to its first floor window openings have been straightened. As a result there has been a loss of character in the streetscene.

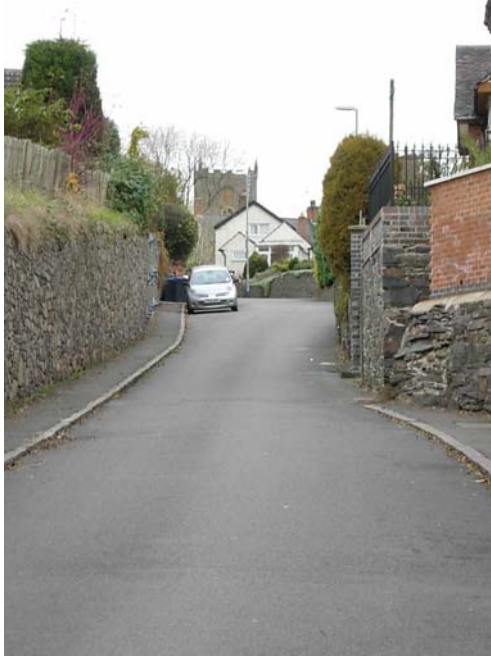
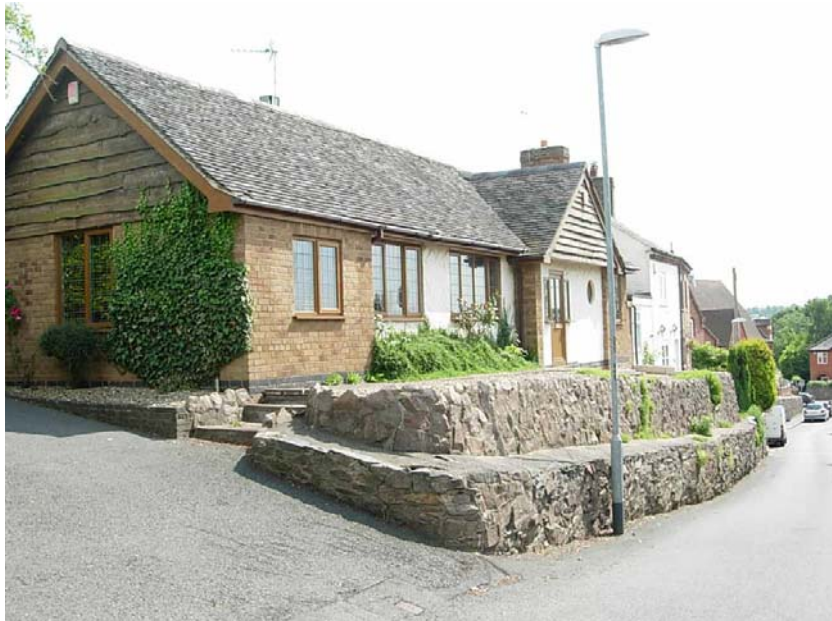
The brick retaining wall in this view along Chapel Lane would have enhanced this part of the Conservation Area if stone had been used instead.
