**SPECIFICATION AND SCHEDULE  
OF MINIMUM WORKS  
FOR  
STABLES  
TO BRADGATE HOUSE  
GROBY  
LEICESTERSHIRE**

**Date:** January 2024

**Reference:** EJM/CH/SPEC/22383-Minimum Works Schedule rev 2

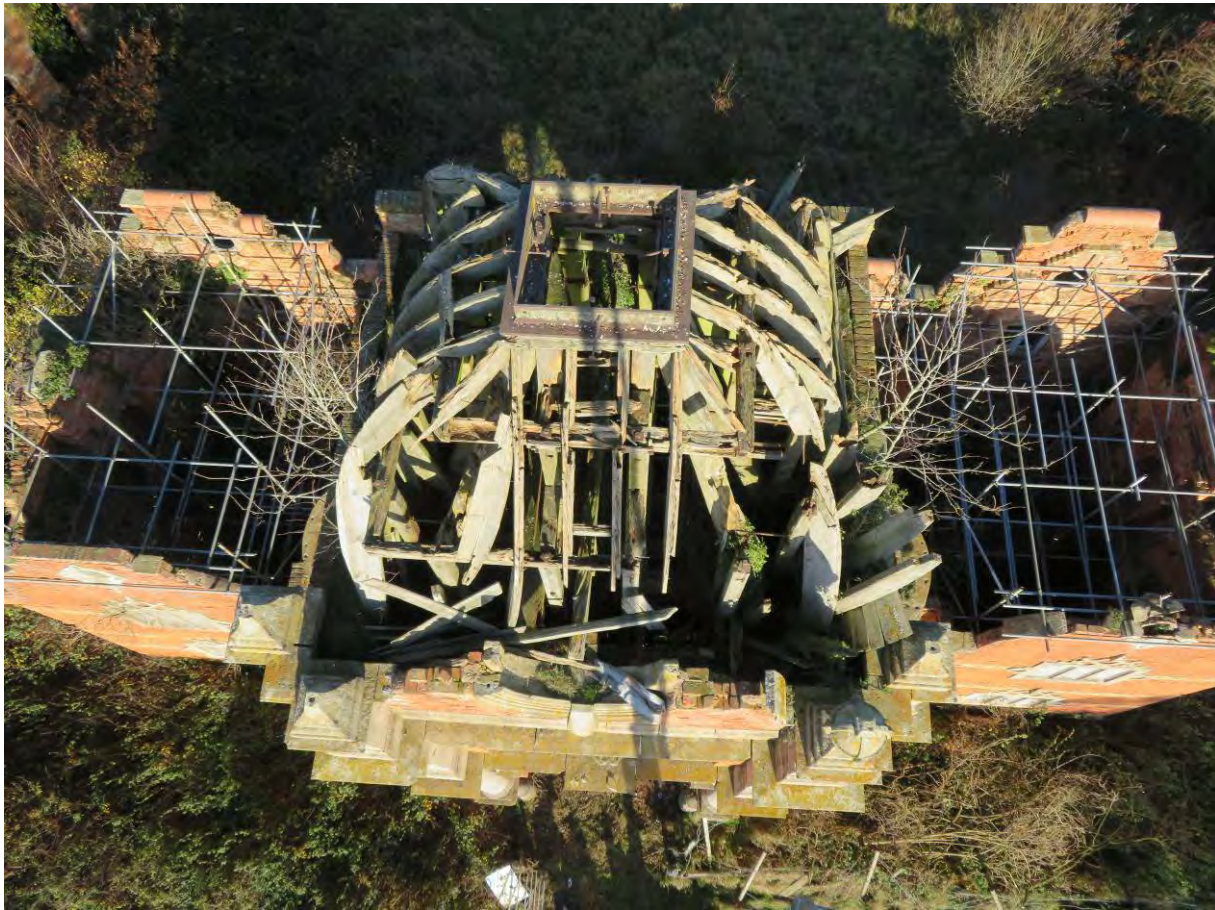
**Photograph 3:** South range tower - remaining timber roof, as seen from the cherry picker

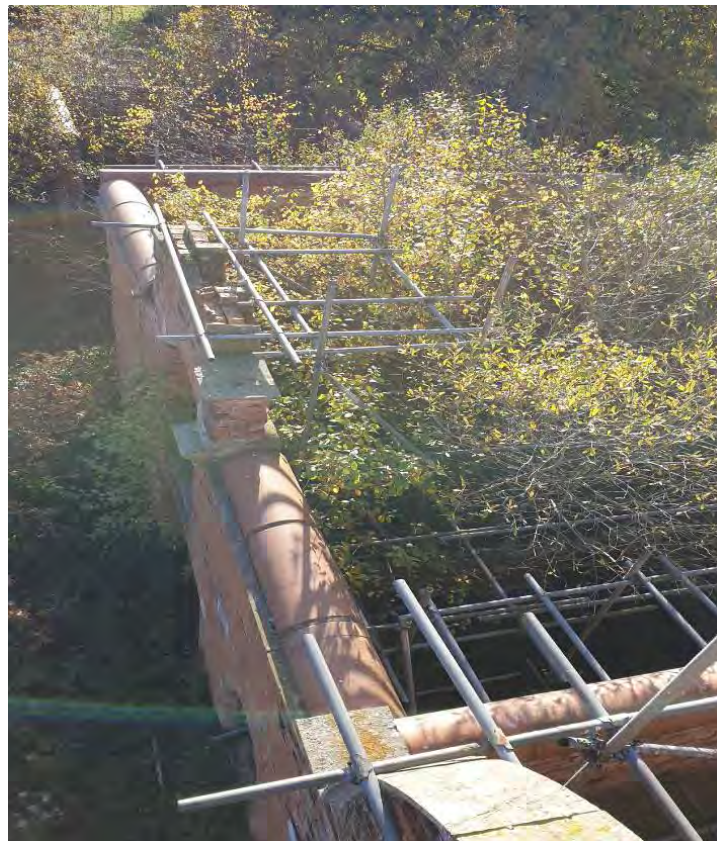
**Photograph 14:** Coping tiles from previous works to mitigate water ingress into the masonry fabric (west range - east elevation)

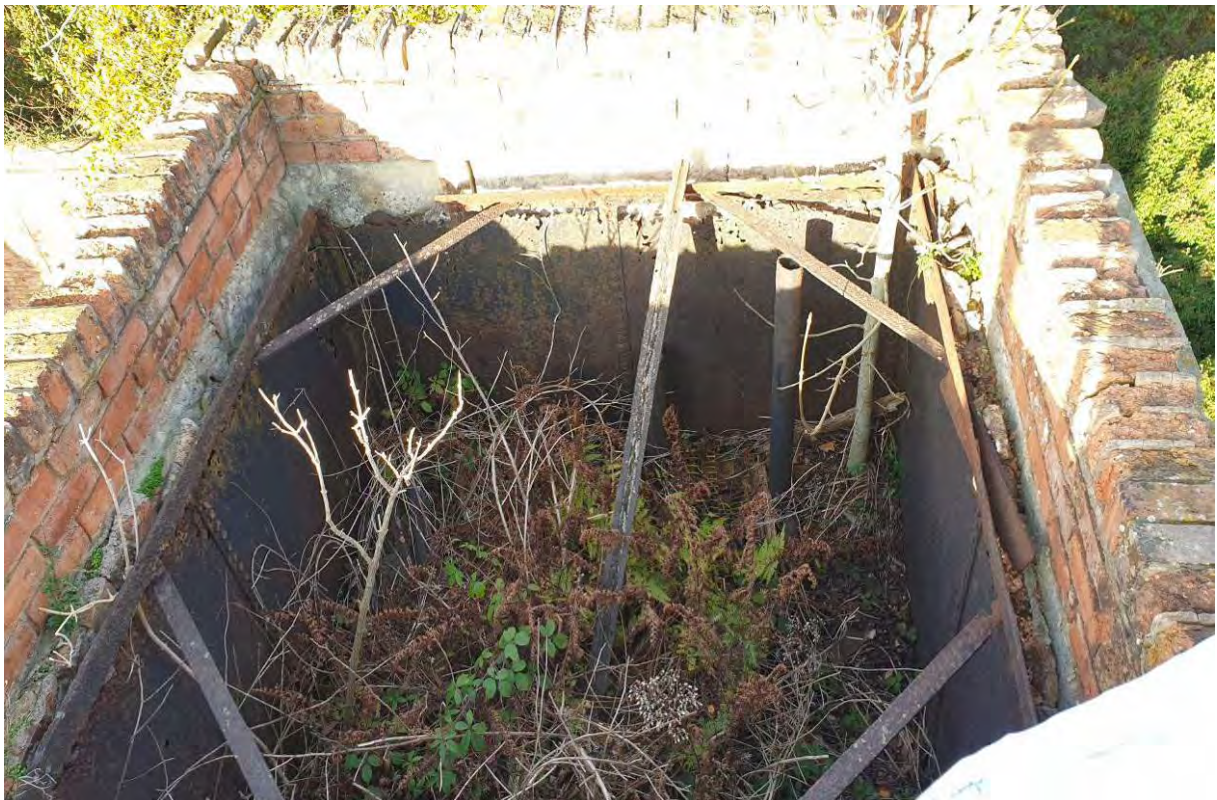
**Photograph 16:** Former water tank as seen from the cherry picker  
(north range - area '10')

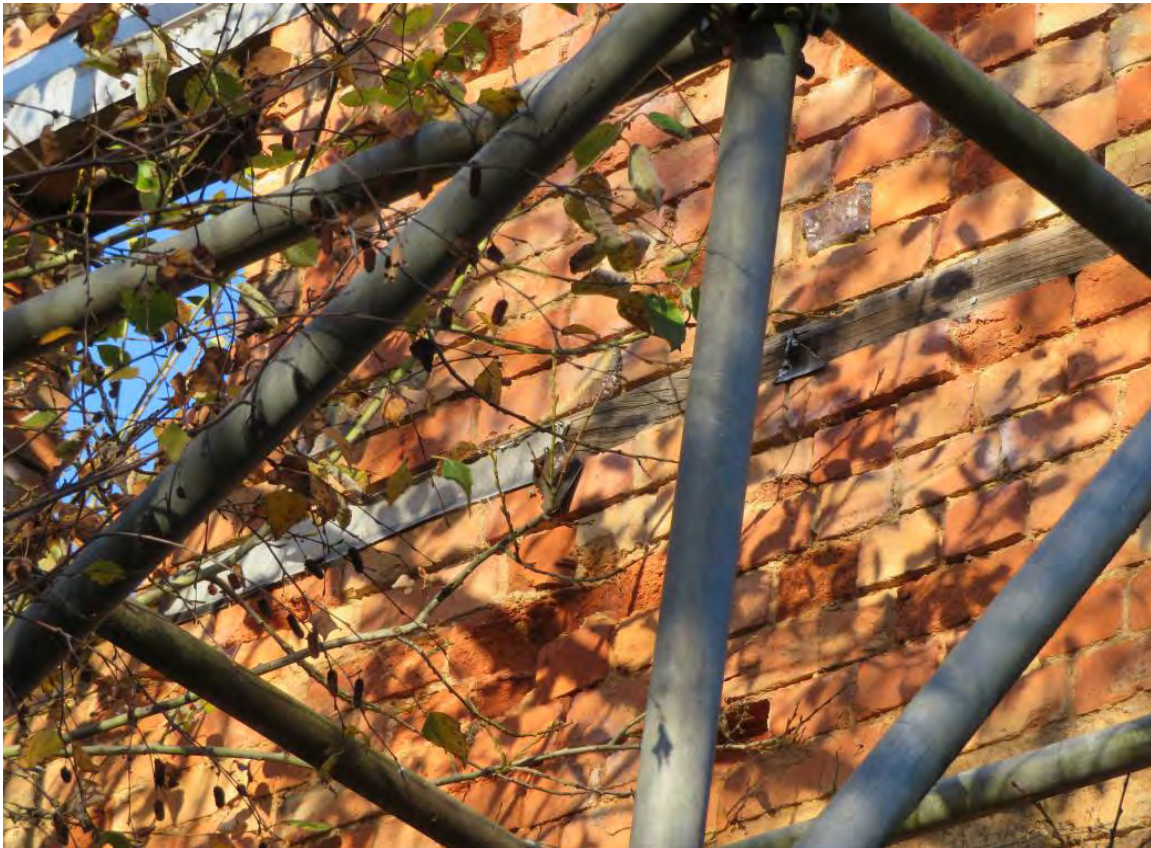
**Photograph 19:** High level bonding timbers between areas '2' and '3' (refer to TMP diagrammatic plan) with flashing over to protect

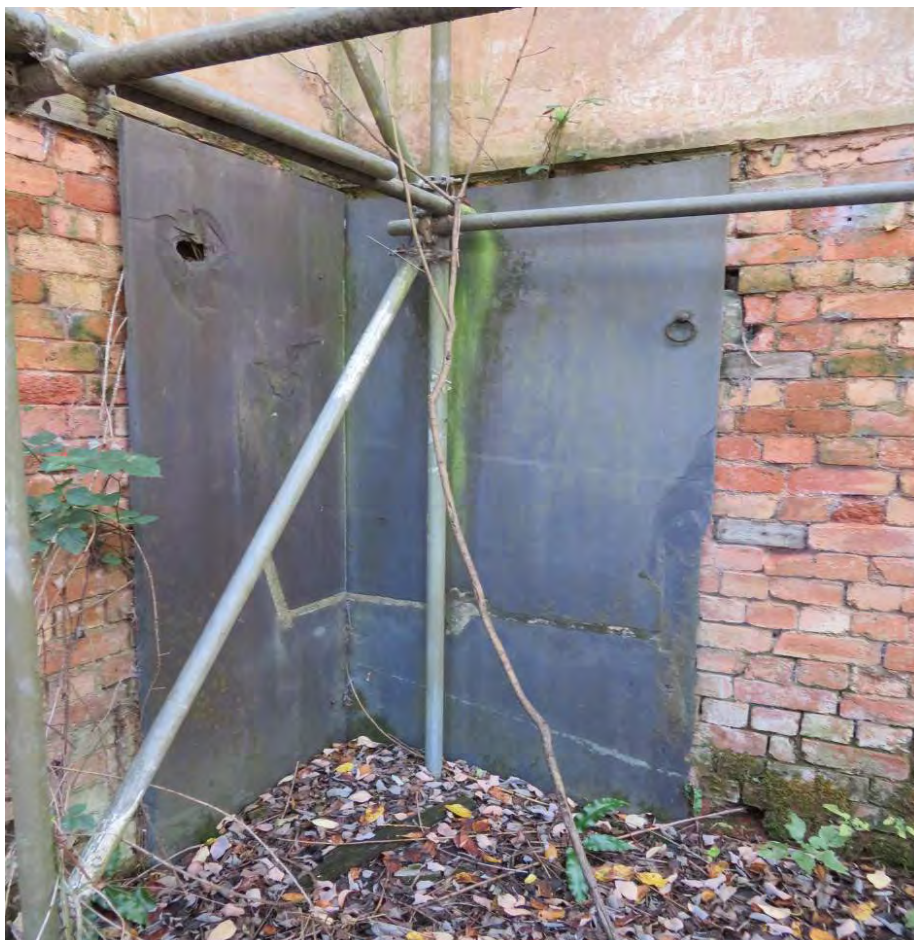
**Photograph 20:** Surviving slate backing for stables

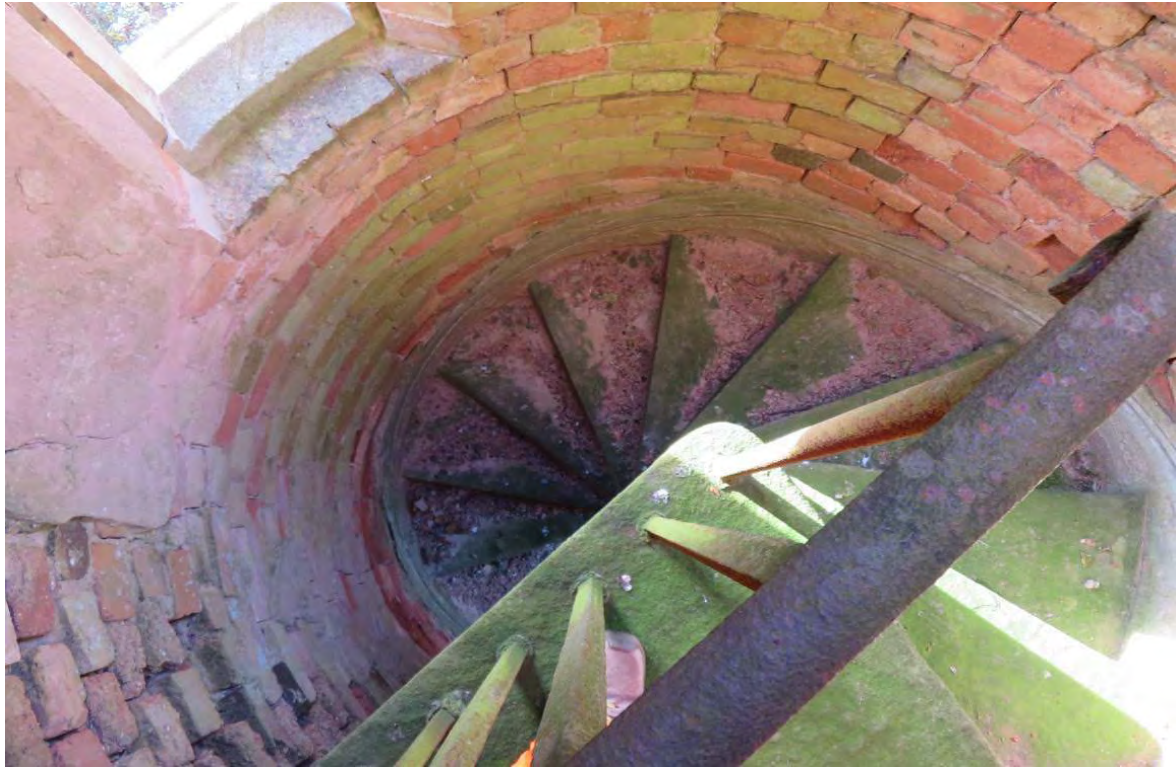
**Photograph 23:** Stone steps to tower stair (south range)

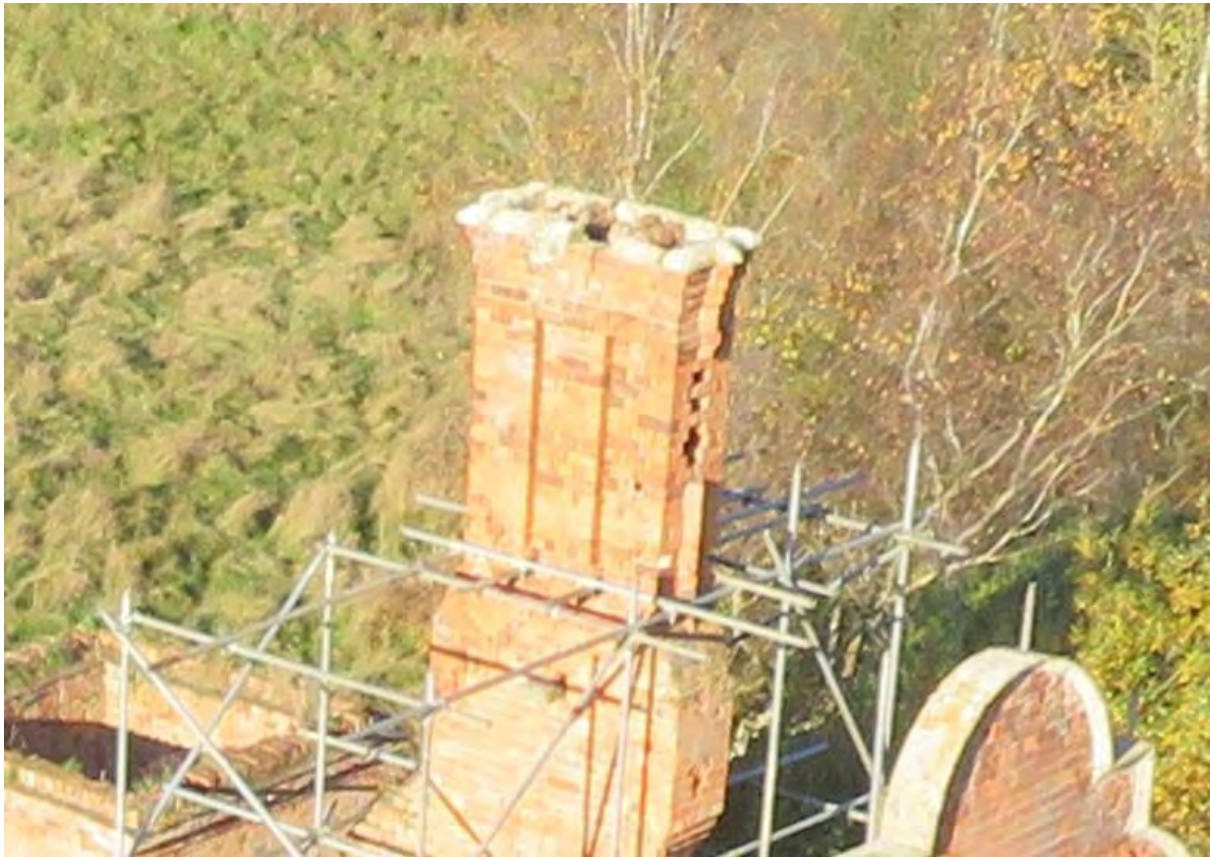
**Photograph 25:** Head of chimney Room 4, 4a, 4b and 4c

- 4.5.5 To chimney rising up from Rooms 4, 4a, b and c (see photographs 25 and 54). Urgent Work has been very recently undertaken by the owner. Temporary scaffold remains in place to provide lateral restraint.

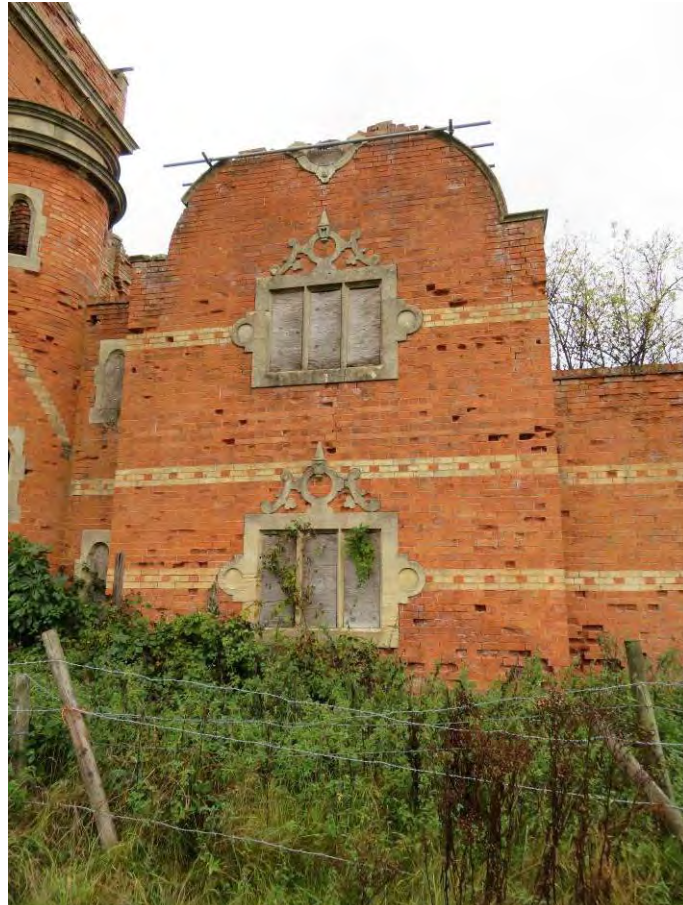
**Photograph 28:** South gable of Building 20

- 4.5.33 To Room 20, south elevation, where head of lost gable is exposed (see photograph 28) provide access, consolidate loose bricks, and allow to cap walls with half round drainage channels. (see photographs 39 and 40).

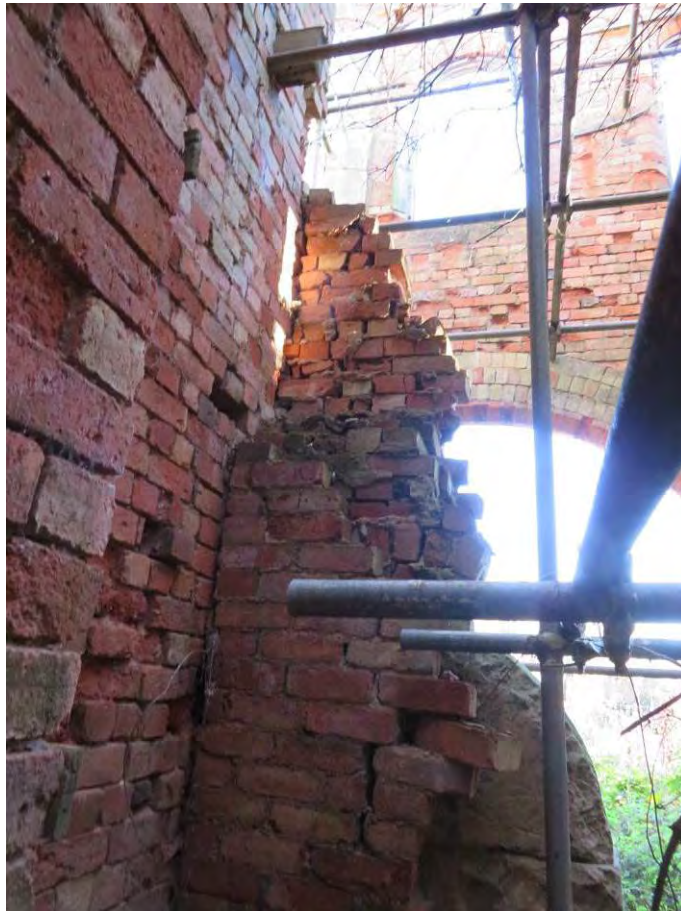
**Photograph 29:** Brickwork to niche to Room 4

- 4.5.11 To Room 4 at ground level there is a projecting section of brickwork forming a niche (see photograph 29) which is loose. Re-point/consolidate brickwork in 1:3 lime (NHL2) to sand mortar include flaunching to head.

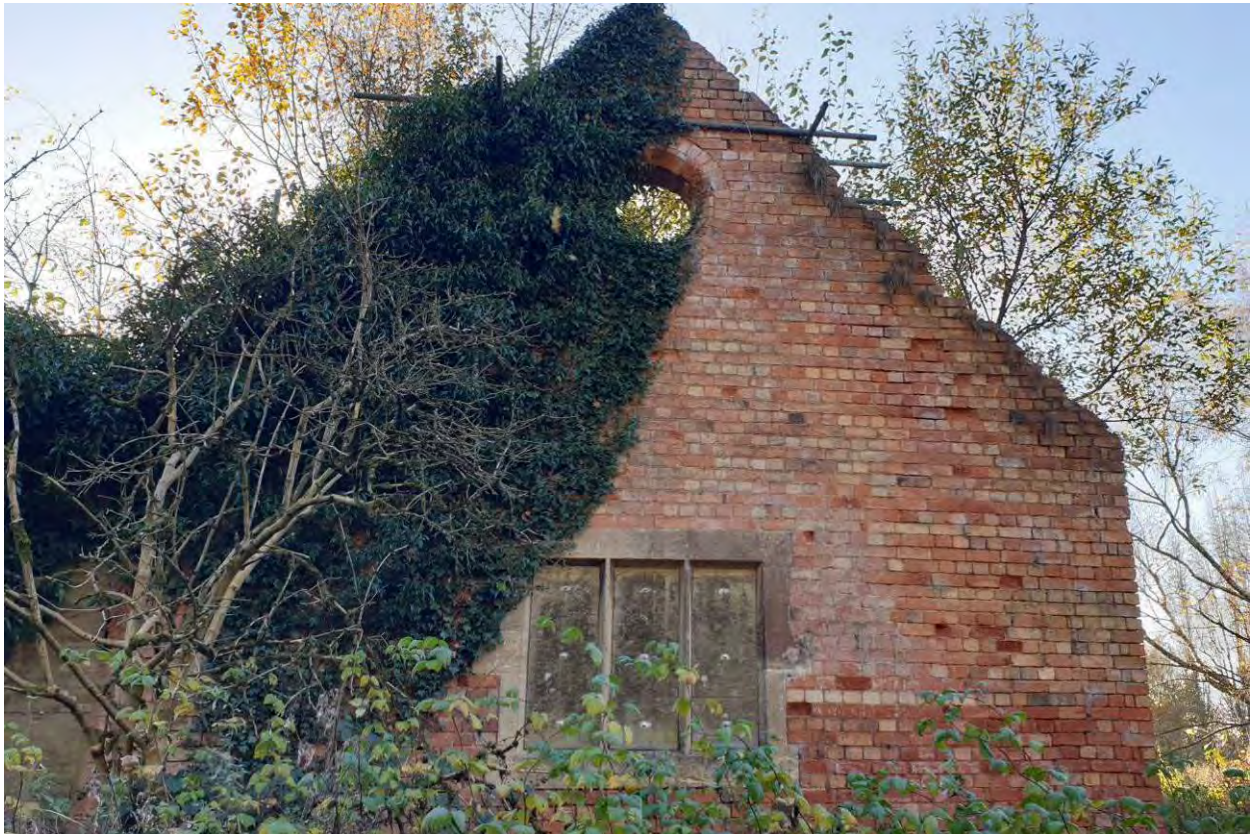
**Photograph 31:** North gable of Room 7

- 4.5.13 To Room 7 to north gable, once ivy is removed, mortar flaunch head in 1:3 lime (NHL5) to sand (see photograph 31).
- 4.5.14 To central high level gable of west wing allow for new horizontal stainless steel channel to rear face of gable and fixed in with 12mm s/s bolts set in resin at 350mm staggered centres. Allow for 2 Nr. stainless steel Diagonals to drop down to cross walls to north and south sides of Rooms 4 and 4a and fixed into masonry with 12mm s/s bolts set on resin at 350mm staggered centres.

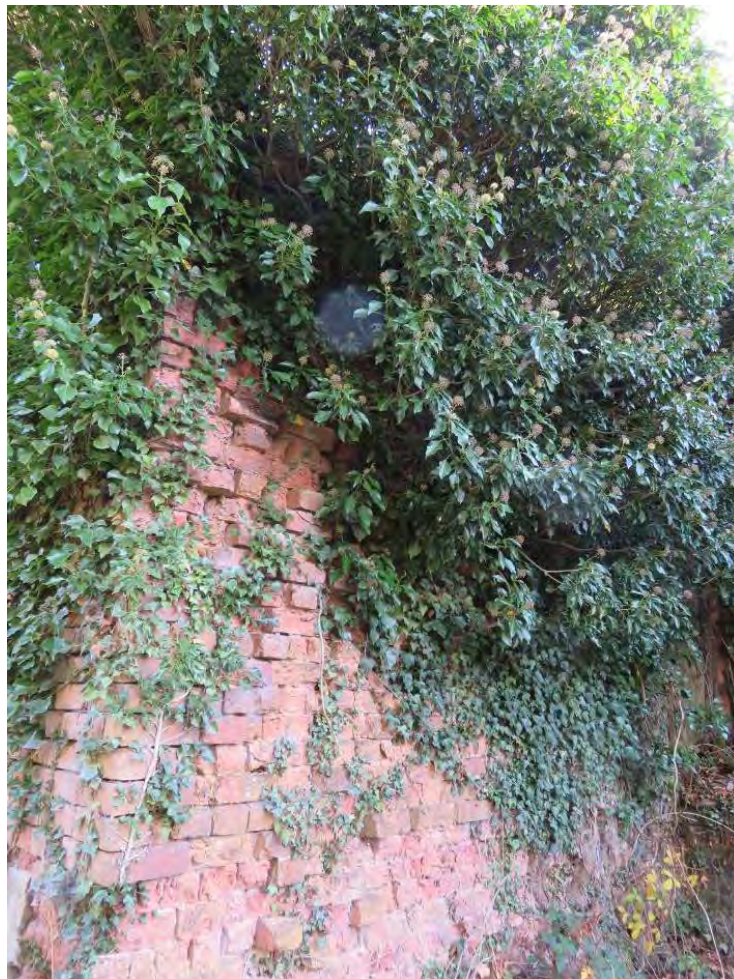
- 4.5.19 To external west facing wall of Room 9a the wall is in poor condition (see photograph 32).
- a) Once ivy removed allow to deep (up to 75mm deep) re-point 8.0m<sup>2</sup> of brickwork.

**Photograph 32:** West wall of Room 9a

- b) Allow to replace 30 Nr. Stretcher bricks to match existing.
  - c) Allow to replace 20 Nr. Header bricks to match existing.
- 4.5.20 To the east side of Room 9 where there is loose and unsupported brickwork (see photograph 22) allow to provide new stainless steel column rising off new mass concrete pad foundations to support the overhanging brickwork with head plate fixed with resin fixings. Include for removal of any hand loose bricks.

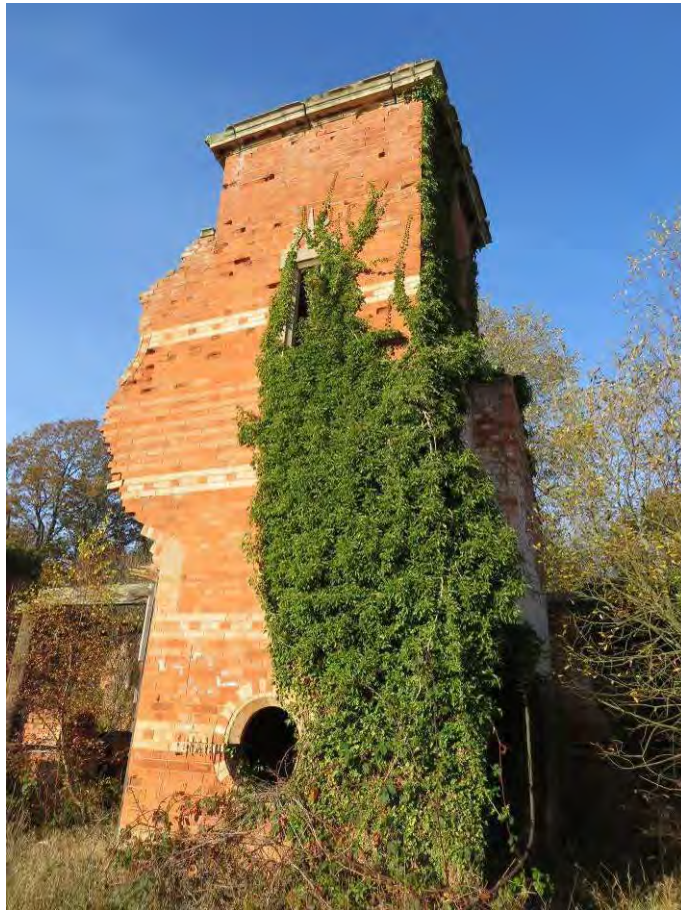
**Photograph 33:** Eroded mortar joints to tower head to Room 10

- 4.5.22 To Room 10 to tower, once ivy is removed allow to cap walls with half round drainage channels. Extend this to full perimeter of tower head where bricks and or stone pointing degraded (see photograph 33).

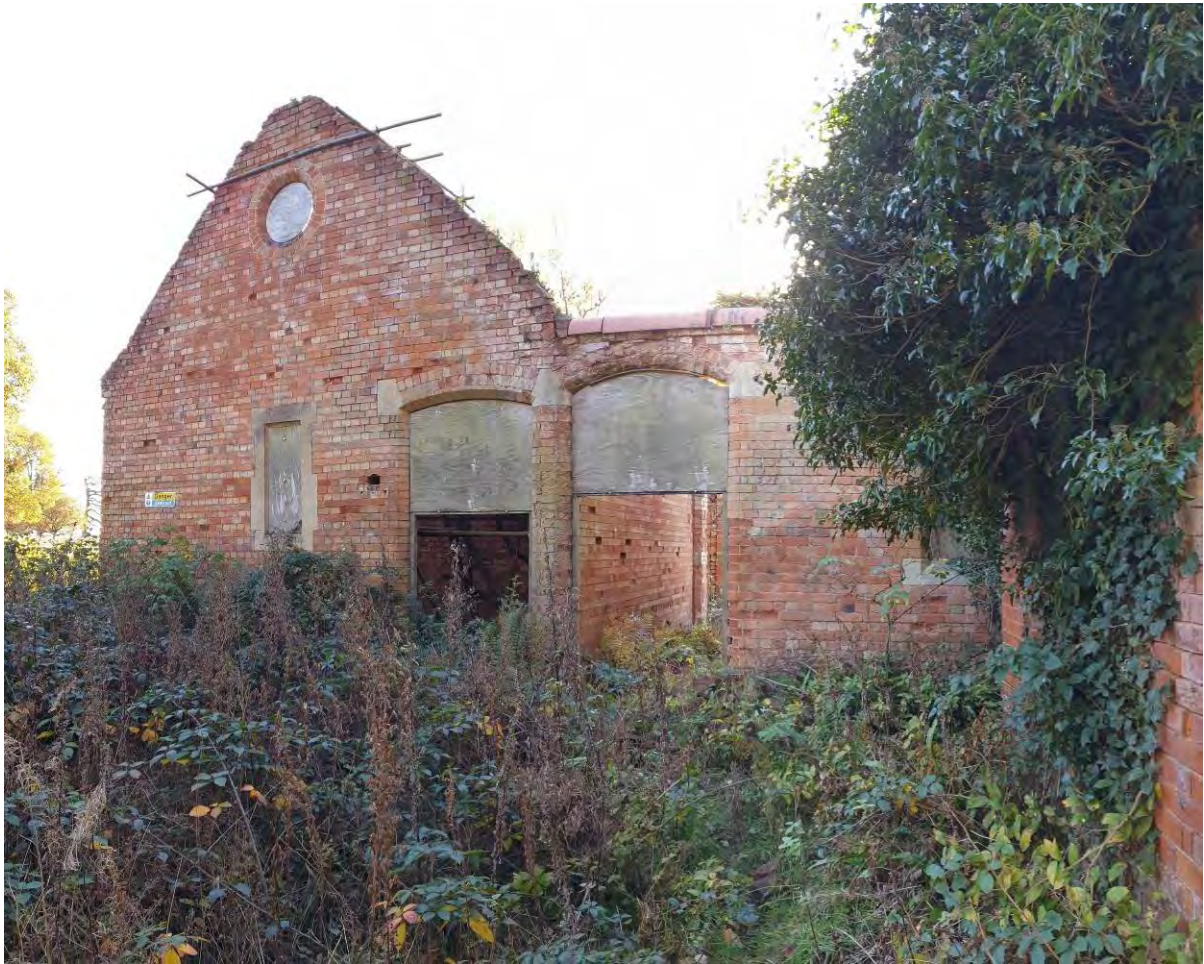
**Photograph 35:** North gable to Room 11

- 4.5.25 To Room 11 to north gable, once ivy is removed, mortar flaunch head in 1:3 lime (NHL5) to sand (see photographs 35 and 36).
- 4.5.26 Allow provisionally to Room 11 to install 1 Nr. horizontal stainless steel beam with end plates and 12mm s/s fixings set in resin set into the east and west walls. Allow to span a diagonal stainless steel off the beam and rising up the north gable with end plate fixed to the wall to provide stability.

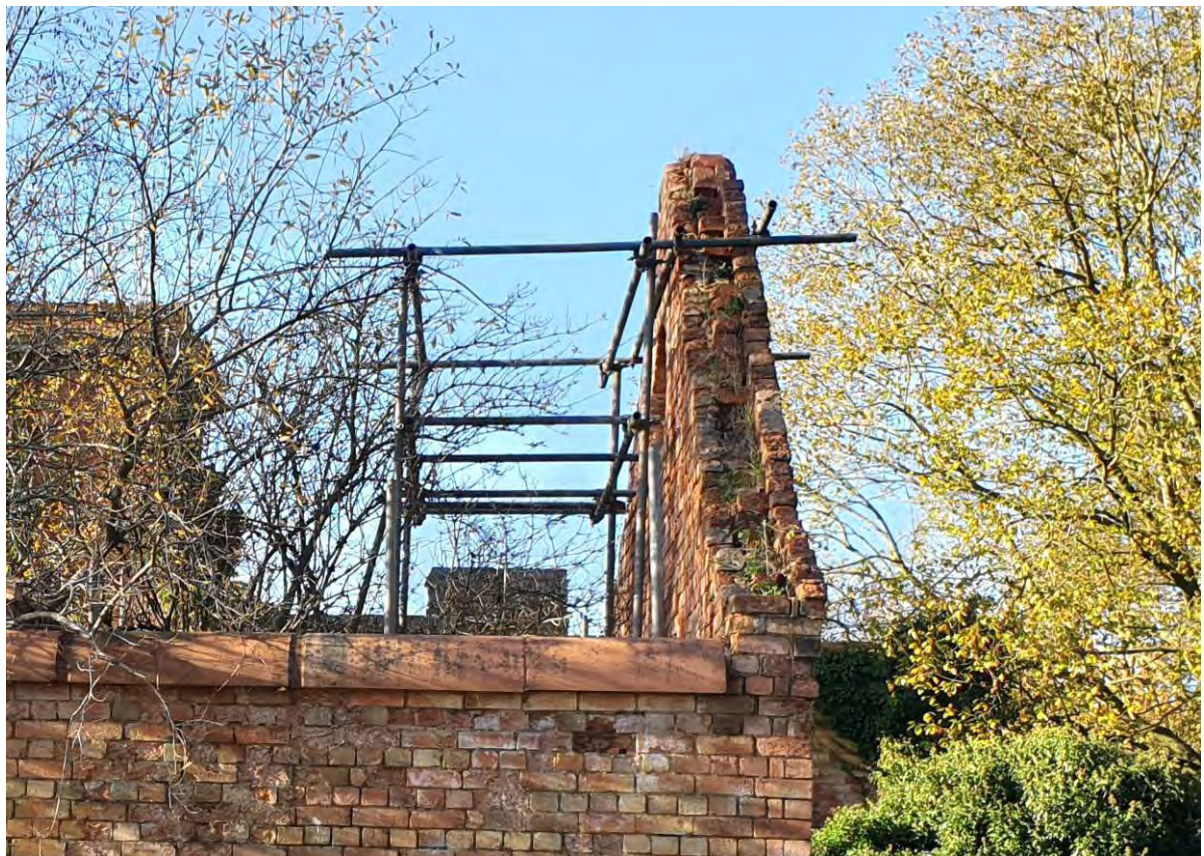
**Photograph 36:** Wall head to north gable of Room 11

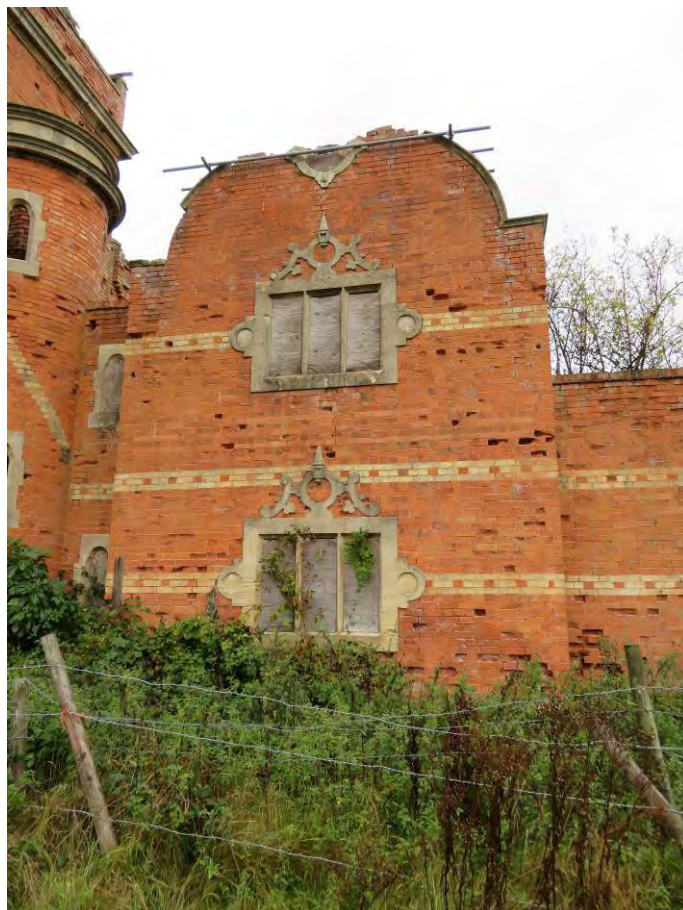
**Photograph 39:** South gable to Room 20

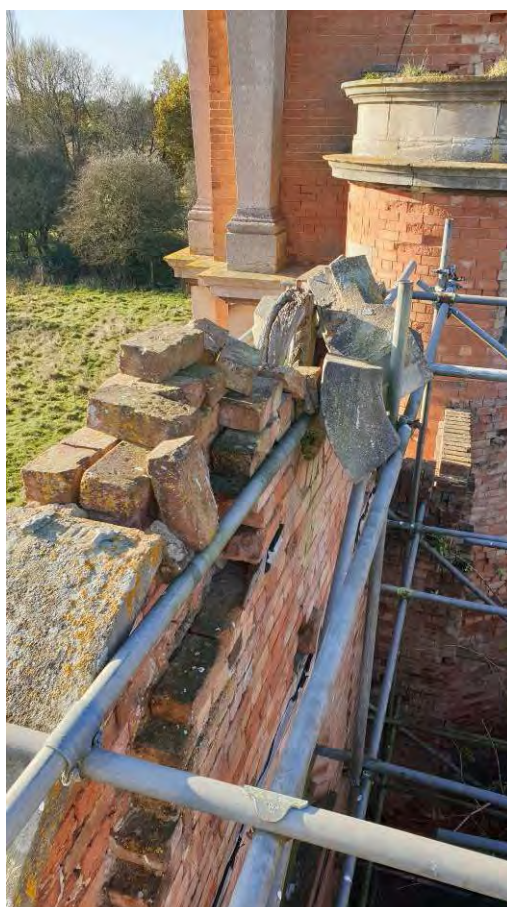
**Photograph 40:**Head of south gable to Room 20

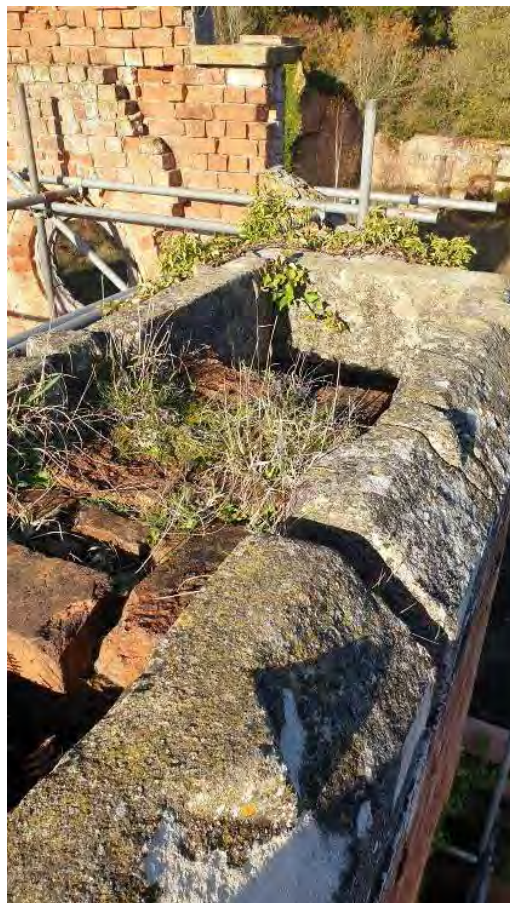
**Photograph 42:** Chimney to east side of Rooms 20a and 20b

- 4.5.36 To 2 Nr. chimneys rising up to east wall of Room 20 a and 20b respectively provide high level access and for re-pointing all of head stonework/brickwork (see photograph 42).

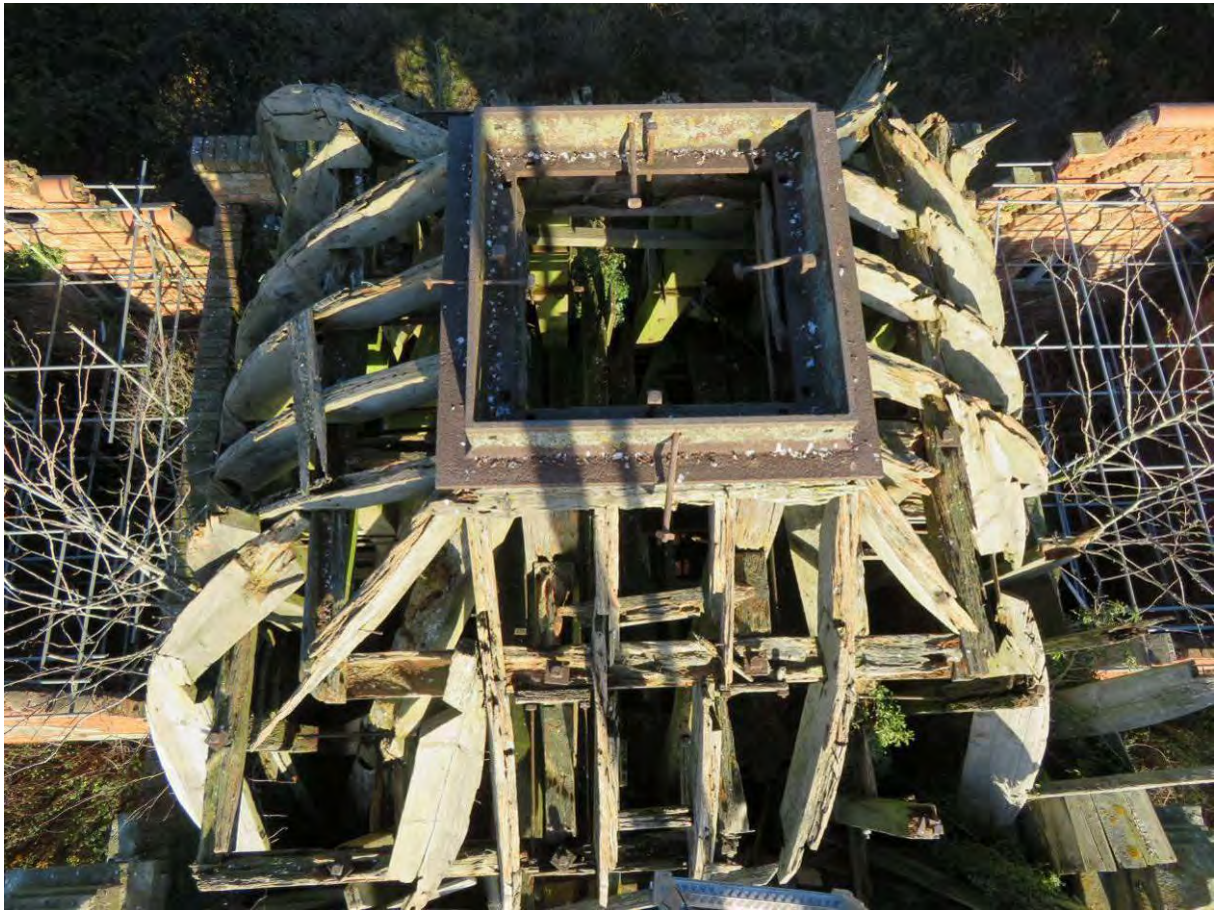
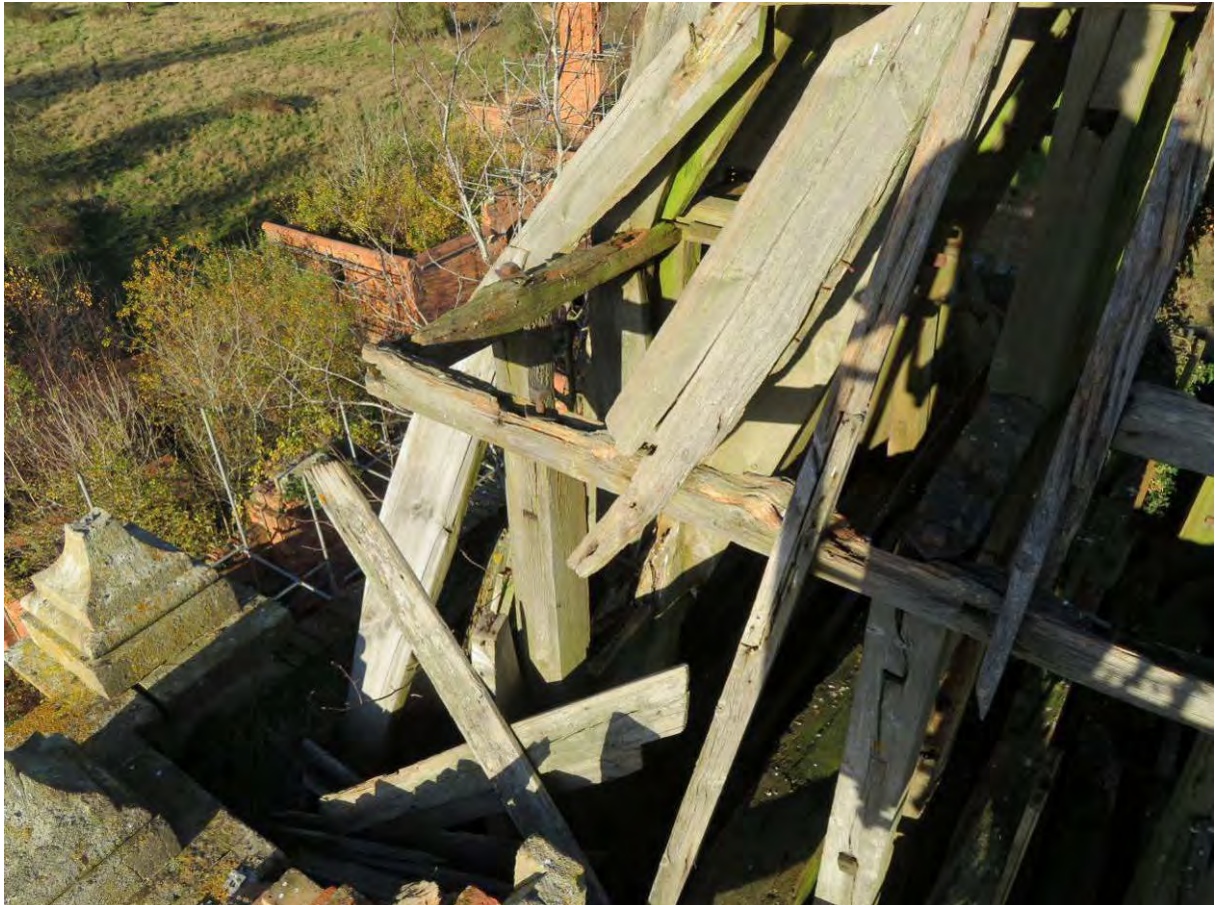
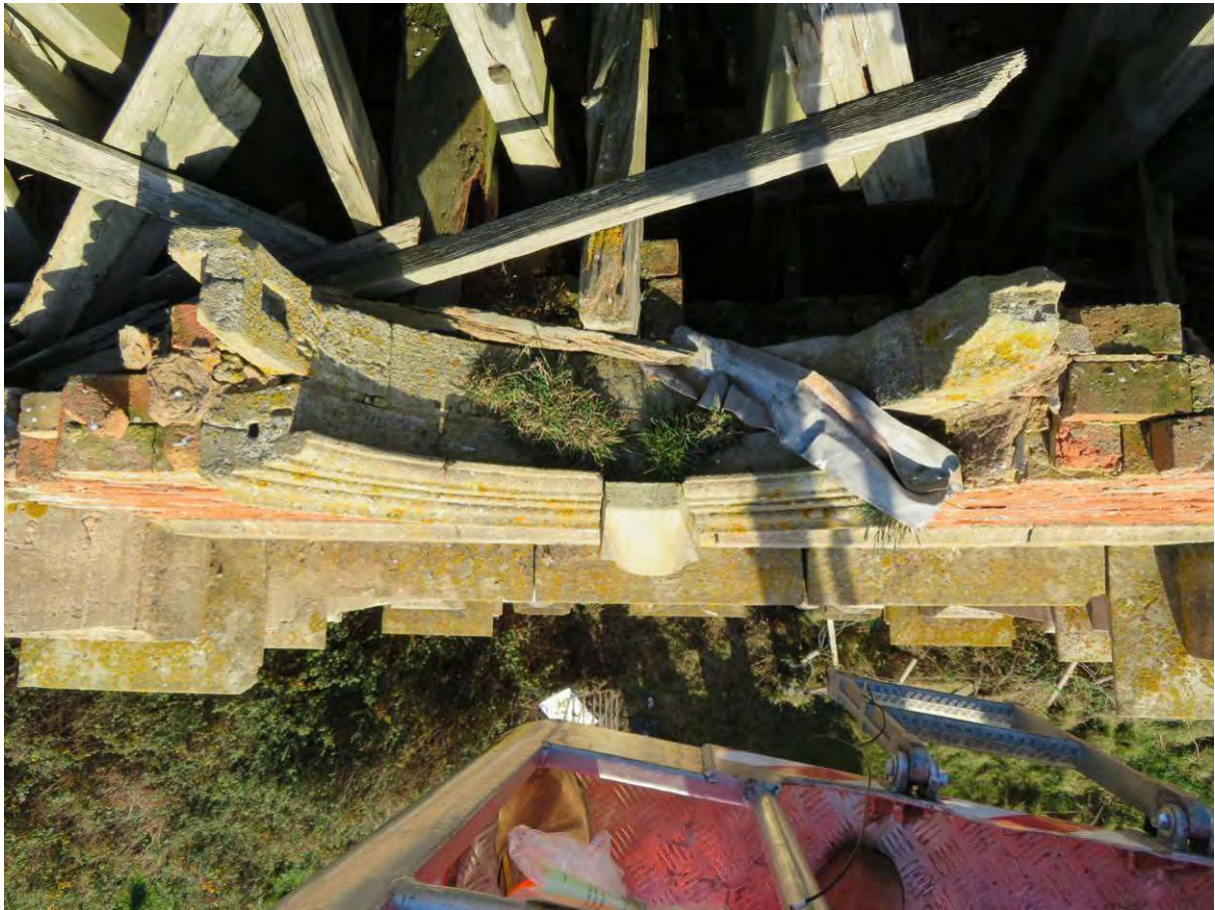
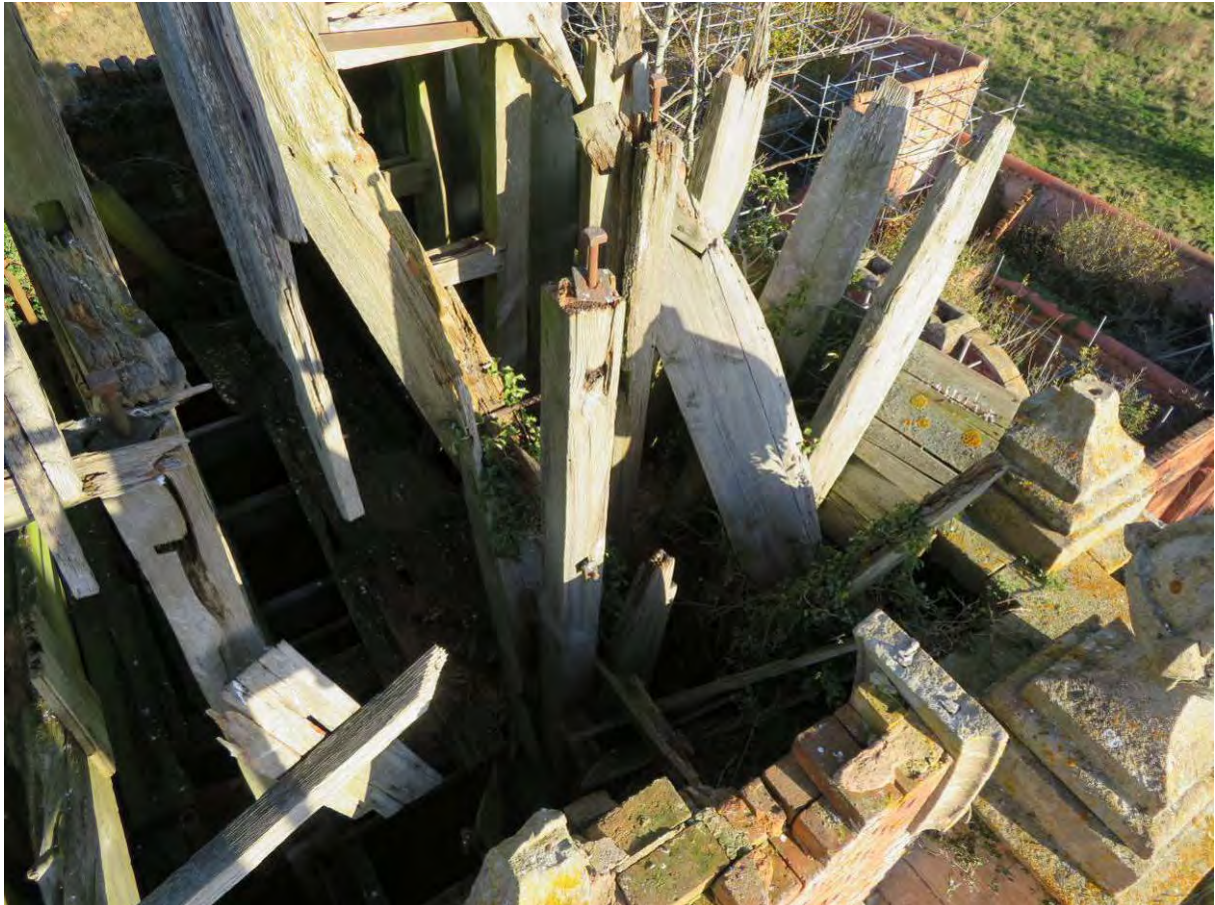
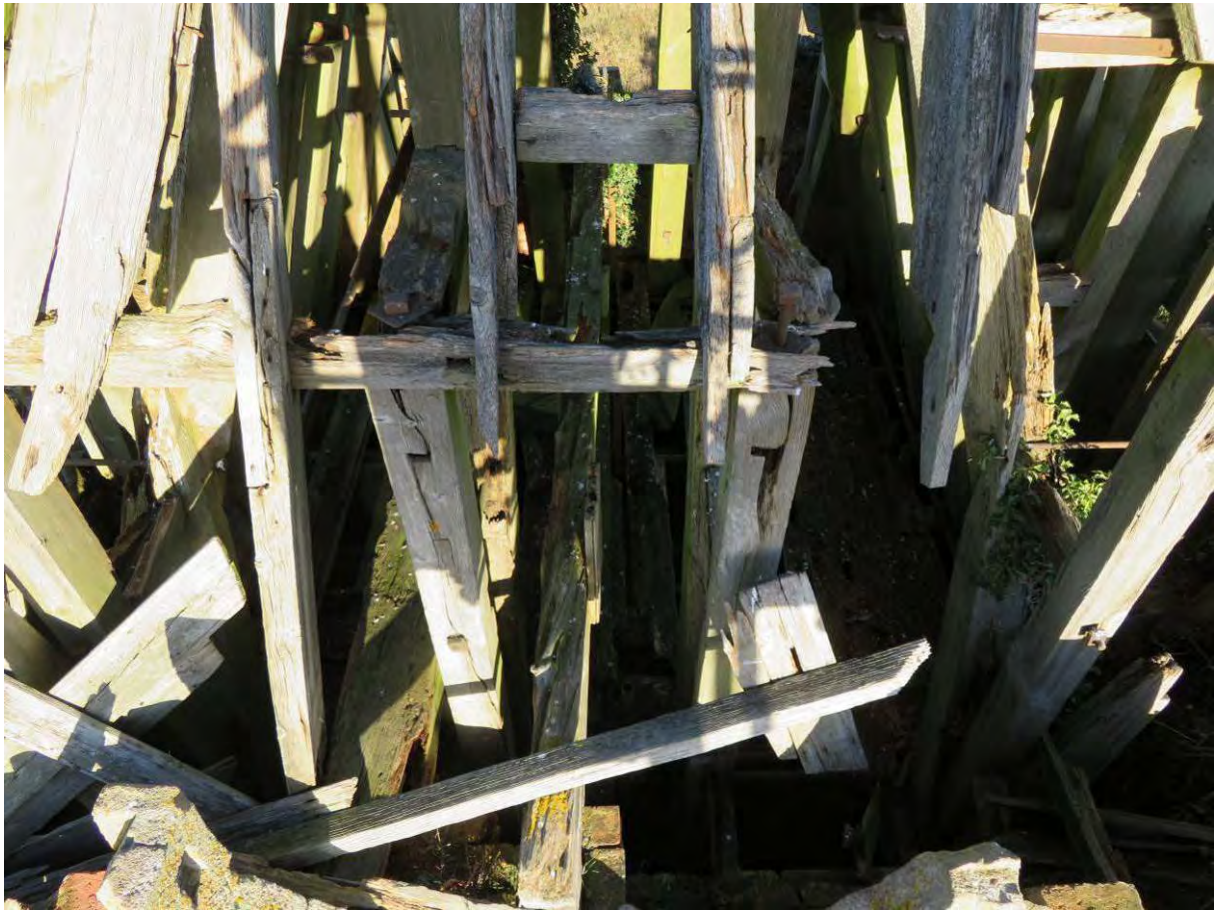
Photograph 43: Tower roof structure

Photograph 44: Tower roof structure

Photograph 45: Tower roof structure

Photograph 46: Tower roof structure

**Photograph 47: Tower roof structure**

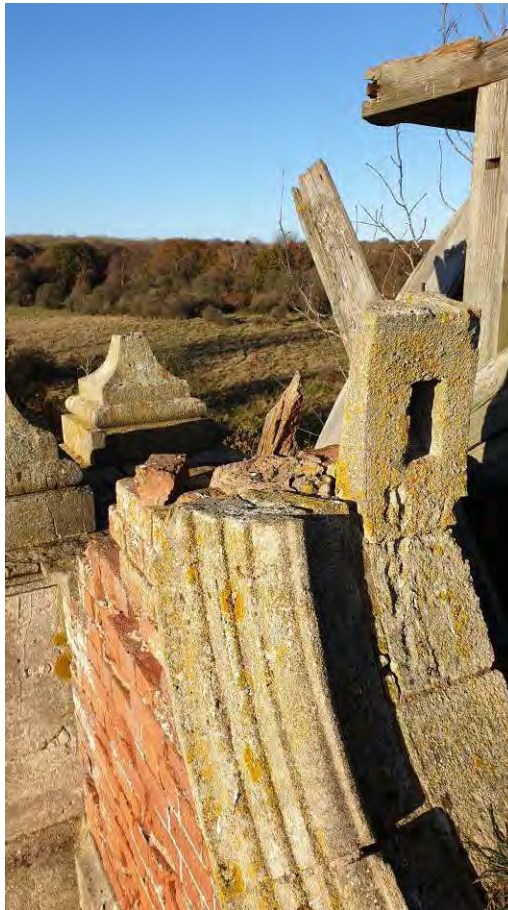
**Photograph 49:** Head of opening to tower to south side

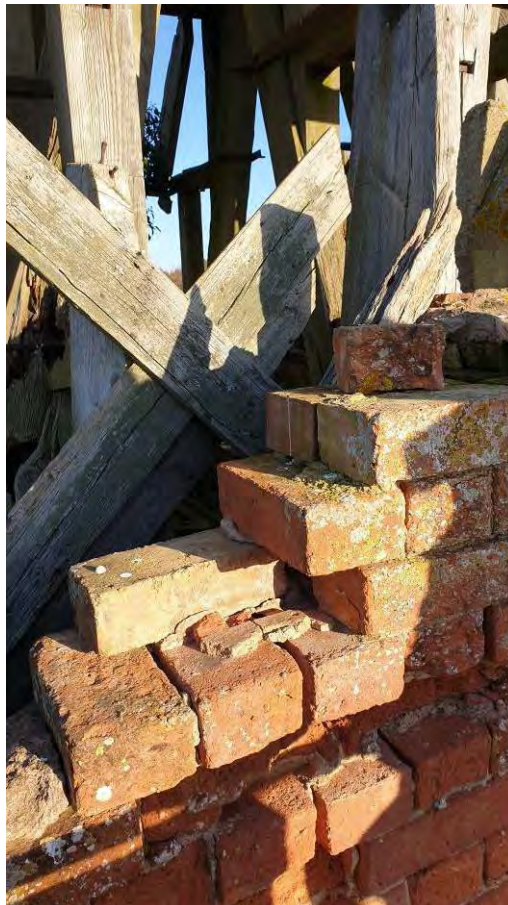
**Photograph 50:** Brickwork to head of tower Room 21

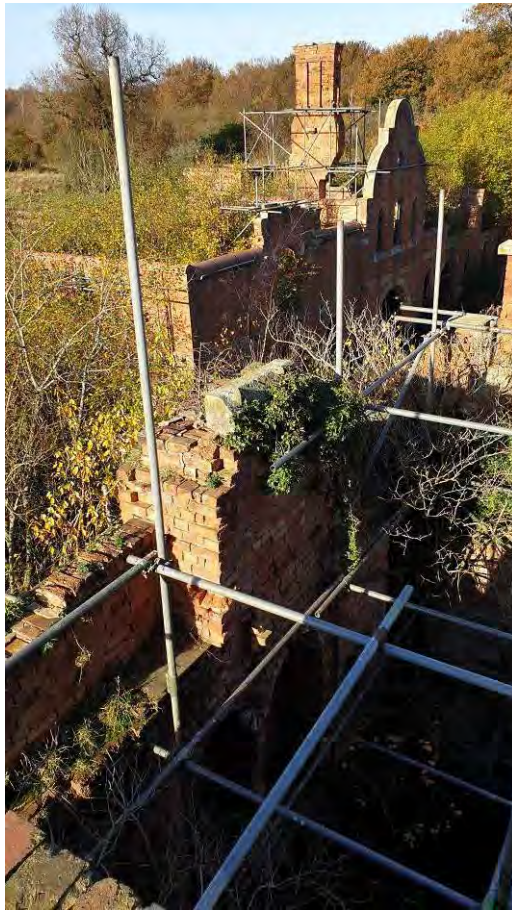
**Photograph 51:** Chimney and wall head to west of Room 22

- 4.5.40 To 1 Nr. chimney rising up and wall to west wall of Room 22a and 22b provide high level access and for re-pointing all of head stonework/brickwork (see photograph 51).

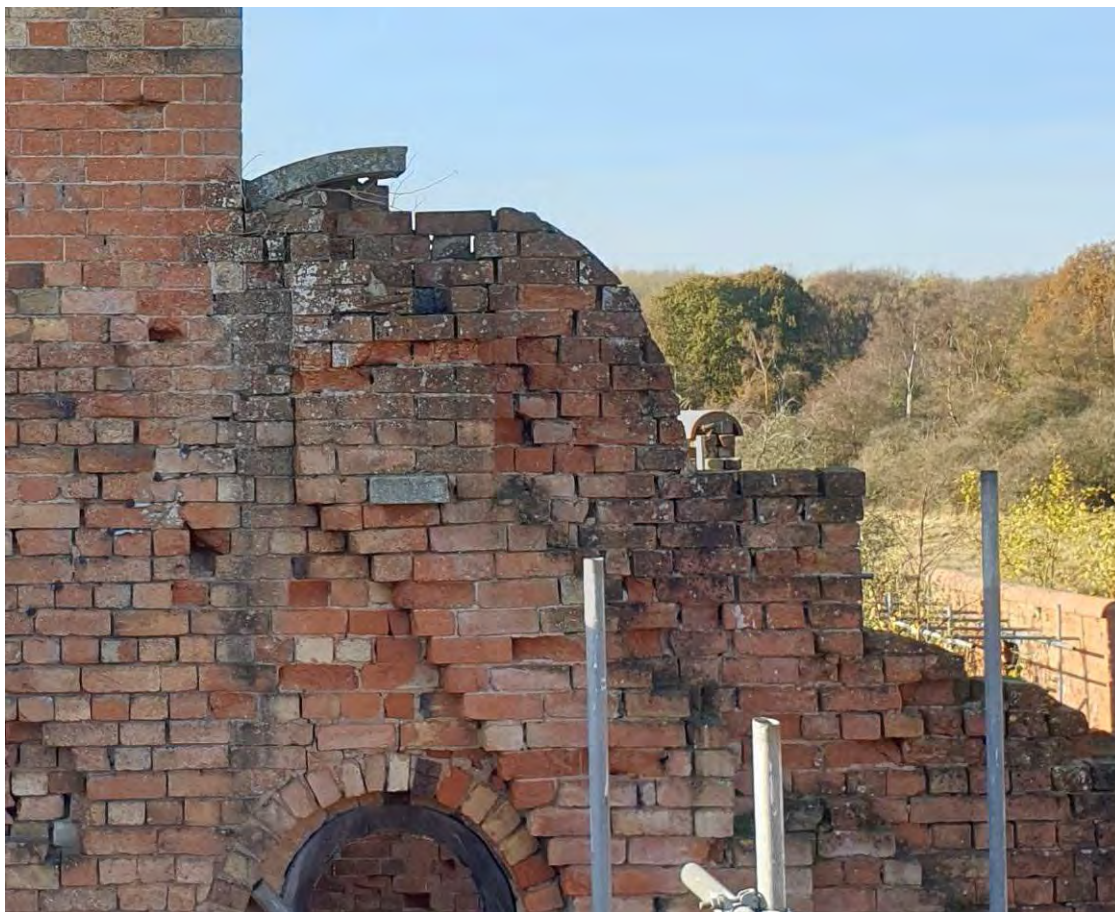
**Photograph 53:** Head of gable to Room 20 to west side

- 4.5.35 To head of the west wall of Room 20c, provide access gable over to re-point and flaunch wall head (see photograph 53) including consolidating all loose masonry.
