**SPECIFICATION AND SCHEDULE  
OF MINIMUM WORKS  
FOR  
STABLES  
TO BRADGATE HOUSE  
GROBY  
LEICESTERSHIRE**

**Date:** January 2024

**Reference:** EJM/CH/SPEC/22383-Minimum Works Schedule rev 2

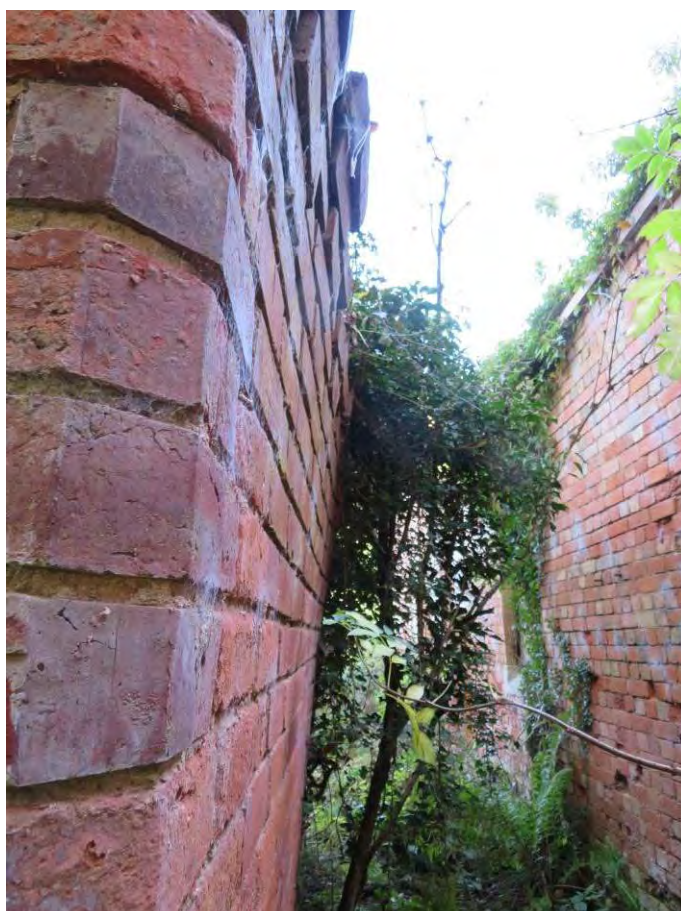
**Photograph 56:** Leaning south wall of kennels

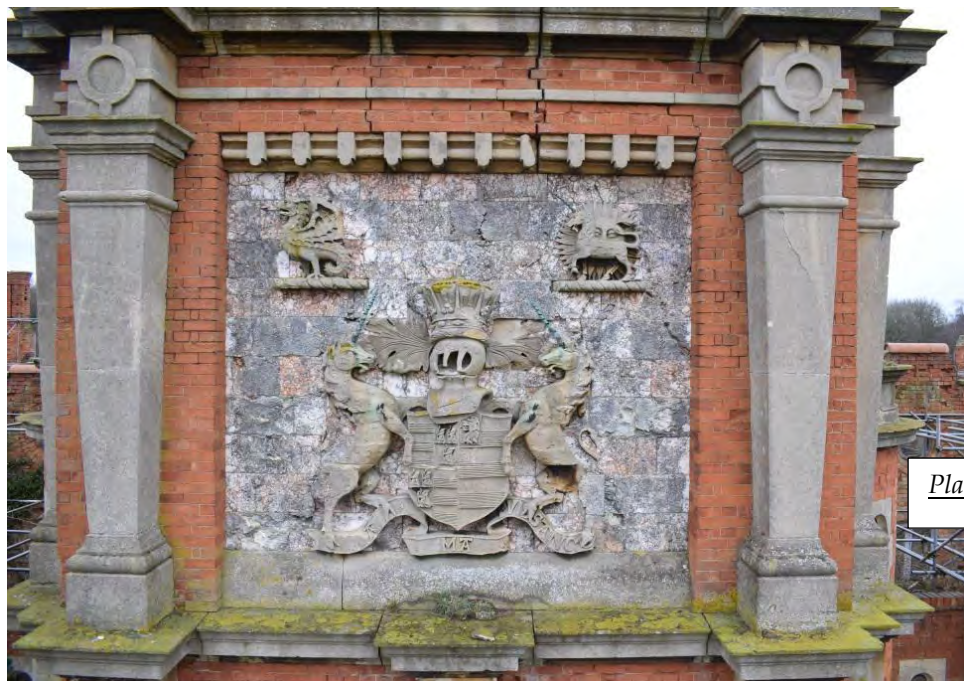
*Plate 3*

As can be seen from Plate 3, above, the arms, which are of the 7<sup>th</sup> Earl of Stamford, comprise the shield with the arms to the dexter side of quarterly, 1<sup>st</sup> and 4<sup>th</sup> Barry of six argent and azure, 2<sup>nd</sup> and 3<sup>rd</sup> three boars' heads sable. To the sinister side is a quarter with a lion's head set against a Barry – I'm not sure of the arms here. The supporters are two unicorns, the helm above with elaborate mantling and the earl's coronet, and below the family motto *À ma puissance*. There are two heraldic crests set above; on the dexter side a wyvern; to the sinister the unicorn passant against the sun in splendour, of the Greys.

These are all of limestone. The source would need confirming by a Geologist but I suspect it is a Bath stone. It is the same stone used for the dressings of the general building features, used there in conjunction with red brick. The background to the arms is, as previously noted, of alabaster ashlar – which can be seen to be at least 90mm thick where and edge is exposed adjacent to the sinister unicorn's proper left hind leg. The ashlar can be seen to be

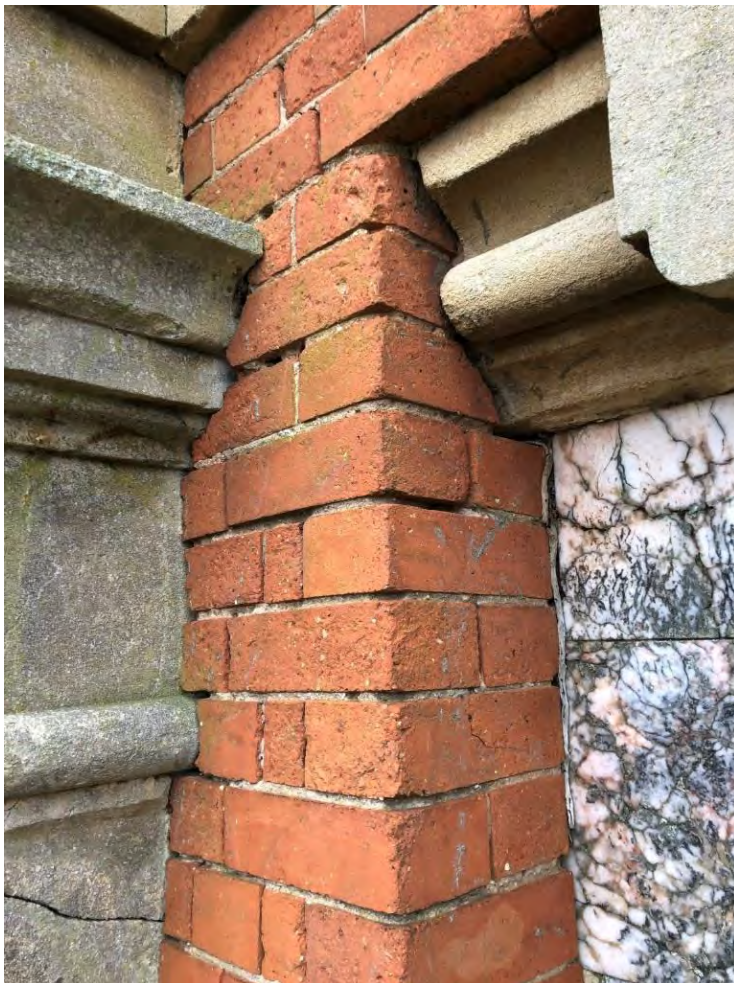
*Plate 4: The upper left-hand corner showing the alabaster rebated behind the brick and the brick and stone interlocking.*

*Plate 5: The upper right-hand corner showing the interlocking construction as well as the contrast in colours and textures of the materials.*

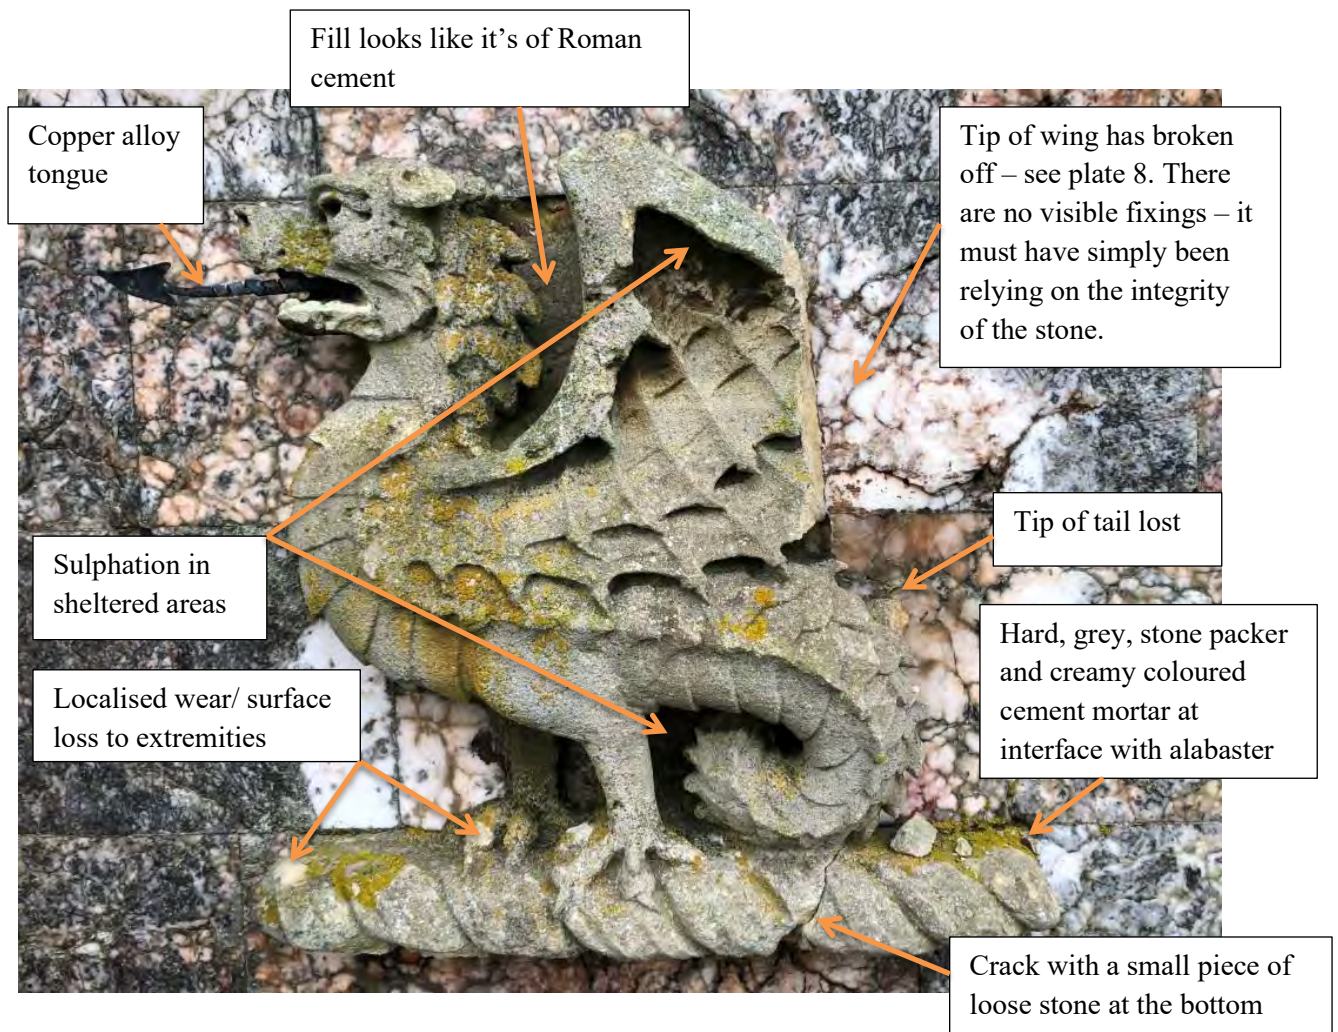
*Plate 7 (above): Annotated photo of the wyvern.*

The overall size of the exposed stone is 710mm high and 720mm wide.

- The rays of the 'sun in splendour' and the base of the unicorn and sun crest (see plate 6)
- The base of the Wyvern Crest (see plate 7)
- A section of mane on the dexter unicorn bearer (see plate 14)
- The tip of the tail to the sinister unicorn bearer (see plate 15)
- The proper left rear leg of the sinister unicorn bearer (see plate 15)
- The right vertical edge of the shield (see plate 15)

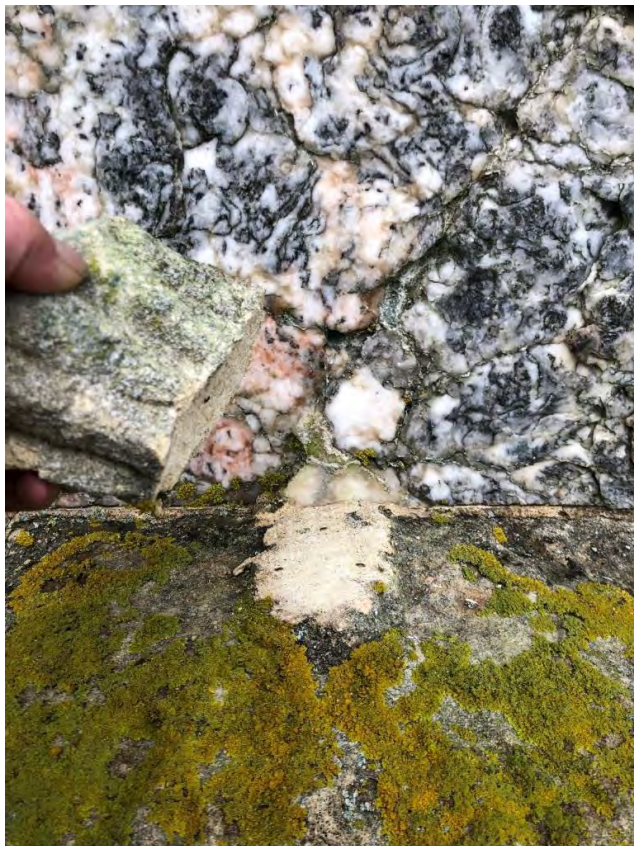
*Plate 10: Detail from plate 9 showing the tip of the coronet which has become completely detached. This was left in place for safe-keeping.*

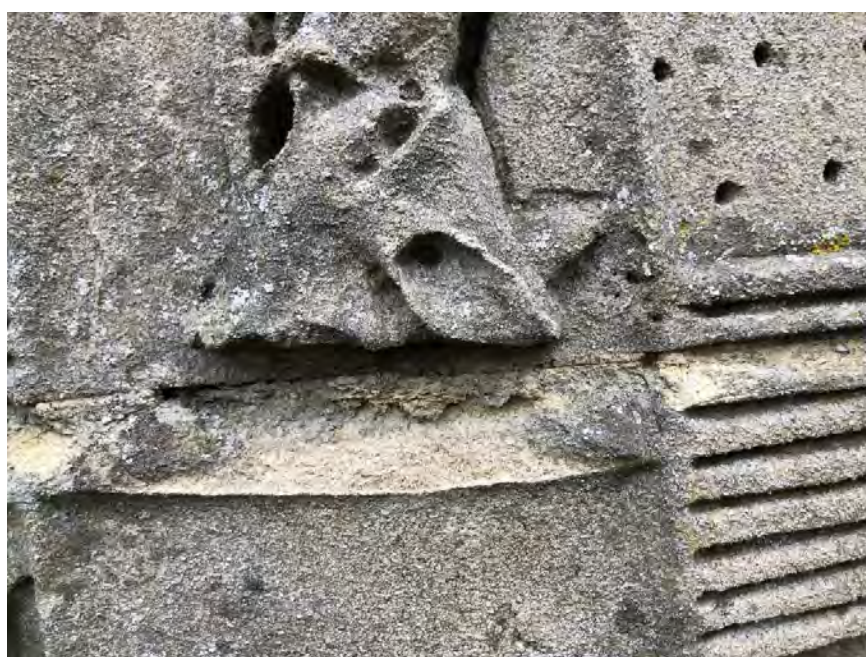
*Plate 13: Detail showing breakdown and recent loss of stone adjacent to the construction joint in the centre of the shield.*

- Parts of the helm (see plate 11)
- Adjacent to the construction joint in the centre of the shield (see plate 13)
