Hinckley & Bosworth Borough Council

## EARL SHILTON CONSERVATION AREA MANAGEMENT PLAN

PHOTOGRAPHIC RECORD OF EARL SHILTON CONSERVATION AREA

February 2010

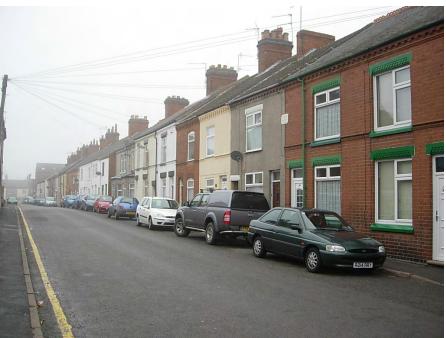
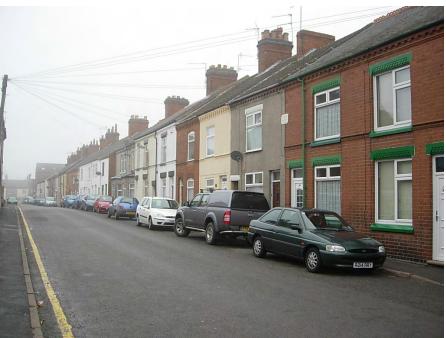
The view into the conservation area of the row of terraces along New Street identifies many excellent details including terracotta brickwork, window lintel details, and brick chimney stacks and stone pots.

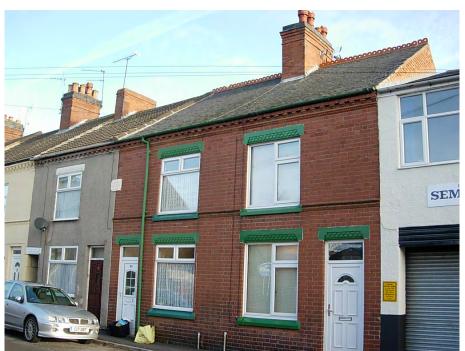
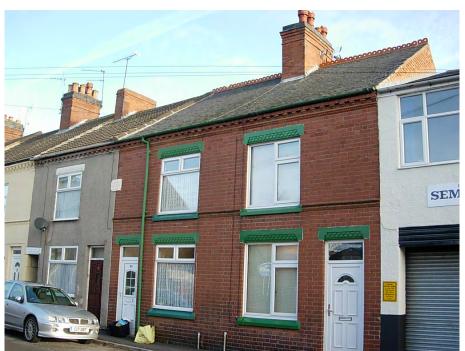
The residential terrace at 49 to 57 New Street was built in 1899 and known as Druid Cottages, as signified by the date stone. The terracotta brickwork and window lintel detail on numbers 55 and 57 New Street can clearly be seen.

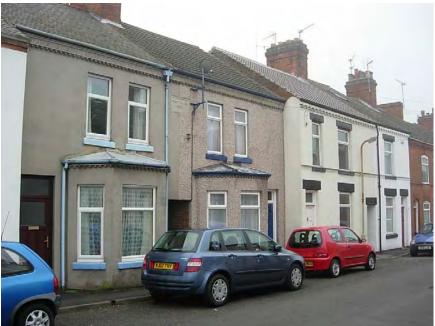
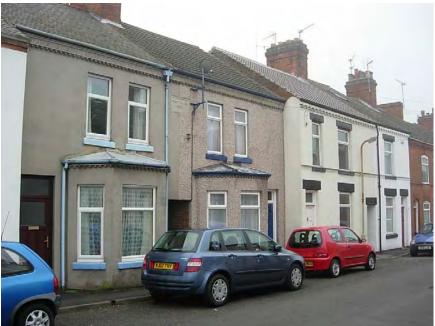
The two dwellings at 41 & 43 New Street, known as Fern Villas and built in 1894, were constructed to a slightly different building line to the adjacent rows of terraces, and include bay windows. The render, concrete roof tiles, and installation of a satellite dish detract from the original character of the dwellings.

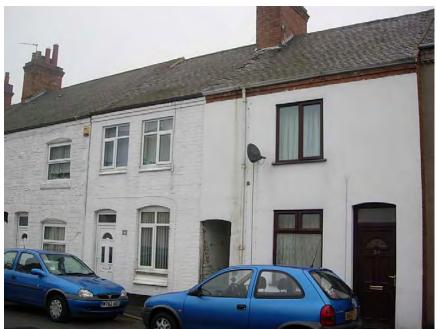
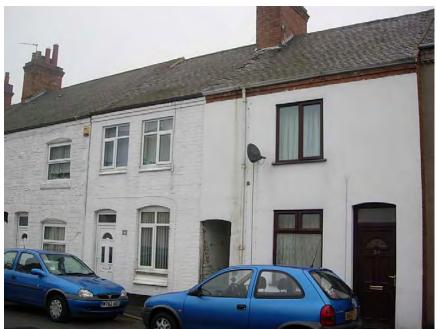
The painted brickwork, window sills and lintels on the row of terraces at 33 to 39 New Street detract from the historic character of the dwellings. The properties do however retain their original slate roof tiles.

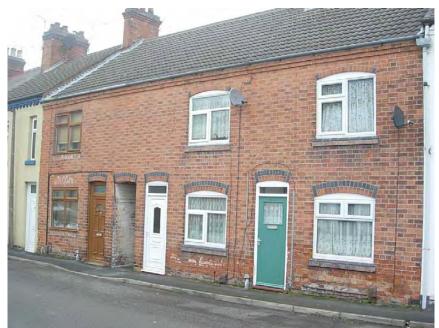
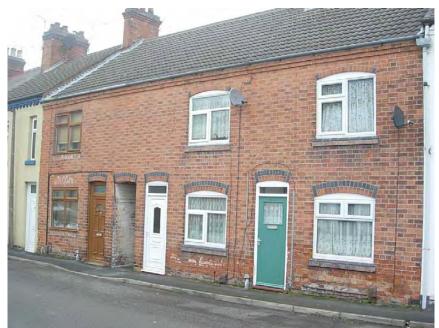
The brickwork on 27 to 31 New Street has been re-pointed and the original window openings retained. The replacement of the concrete roof tiles and plastic windows with traditional materials on these properties would benefit the conservation area.

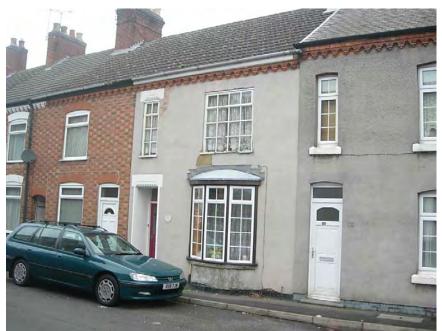
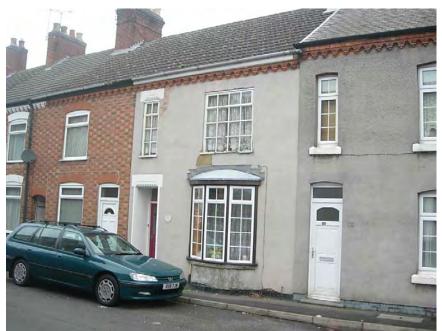
Number 21 New Street is a distinctive property due to the ground floor bay window and wooden window frames at first floor level. This property was originally the foreman's house for the former factory at 6 New Street, and therefore has a slightly widened front elevation.

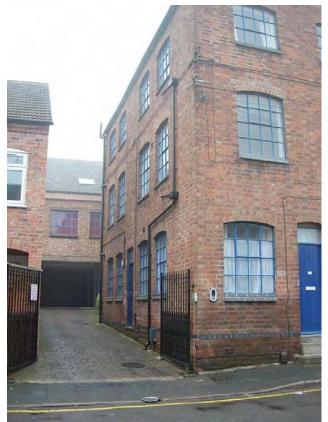
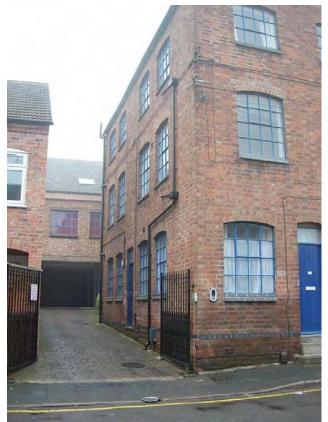
The recently converted boot and shoe factory at 6 New Street retains many original features including cast iron windows and external brickwork detail. Metal gates have been installed and the surface of the courtyard has been treated with concrete pavers.

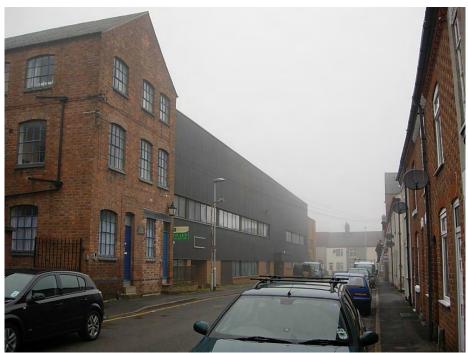
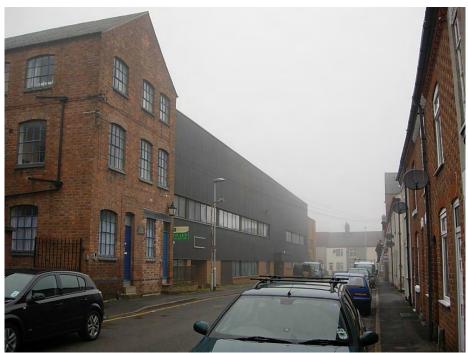
The view north-west from the conservation area along New Street is spoilt by the rebuilt Eatoughs factory (now known as Warwick Buildings), detracting from the visual quality of the converted industrial premises at 6 New Street.

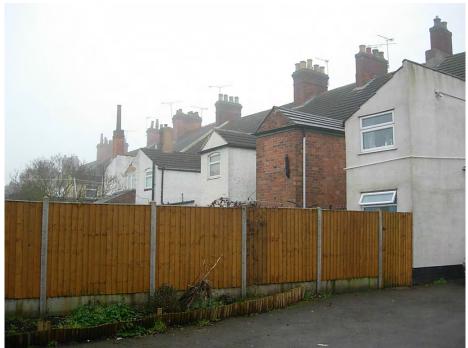
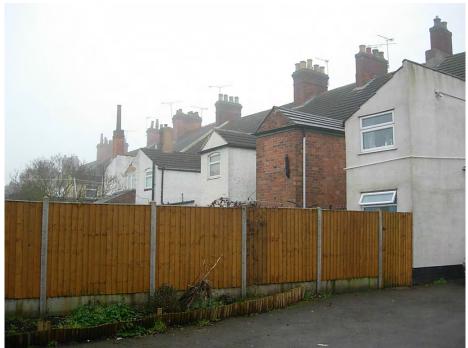
A timber panel and concrete post fence has unfortunately been used to replace a traditional brick wall at the rear of this New Street terrace. However the location does provide an excellent view of the brick chimney stacks and stone and clay pots on the terrace.

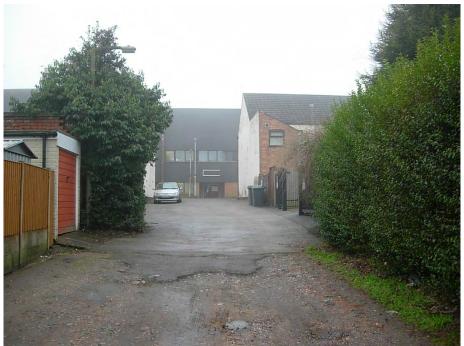
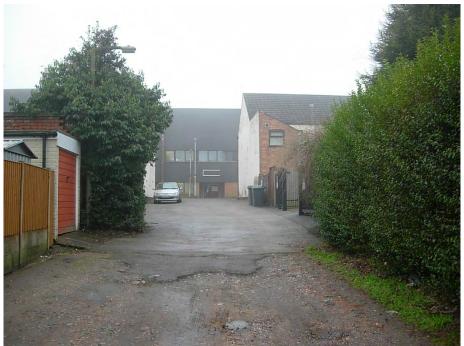
The section of the private road linking New Street with Melton Street has been treated as part of the recent factory conversion at 1-5 New Street. This is a poor view into the conservation area due to the modern materials utilised on the rebuilt Eatoughs factory.

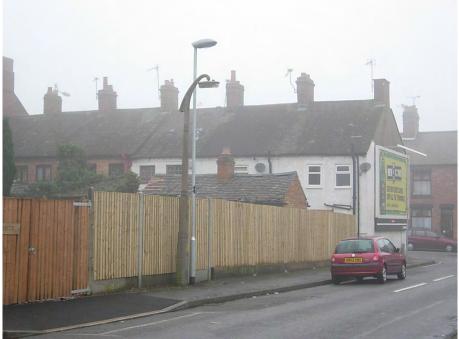
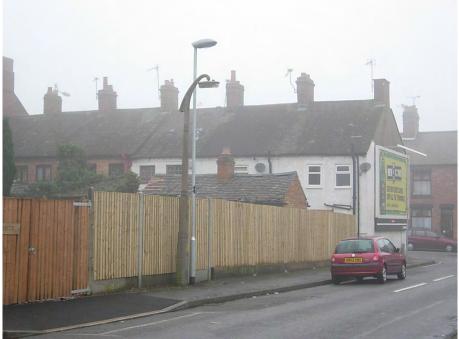
The concrete post and timber panel fence bounding the rear of 9 Hinckley Road could be replaced with traditional materials, providing a more sympathetic setting to the boot and shoe workshops. The concrete and metal lamp posts could also be replaced with a cast iron heritage lamp post.

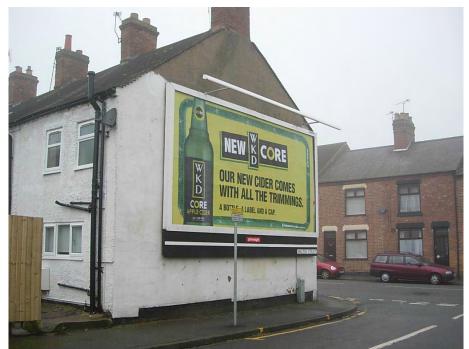
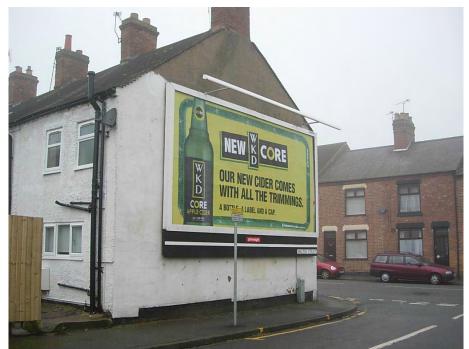
The illuminated advertisement hoarding attached to the side elevation of 9 Hinckley Road is a feature that detracts from the quality of the conservation area. The street name plate should also be replaced with a heritage name plate.

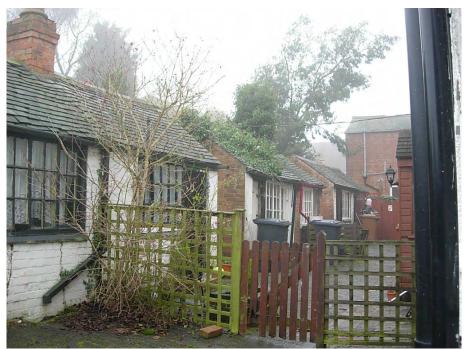
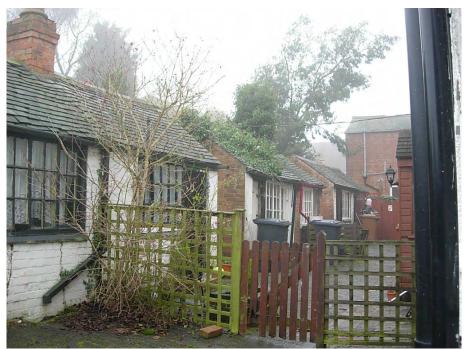
The boot and shoe workshops to rear of Chelsea Row are significant local buildings within the conservation area. The courtyard still retains the original Victorian blue clay floor tiles.

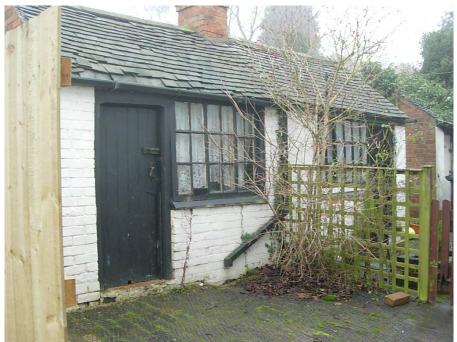
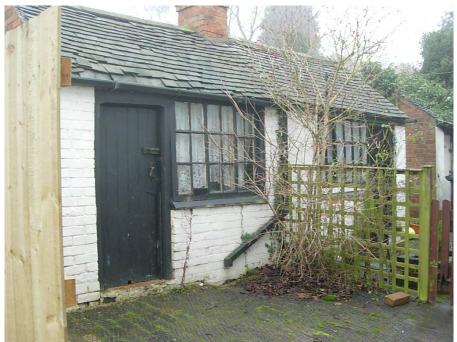
The workshops have some excellent remaining original features including slate roof tiles, a red brick chimney, wooden horizontal sliding sash windows, and internal features including lime plastered timber roofs and in one case a copper boiler.

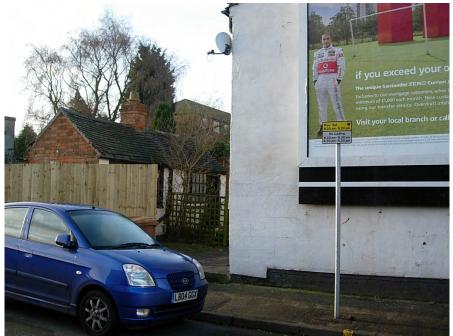
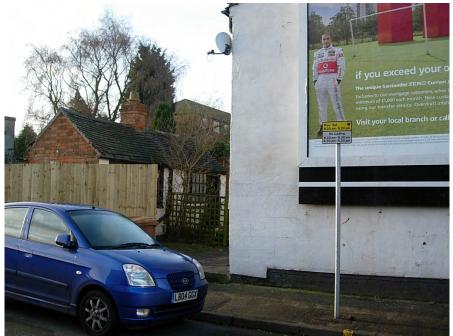
The opening to the rear of 9 Hinckley Road should remain open to allow the important view of the boot and shoe workshops, and should not be replaced with a timber gate, for example. This would also be an excellent location for an information board explaining the heritage of the boot and shoe industry in Earl Shilton.

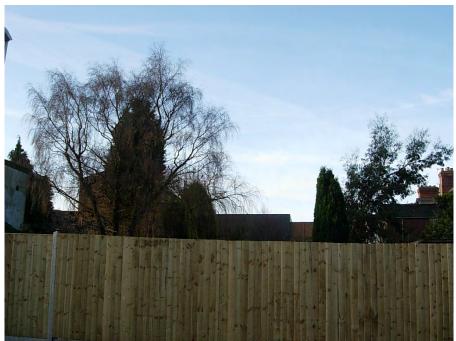
There are a small number of trees in some of the rear gardens of the terraces, including this protected silver birch tree in the rear garden of 17 Hinckley Road. There is little greenery in the conservation area reflecting its industrial past.

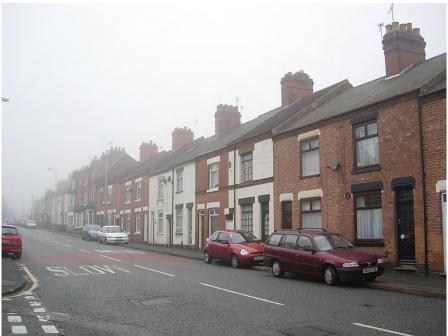
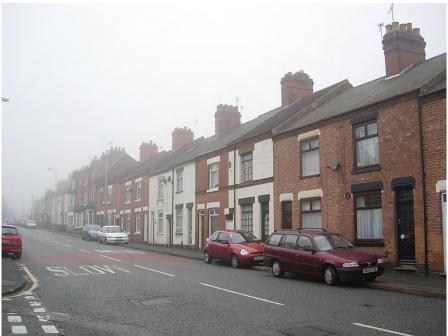
There is an excellent view south-westwards up Hinckley Road of the Victorian residential terracing. There have been some modern alterations, but many original features such as the red brick chimney stacks, for example, remain highly visible.

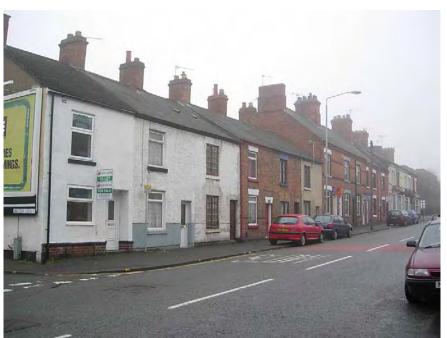
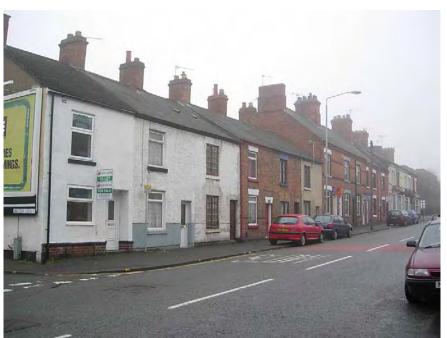
Numbers 9 to 17 Hinckley Road are known as Chelsea Row, a row of six cottages built around 1860 for framework knitting. Few traditional features remain on the front elevations of the cottages.

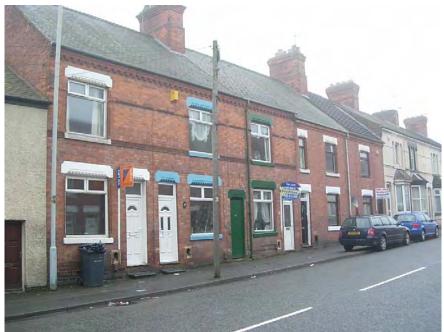
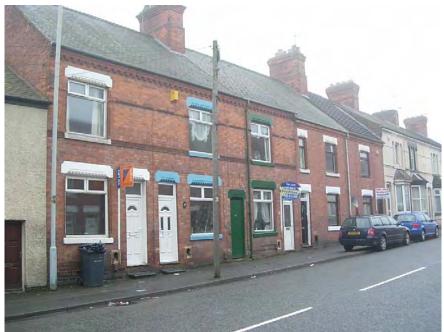
This residential terrace on Hinckley Road retains some excellent original features including terracotta brickwork and window lintel detail. The terrace would benefit from the window lintels and sills being returned to their natural stone colour. The row also contains recessed stone boot scrapers adjacent to the front doors.

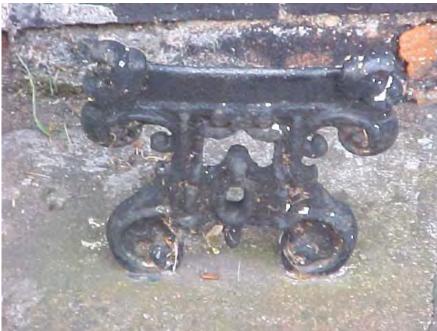
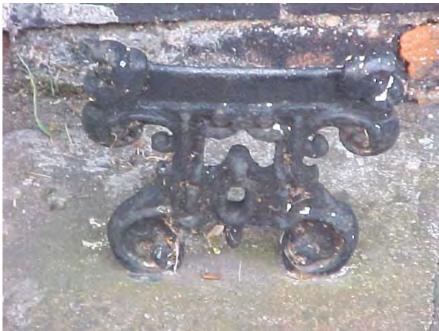
The original cast iron boot scrapers remain outside the front entrances to numbers 33 to 37 Hinckley Road.

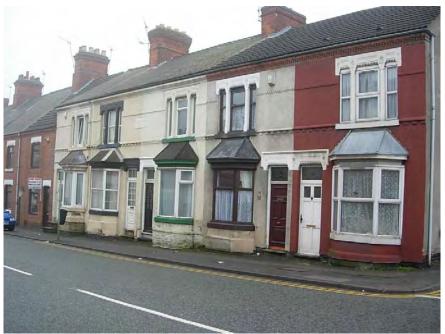
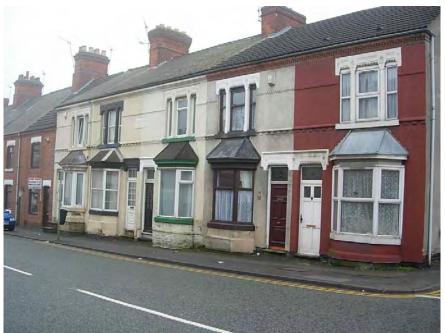
At numbers 31 to 39 Hinckley Road (known as West End Terrace) the conservation area would benefit from the painted render and brickwork being returned to its original state. These are the only properties on this row to have bay windows.

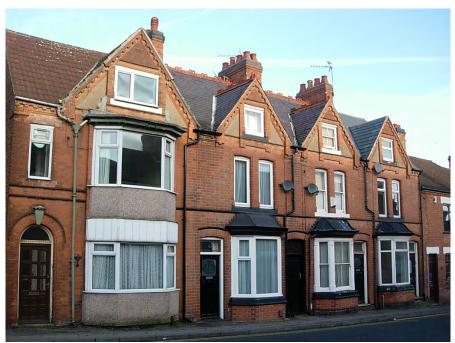
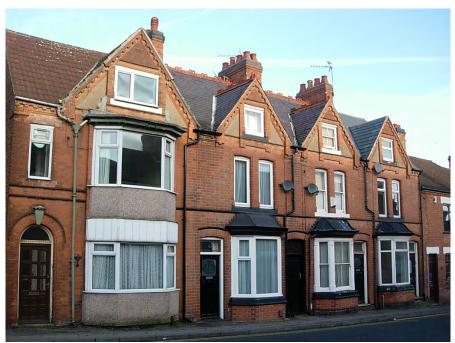
The three storey terraces at 38 to 44 Hinckley Road retain many interesting features, including bay windows, intricate door derails, gablet terracotta brickwork, and slate roof tiles. The former balustrading above the second storey bay at number 44 Hinckley Road has been removed.

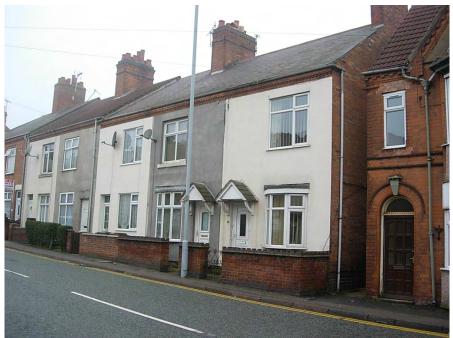
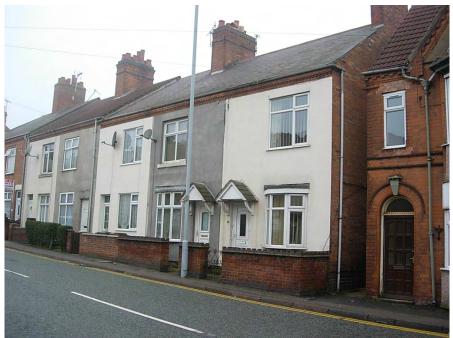
Unsympathetic modern alterations may be identified on the residential terrace at 46 to 54 Hinckley Road, including low boundary walls, plastic windows and downpipes, rendered brickwork, satellite dishes and porches.

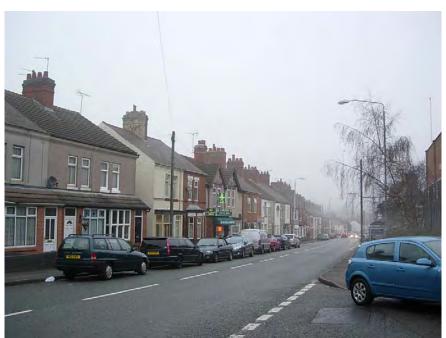
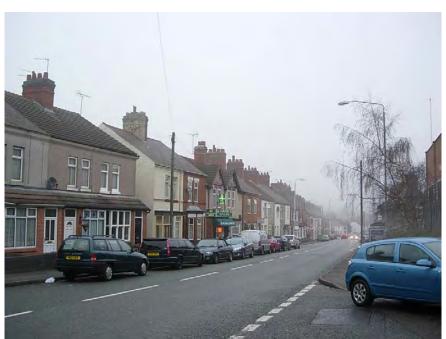
The subtle variations in the building, eave and ridge lines as each section of residential terracing was built can be seen from the view north-eastwards into the conservation area along Hinckley Road. The on street parking does detract from the visual quality of the conservation area.

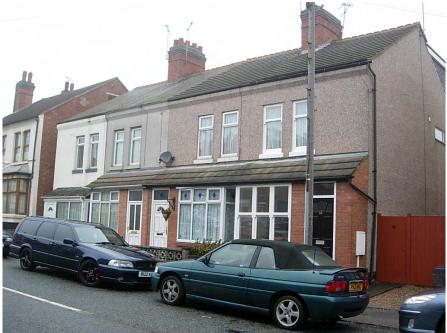
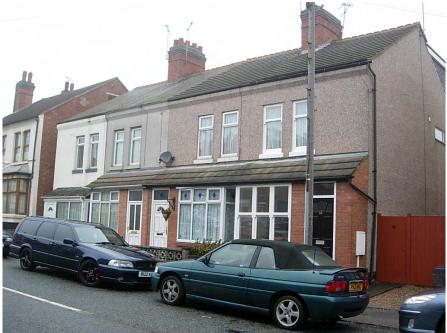
The small front extensions and gardens, rendered brickwork and concrete roof tiles are poor alterations to the terrace at 68 to 74 Hinckley Road. However, the dwellings do retain their original chimney stacks.

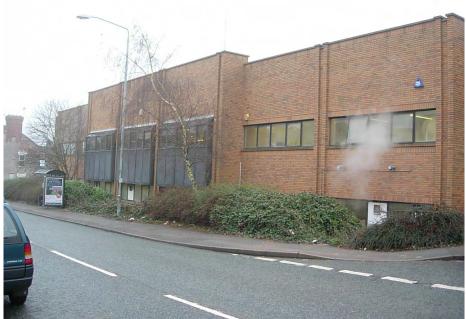
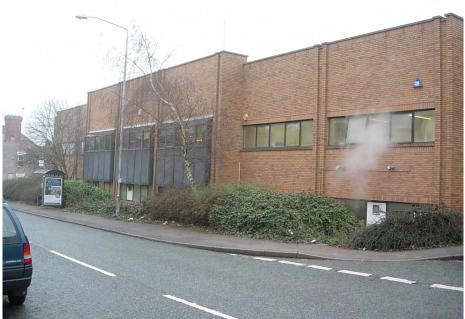
The view north-eastwards along Hinckley Road into the conservation area is dominated by the northern elevation of the rebuilt Eatoughs factory (now known as Warwick Buildings). Although not in the conservation area, this building has a detrimental visual impact on the setting of the conservation area.

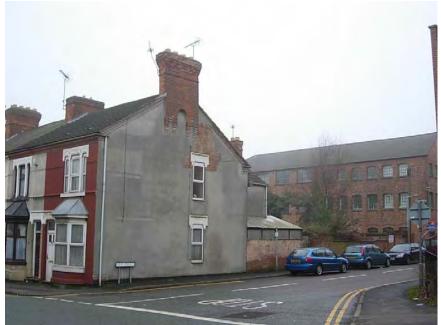
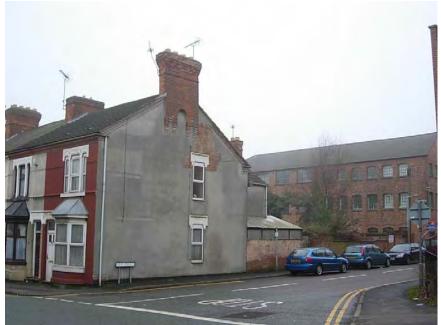
The gable end of 39 Hinckley Road has been rendered, so the visual aspect of the conservation area would benefit if the original brickwork was restored. Some excellent features do remain, including the brickwork detail on the chimney stack, and the original brick boundary walls.

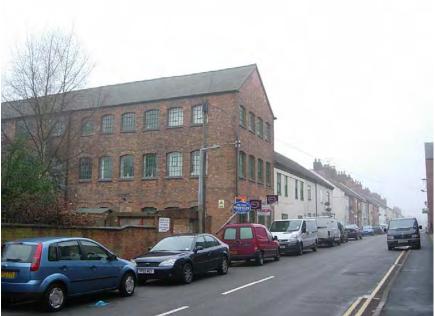
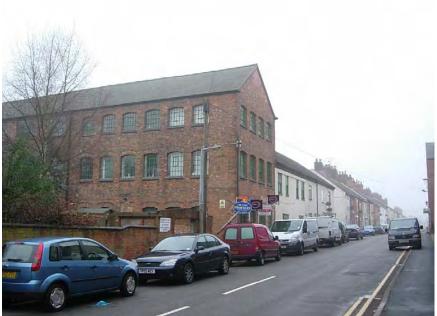
The recently converted three storey factory at 1-5 New Street is a fine example of Earl Shilton's industrial heritage. Many original features remain and have been restored, including the decorative brickwork, cast iron windows and slate roof tiles.

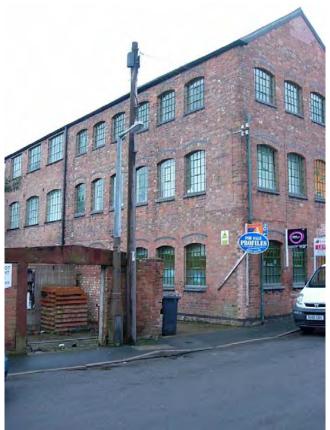
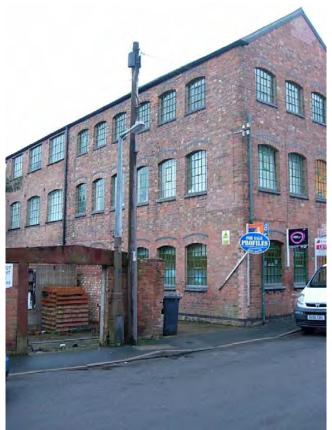
There are a number of concrete and metal lamp posts within the conservation area that should be replaced with a heritage cast iron post, including this concrete lamp post outside 1-5 New Street.

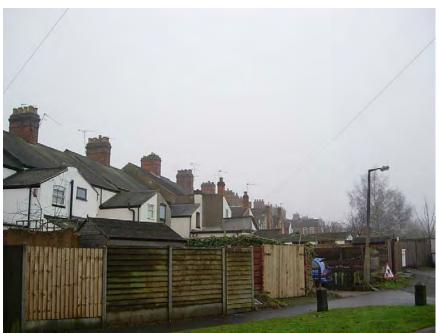
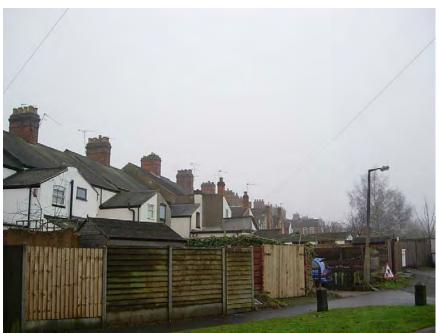
Viewing the rear of the residential terracing on Hinckley Road from Heath Lane South provides an excellent aspect of the roof ridge line as the dwellings were constructed up the road, and the many examples of original chimney stacks and pots can clearly be seen.
