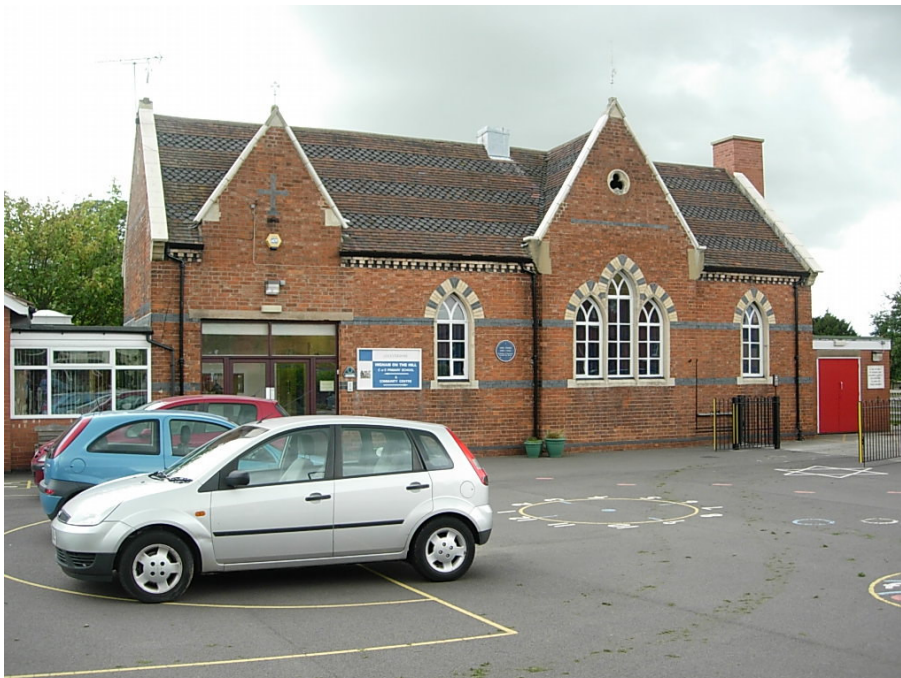
Higham Primary School is of typical village design built towards the end of the C19 with excellent detailing and decorative roof. The recent extensions are completely out of character being of modern design utilizing artificial materials.

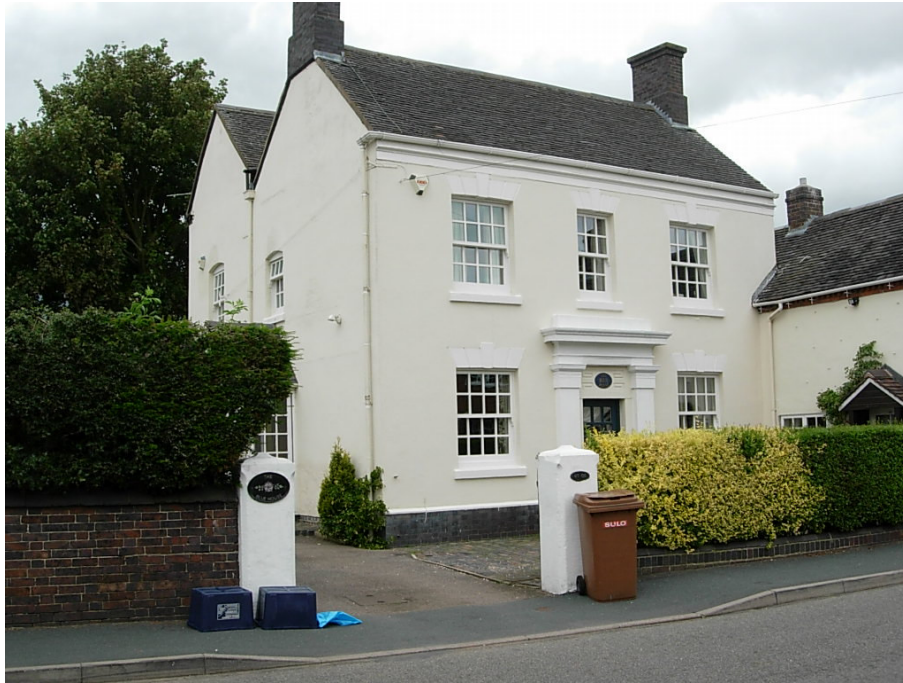
The Blue House was built as the Bull Public House but never used as such. The rendered property is an imposing structure on Main Street that has a fine front entrance. The stone entrance piers are also attractive heritage features

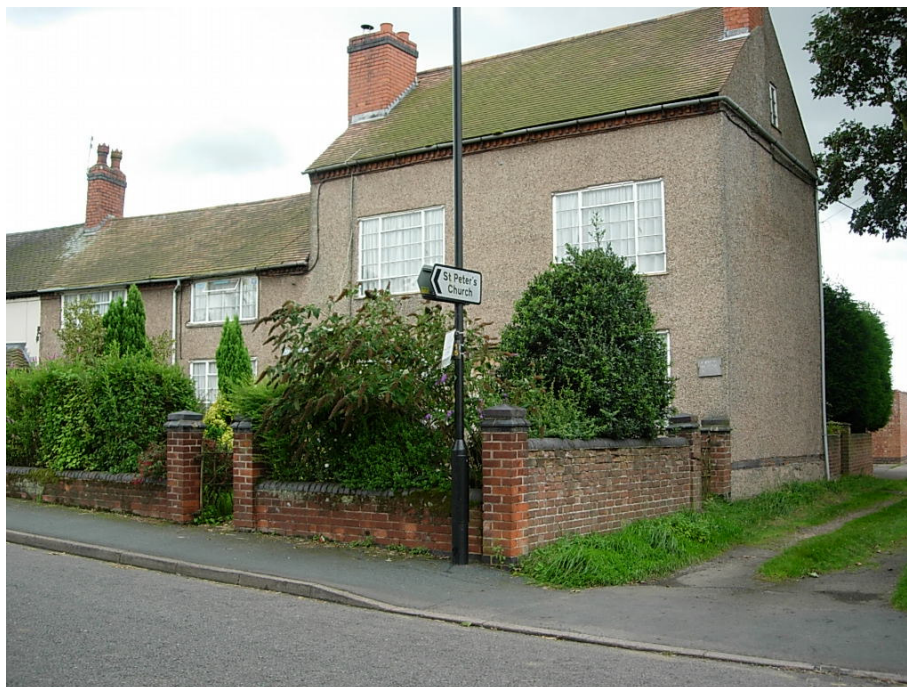
Ivy House Farm is a 2.5 storey structure roughcast rendered with rosemary tiles. The appearance of the building suffers from the 1930's metal windows. The property was once a butchers shop.

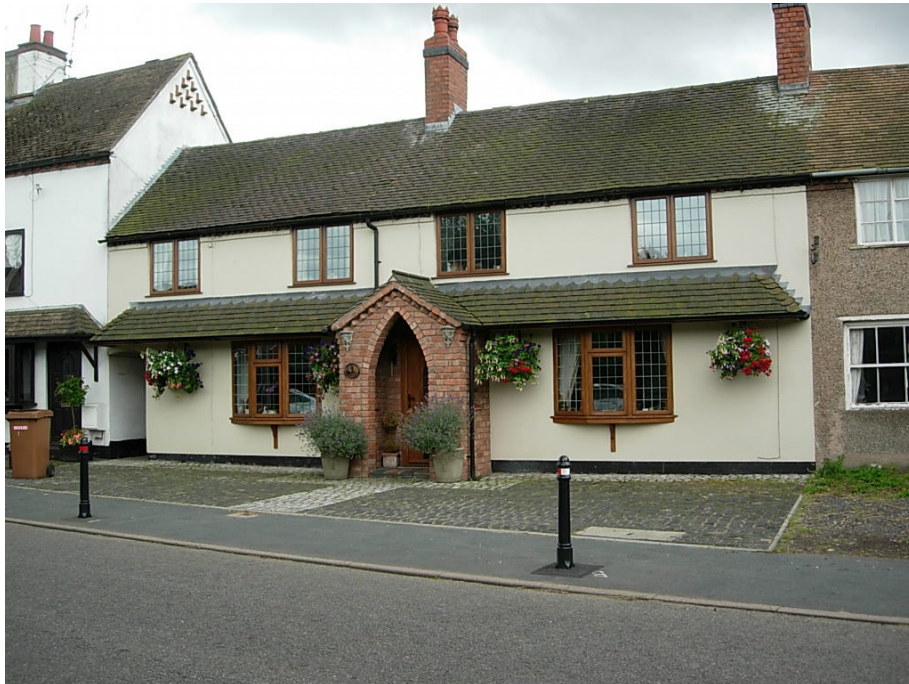
86 – 88 Main Street has recently been modernized but unfortunately does not respect the traditional character of the dwelling with its canopy, porch and bow windows. However its decorative chimney pots have been retained.

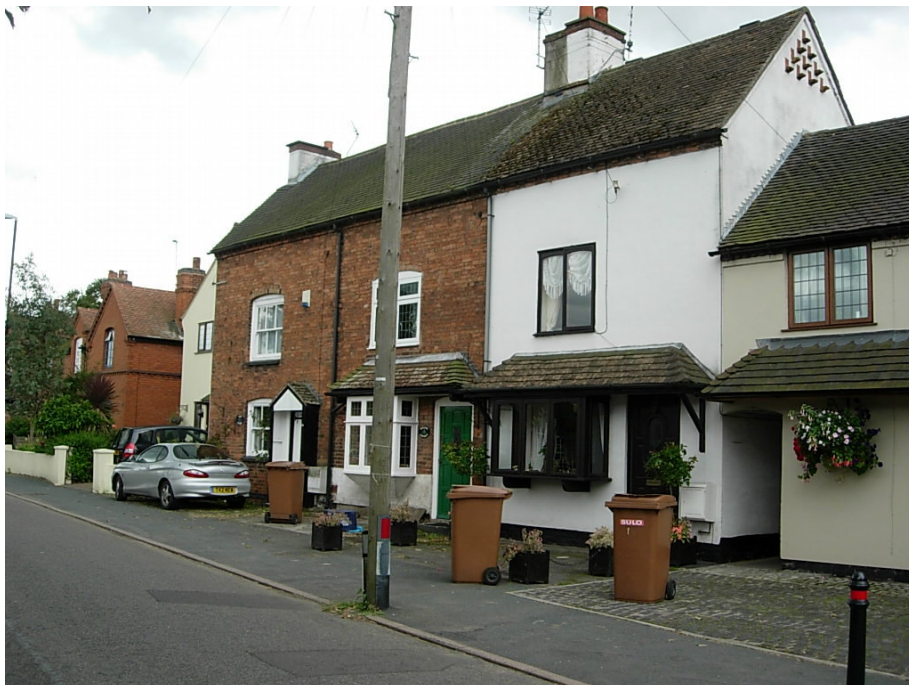
The properties 90 – 94 Main Street have lost their uniformity because of the addition of unsympathetic improvements. These include tiled canopies, bow windows and inconsistent window designs.

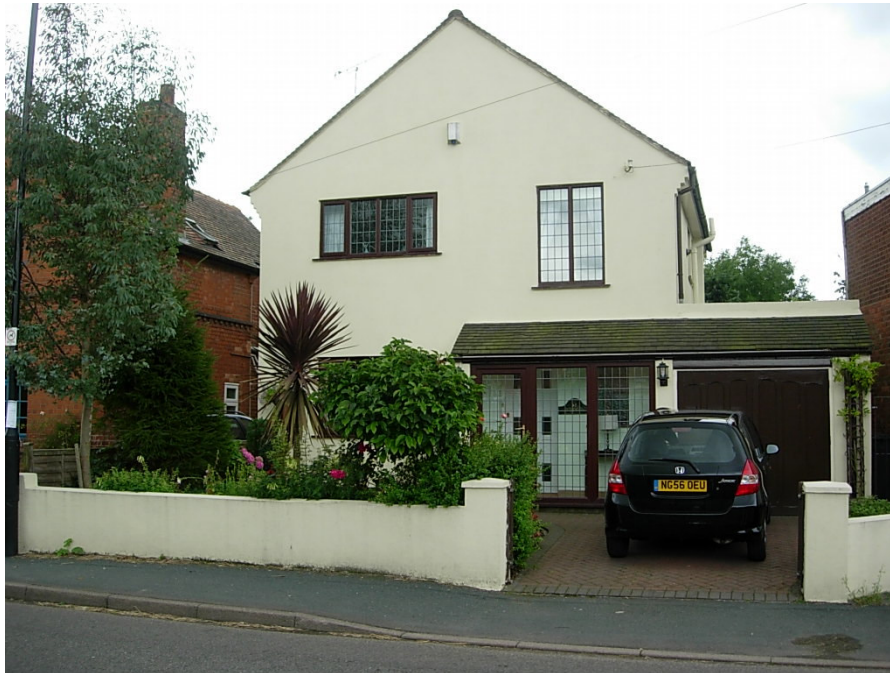
96 Main Street is a new property that does not respect the traditional character of the village. It incorporates excessive large windows, tiled horizontal canopies, metal garage doors and some tropical planting.

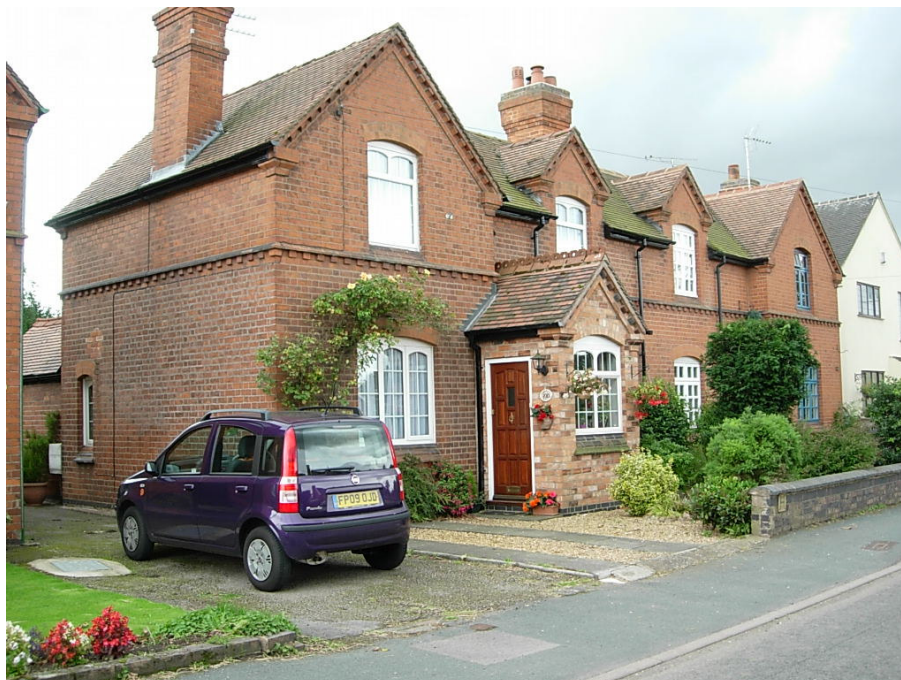
98 -100 Main Street are large semi-detached dwellings that were built as estate houses to Higham Hall. Unfortunately, their uniformity has been lost with the building of a front porch at No 100.

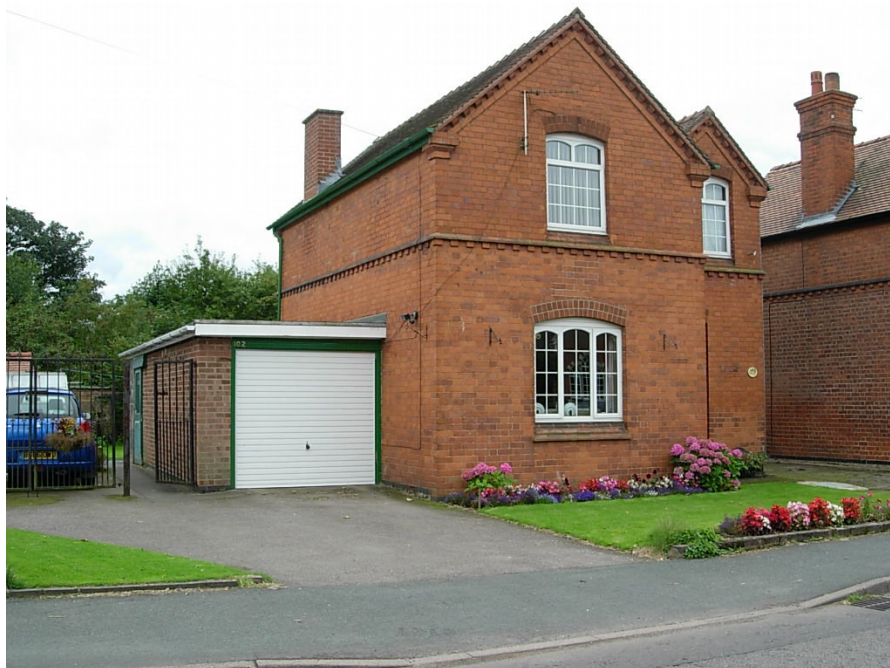
This detached dwelling is of similar design to the adjacent semi-detached dwellings and was also an estate property to Higham Hall . Unfortunately, the modern flat roof garage and up & over door does not respect the traditional character of the dwelling. The chimney stack has also been rebuilt to an unsympathetic design.

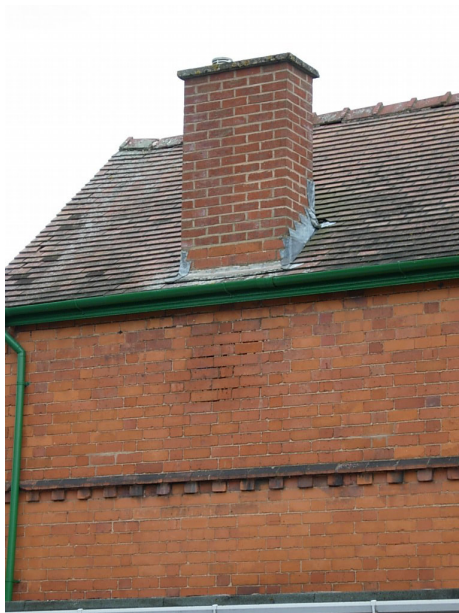
Chimneys and their pots are important features in conservation areas as they are particularly prominent features. Unfortunately, many stacks have been lost or re-built with modern bricks and many have lost their pots. They should be rebuilt to their original design and not like above.

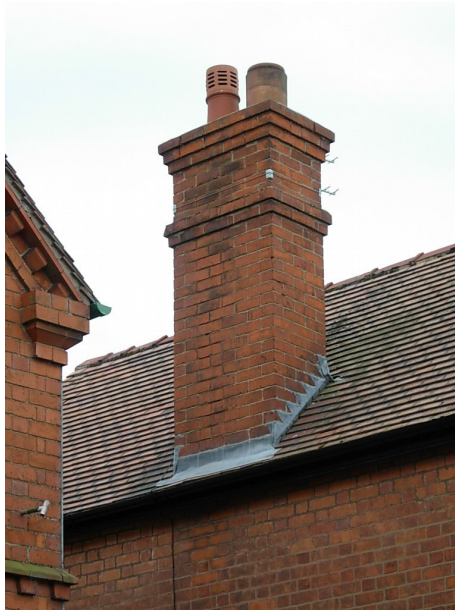
The original chimney stack & pots have been retained at 100 Main Street. The stack is a decorative feature with its oversailing courses which makes a significant contribution to the character of the property.

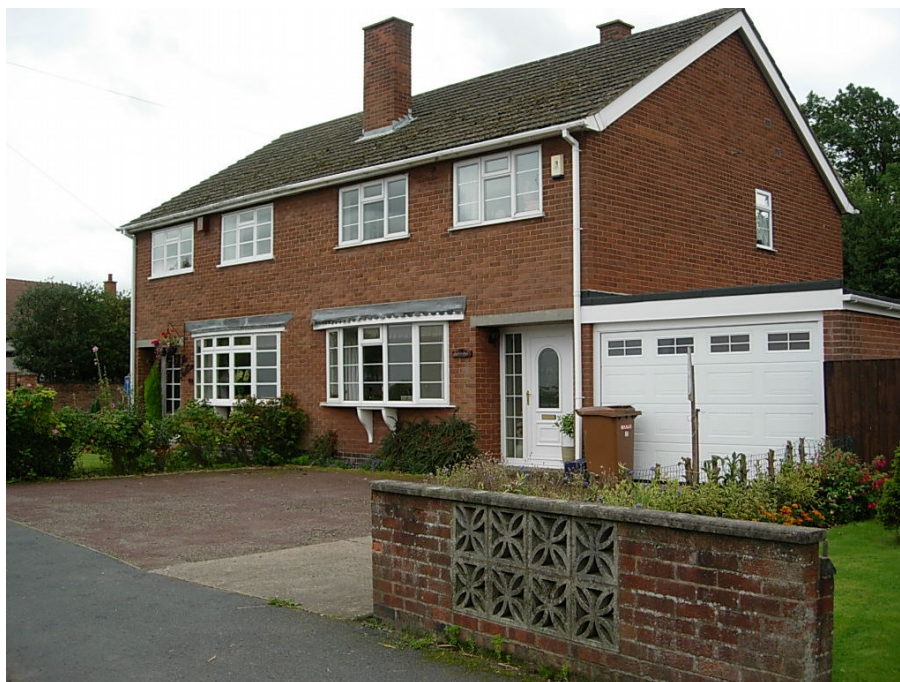
The design and use of modern materials at 104-106 Main Street is totally out of character with the traditional qualities of the village. The site was once the location of the Barley Sheaf Inn.

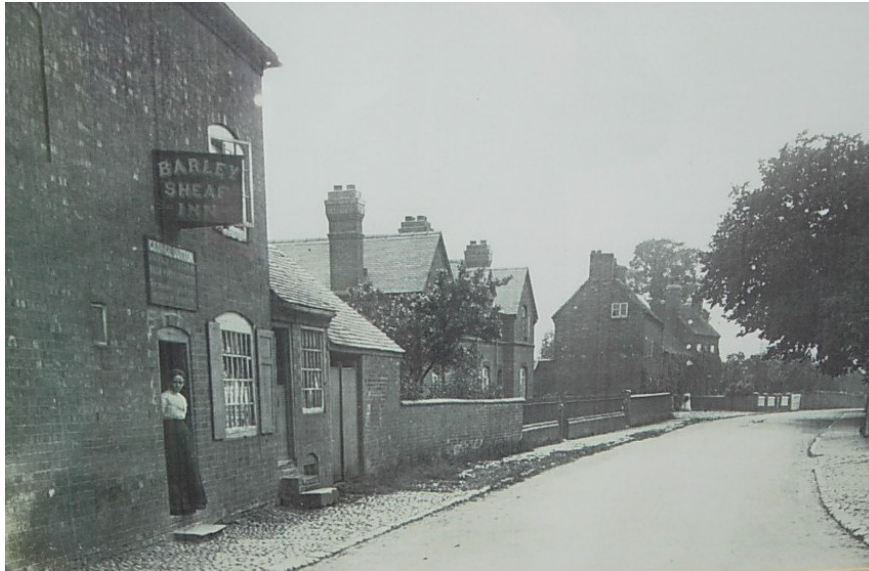
Vista of Main Street from its junction with Barr Lane at the end of C19 showing that walls, railings and chimneys were significant features in the village street scene helping to reinforce the sense of enclosure.

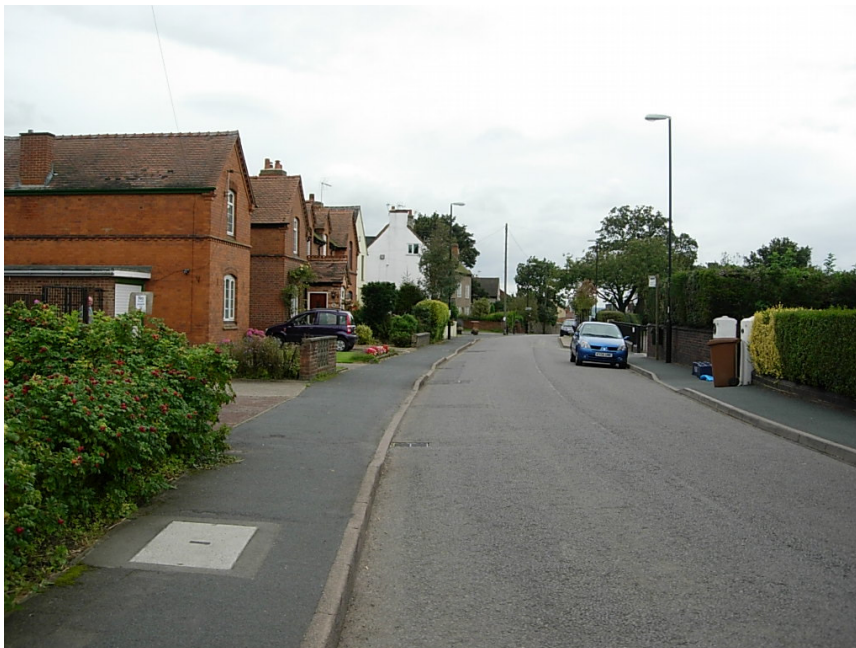
Present day view of Main Street showing how the enclosure has been lost and the chimneys are hardly noticeable now. Chimney pots are important features and in some cases can be quite detailed.

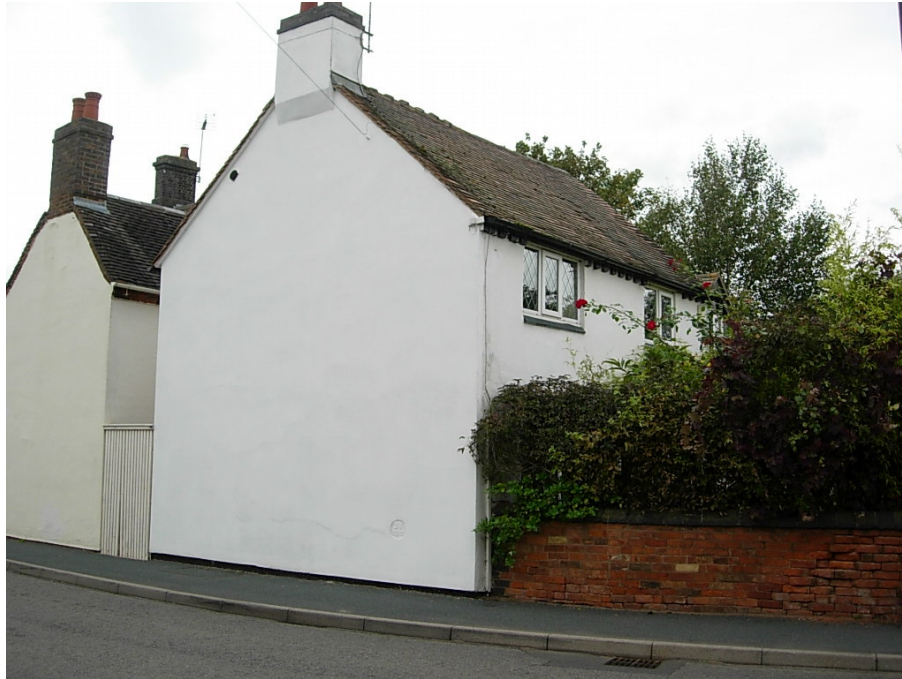
These two rendered properties with their gable ends fronting Main Street are prominent structures. It is understood they contain wattle and daub.

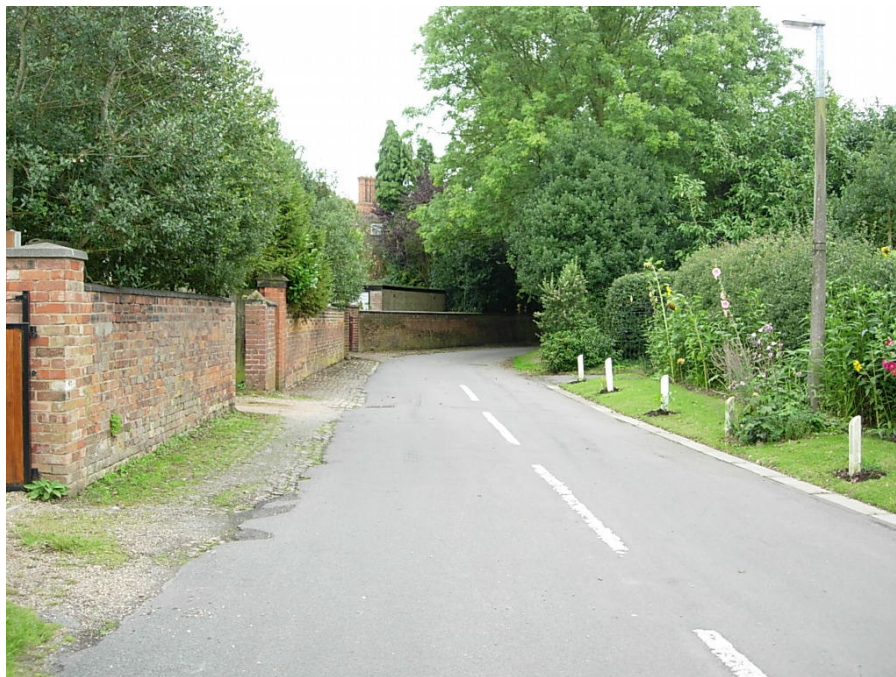
Barr Lane is flanked by tall brick walls along its eastern side with an area surfaced with setts and pebbles. The haphazard edge of the carriageway gives an untidy appearance and needs to be straightened.

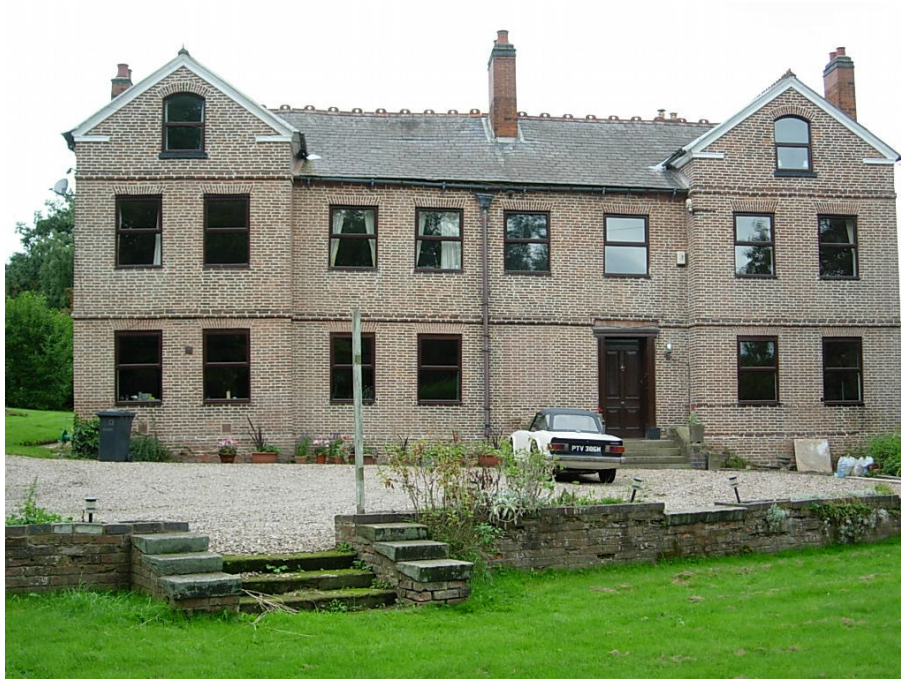
Canterbury House is the birth place of Geoffrey Fisher who became the archbishop of Canterbury and crowned the Queen in 1953. The character of the property has been compromised with the installation of plastic windows and recent pointing that is far too dominant.

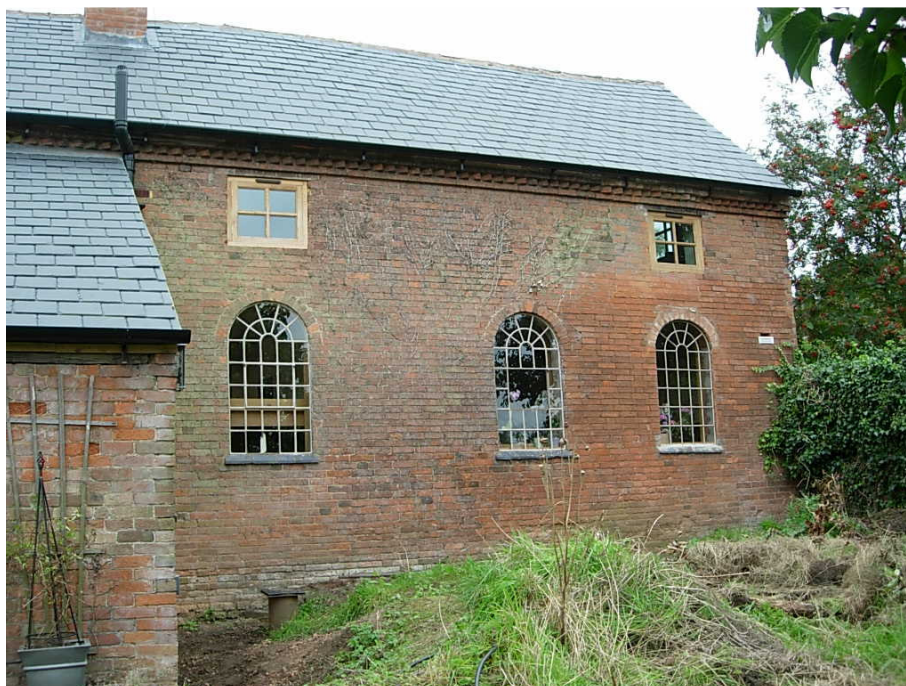
Canterbury Coach House is currently being renovated.

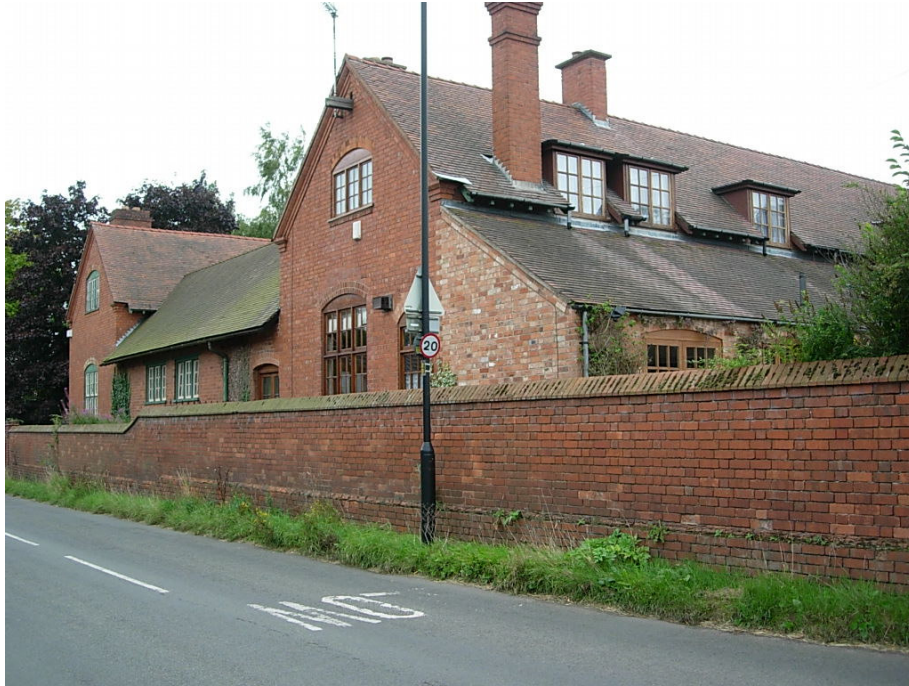
The side elevation to 1 Barr Lane. The recent extension to the former stable buildings to Higham Hall is out of character and spoils what is a fine elevation

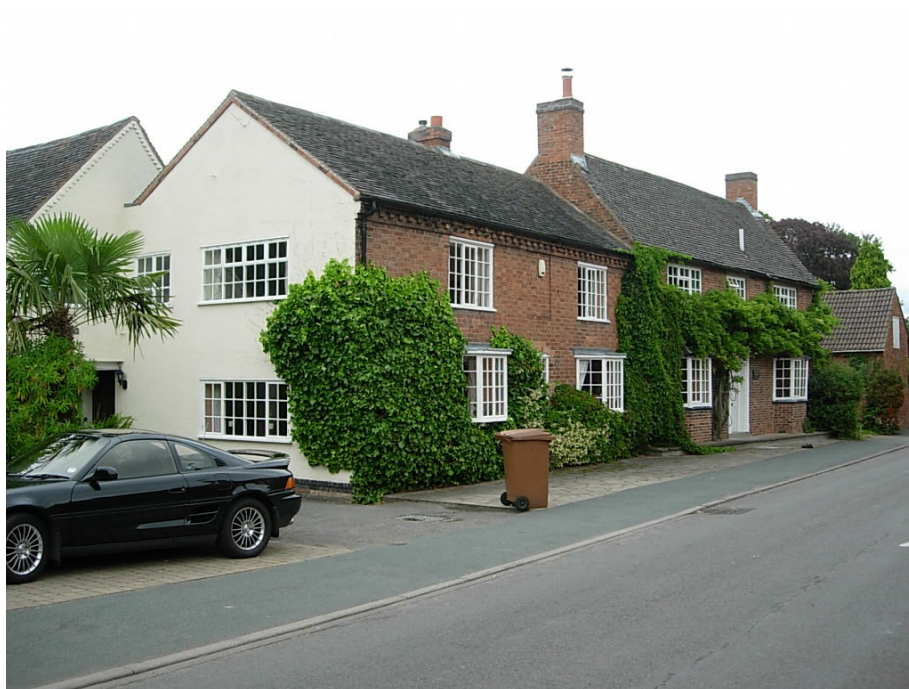
The use of crazy paving fronting 109 – 111 Main Street compromises the visual quality of the properties. Consideration should be given to a surface more appropriate.

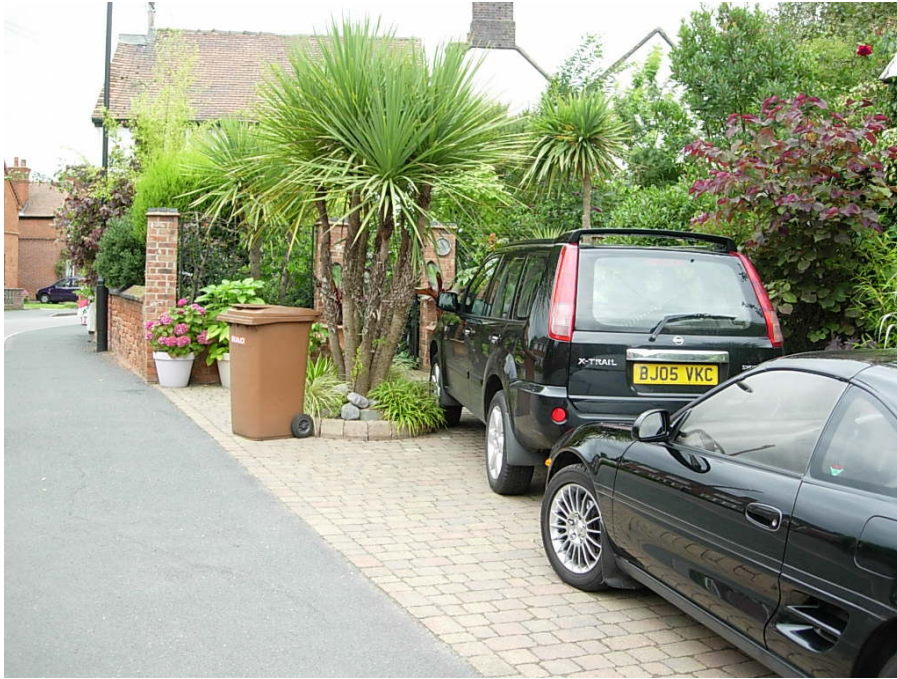
The elements utilized in this parking arrangement tend to resemble a Mediterranean landscape.

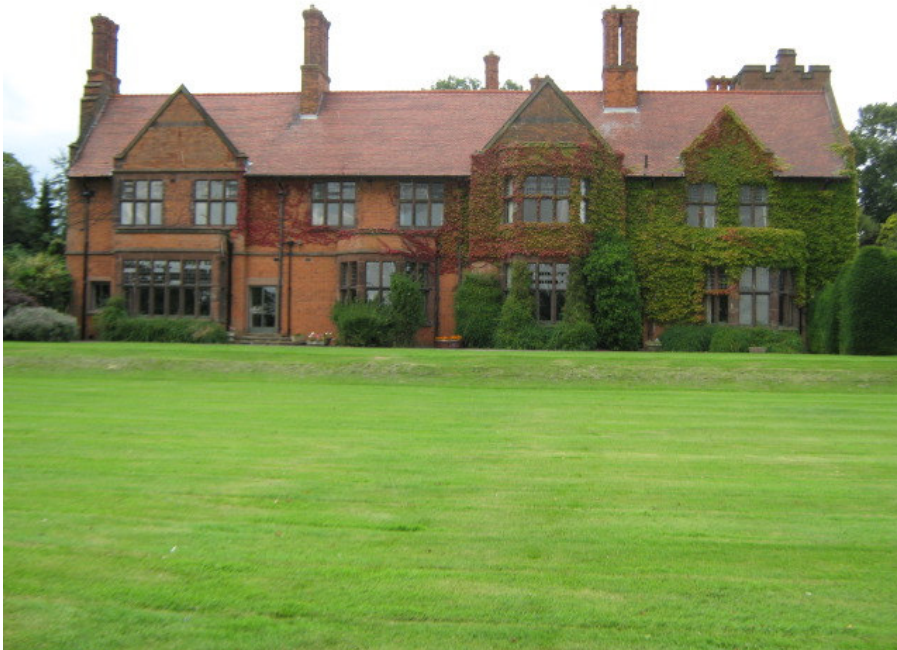
Higham Hall is a grade 2 listed country house set in large mature gardens behind a high brick wall. The house built 1900-02 for C H Morris, a pit owner, is constructed in red brick with sand stone dressings and triple and quadruple ridge stacks.

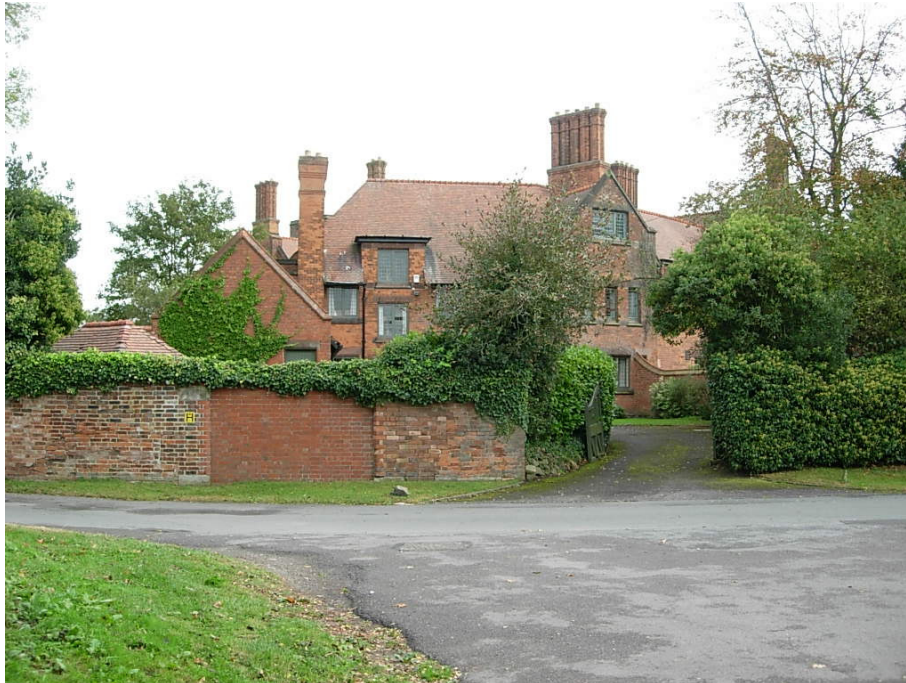
West Hall, an extension to Higham Hall viewed from Barr Lane. The property could be improved if careful consideration is given to the impact of its flat roof extension and attached garage.

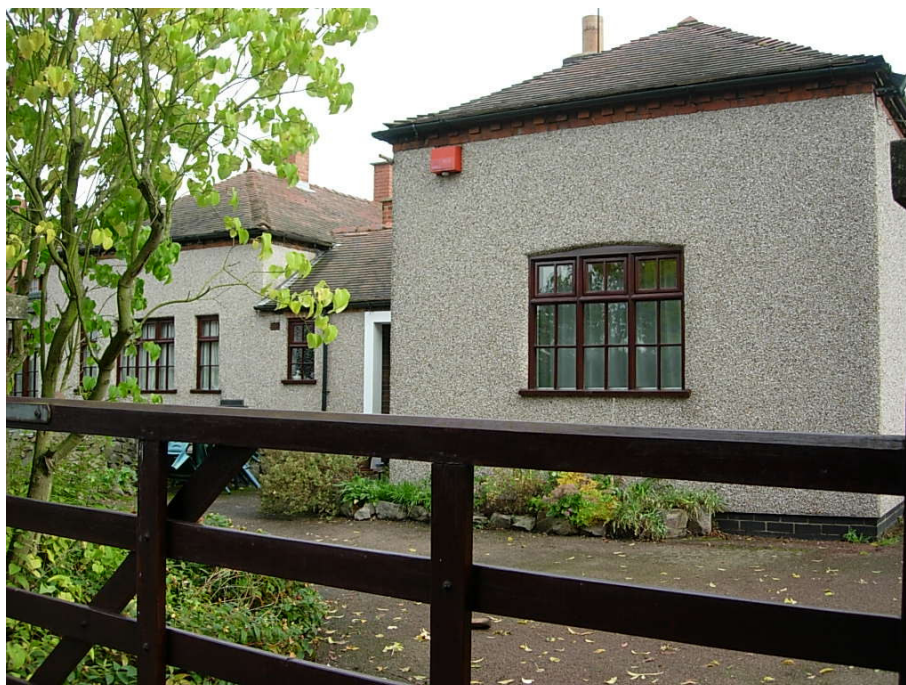
5 Barr Lane that was once the laundry building to Higham Hall. The property has been spoilt by being rendered, the type of windows installed and flat roof extension.

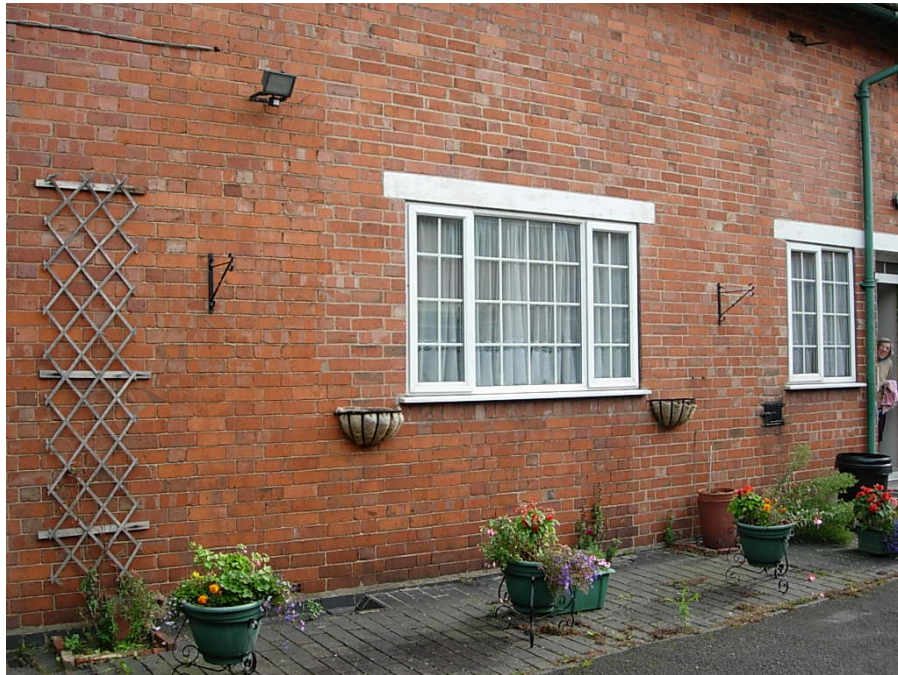
The character of the inner quadrangle of the former stables to Higham Hall has been spoilt with the insertion of modern plastic windows. When compared with the photo below, it shows how the character of the building has been compromised

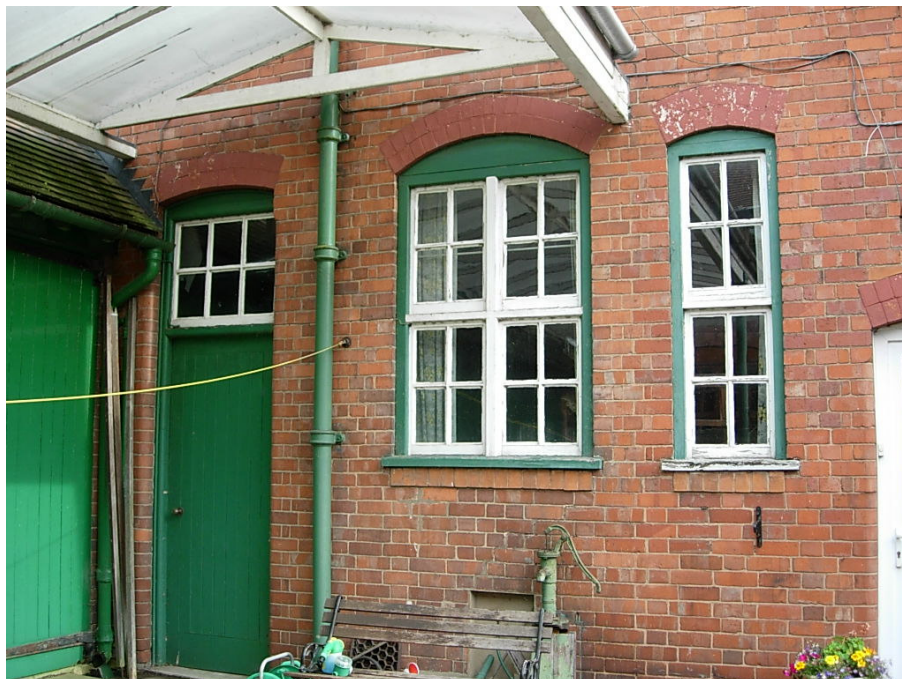
Some of the original windows, canopy and water pump are still extant in the former stable buildings..

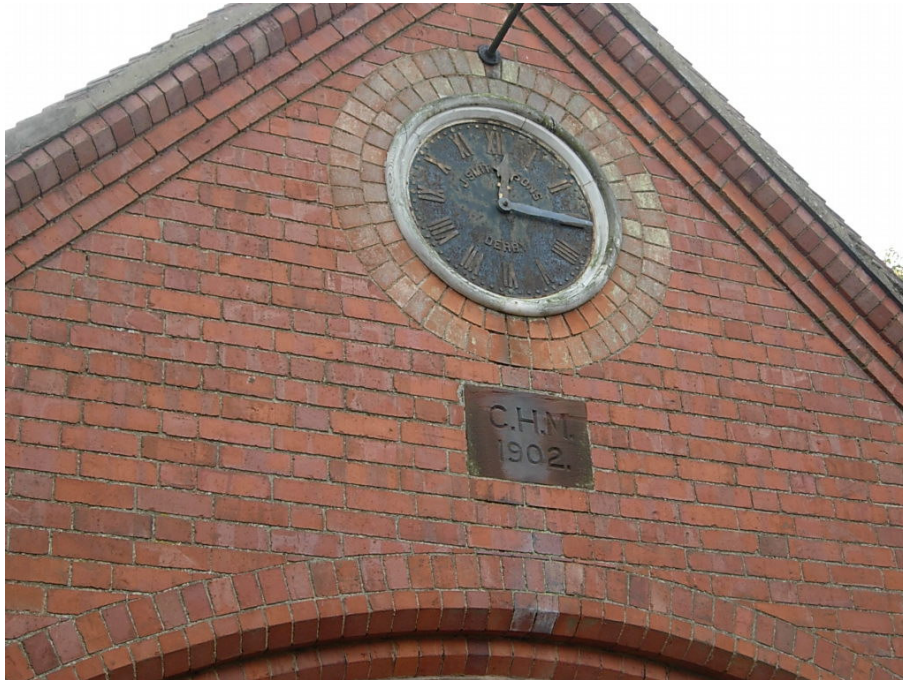
The clock to the former stable block was made by J Smith & Sons of Derby. The date stone 1902 has the initials of the owner C H Morris.

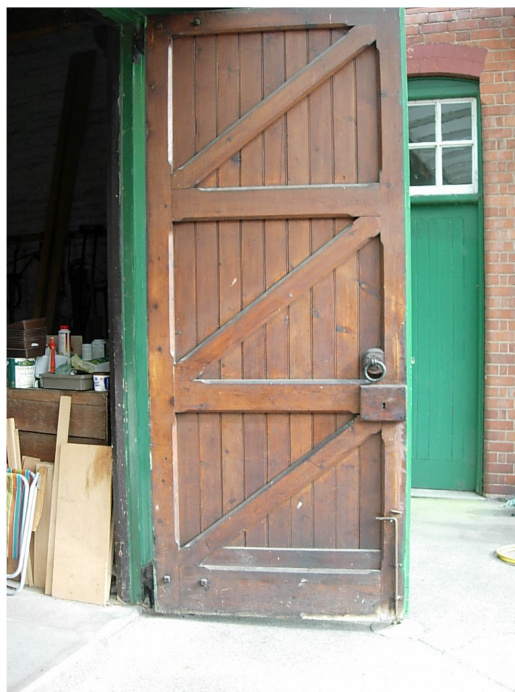
One of the excellent timber doors to Higham Hall's garage showing its timber lock.

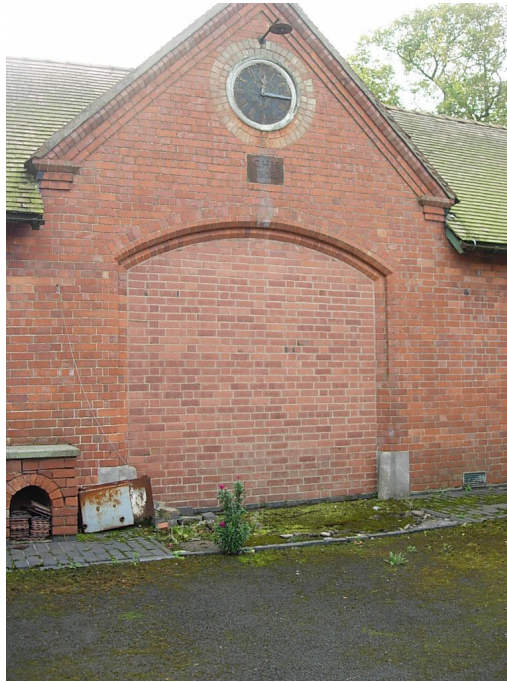
The entrance from the inner quadrangle to Higham Hall has now been bricked up. However the original mounting block has been retained.

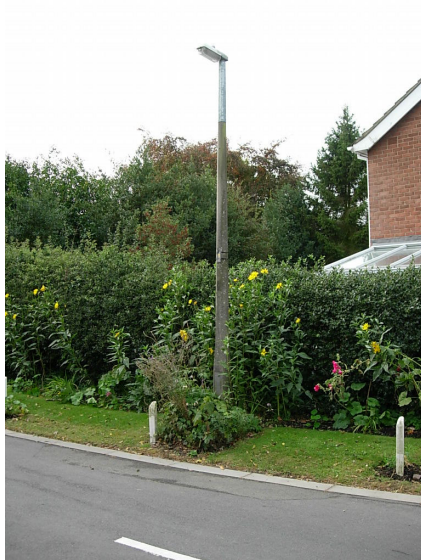
It is suggested that the street light on Barr Lane sited close to the junction with Main Street is replaced with a heritage light.

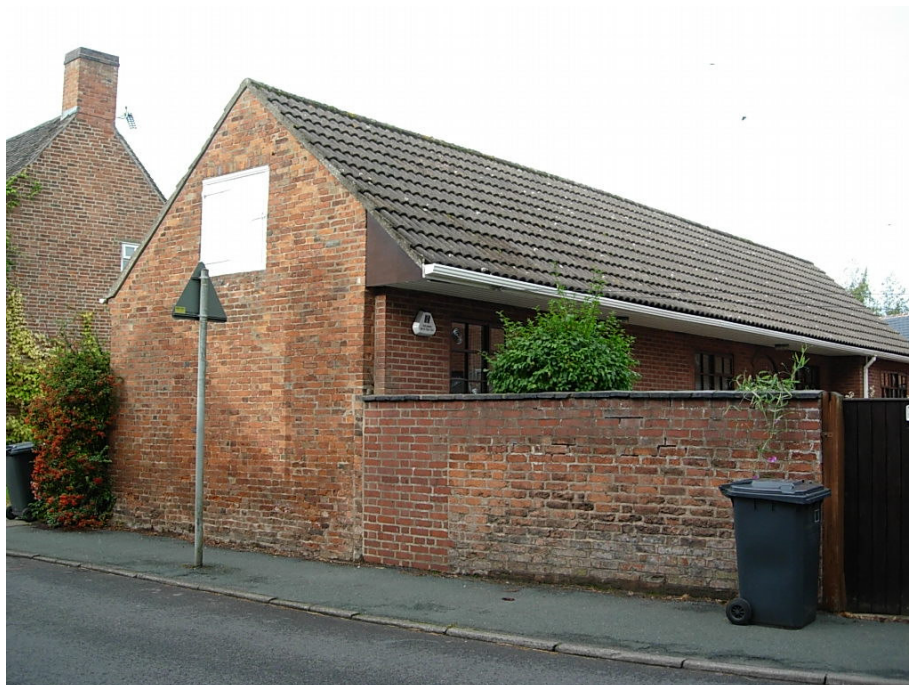
The property 113 Main Street has been converted into a dwelling. Much of the original building has been retained, however, its traditional character has been compromised with the use of concrete roof tiles and plastic guttering.

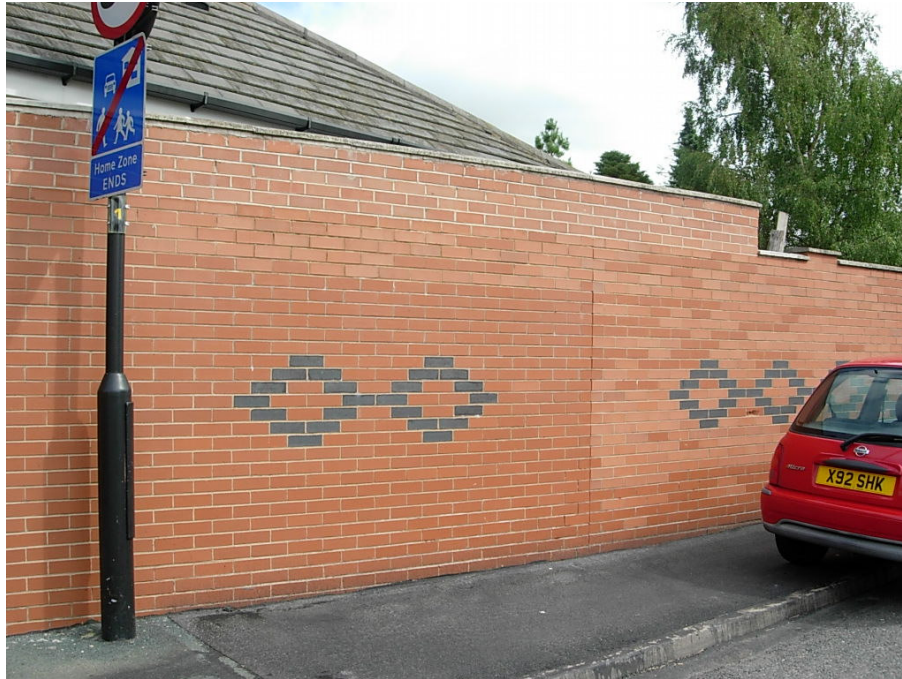
Modern wall consisting of inappropriate bricks
spoils the conservation area approach

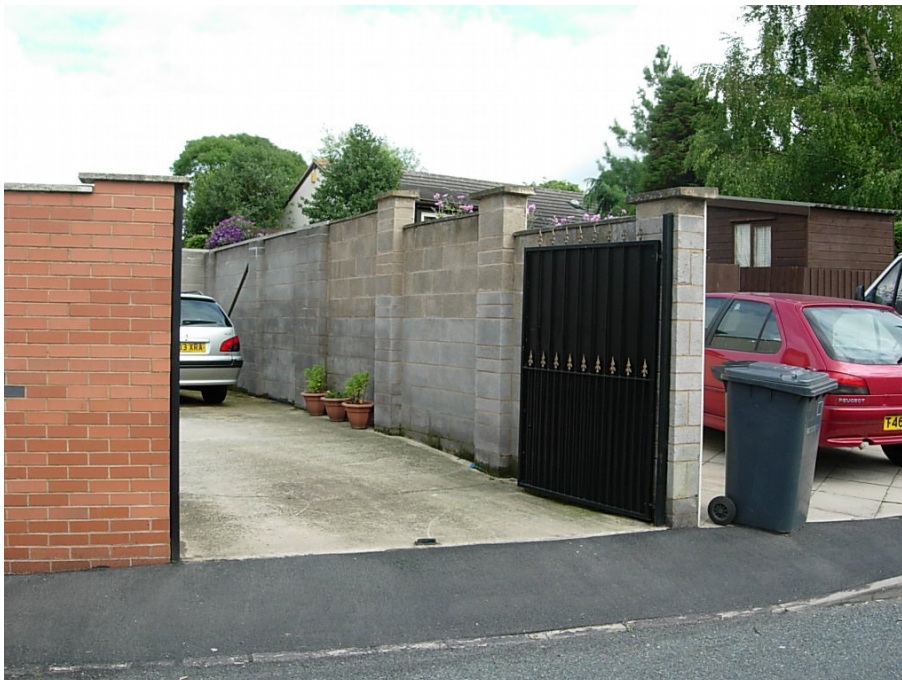
Block wall is an unattractive feature.

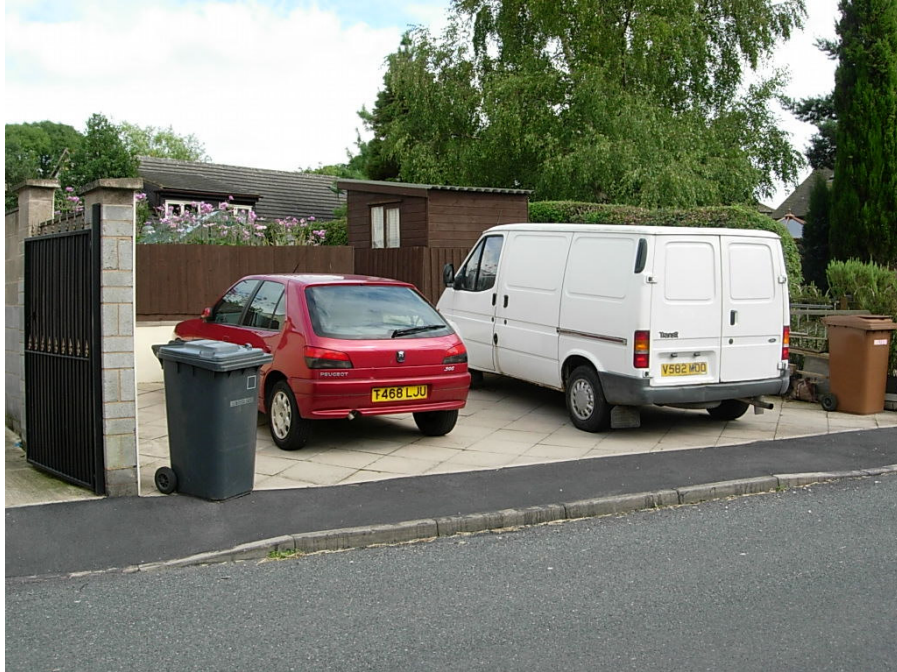
The sense of enclosure is lost due to the open nature of these parking spaces

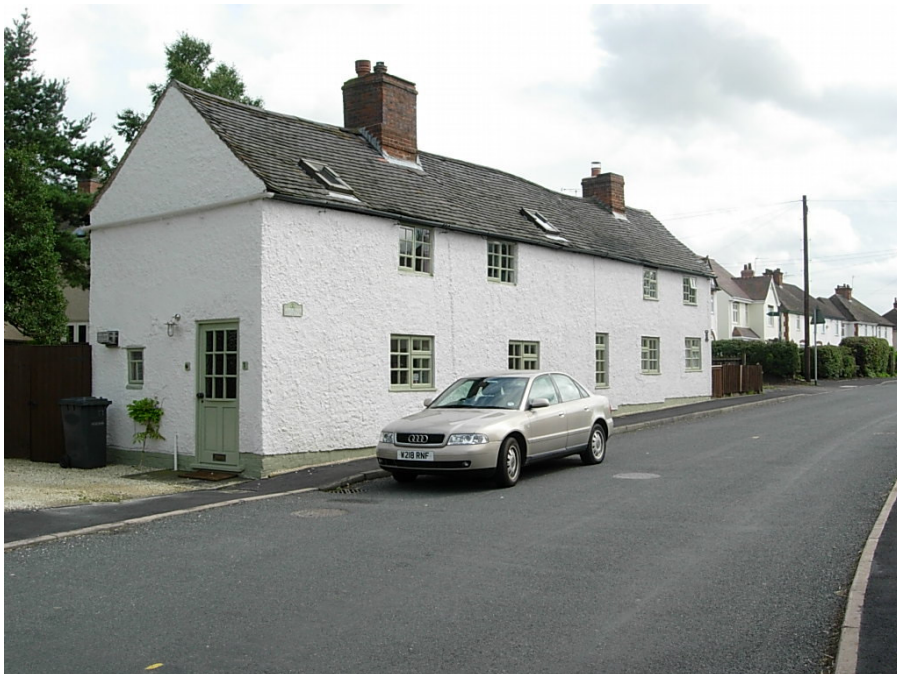
This vernacular building has been spoilt by the introduction of roof lights on the public face.

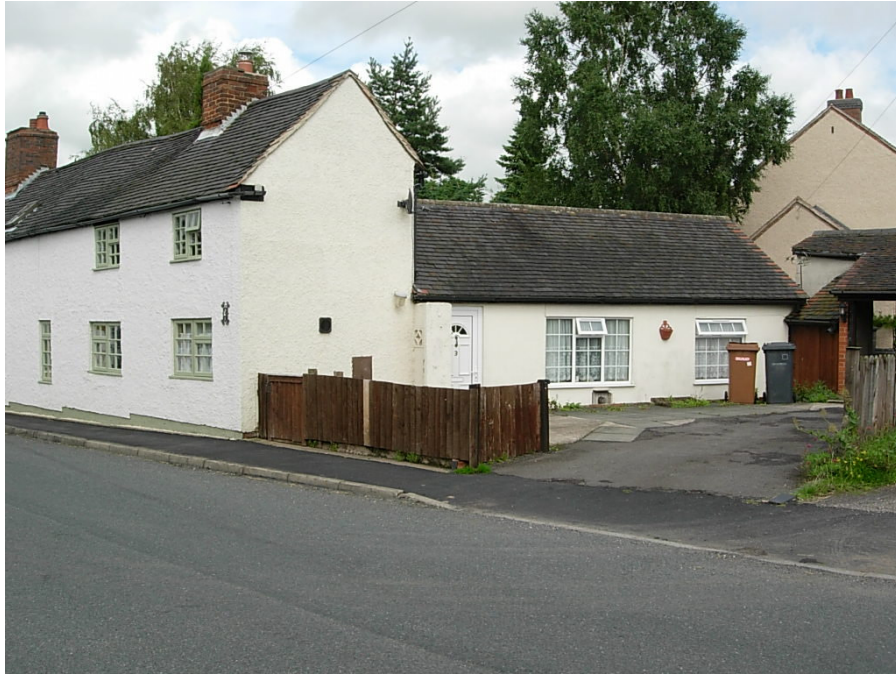
The large modern windows on the rear extension are out of keeping with the traditional features of the street frontage

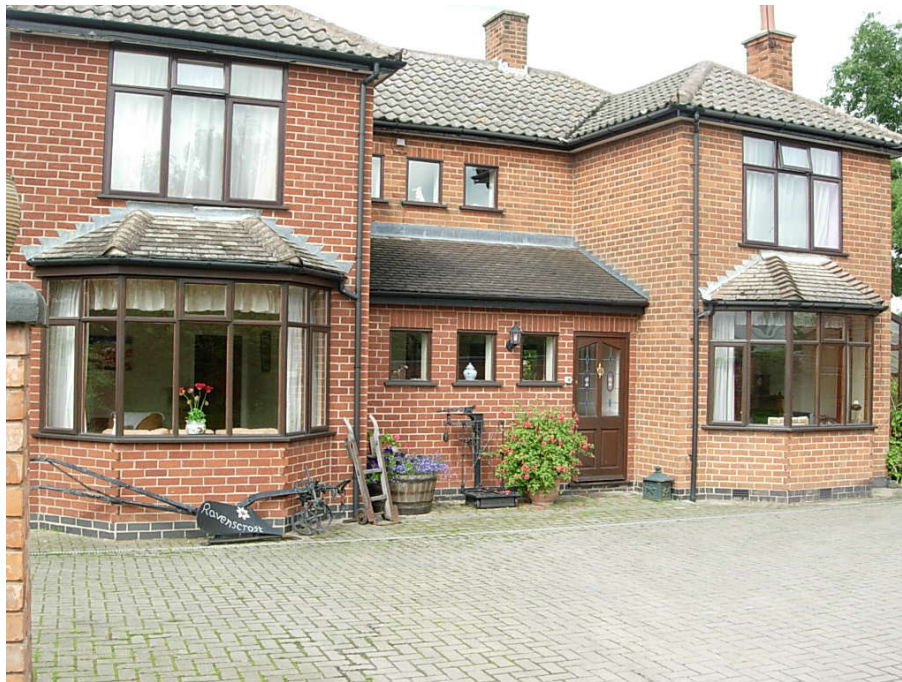
Ravencroft uses a none traditional design and has been constructed with modern materials

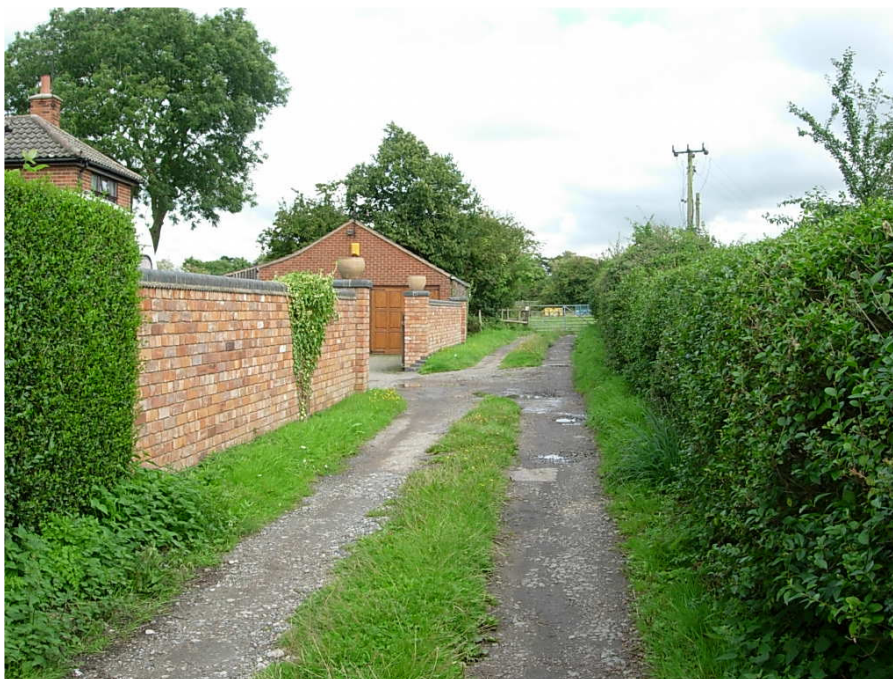
This public footpath forms part of the southern edge of the conservation area boundary. The impact of the modern wall and garage could be reduced by the introduction of a hedge along the footpath.
