**MARKFIELD CONSERVATION
AREA APPRAISAL &
MANAGEMENT PLAN**

**PHOTOGRAPHIC RECORD OF
MARKFIELD CONSERVATION AREA**

February 2010

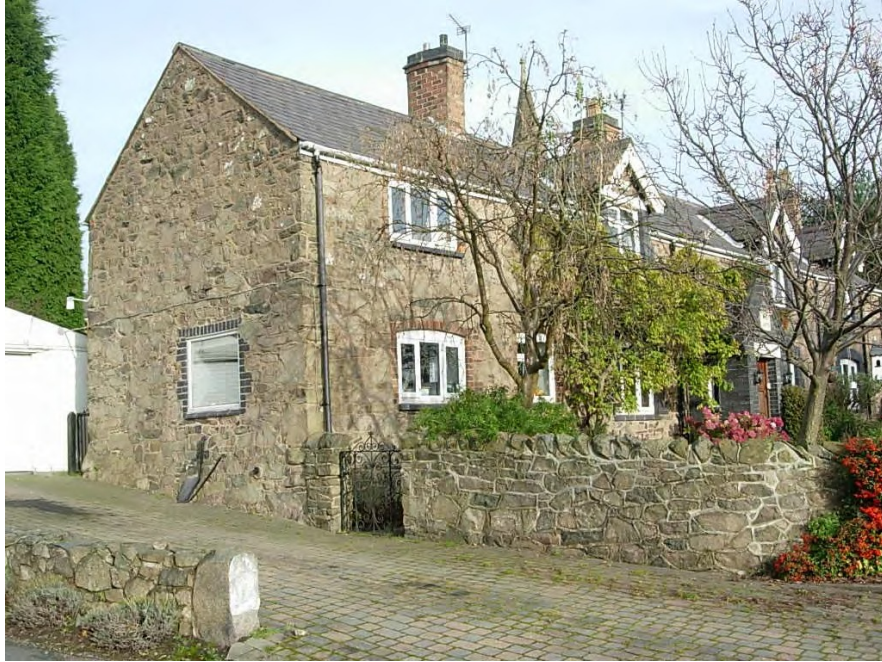
Three Gables on Queen Street is an attractive granite cottage although the insertion of a window in the gable has had a detrimental impact.

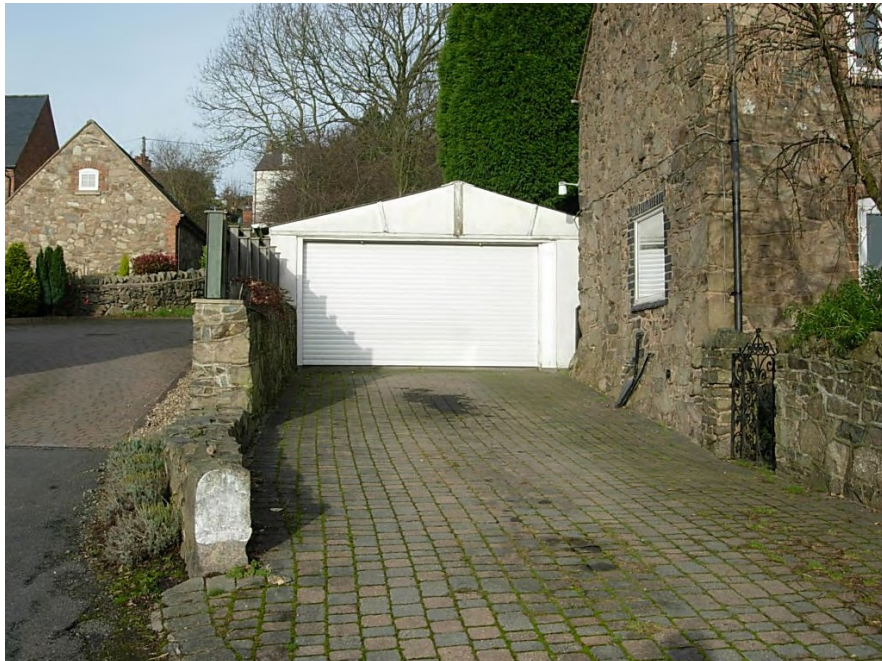
This double garage is an incongruent feature on Queen Street due to the colour and materials used in construction. Its impact would be reduced if two garage doors were to be used and painted in a dark colour.

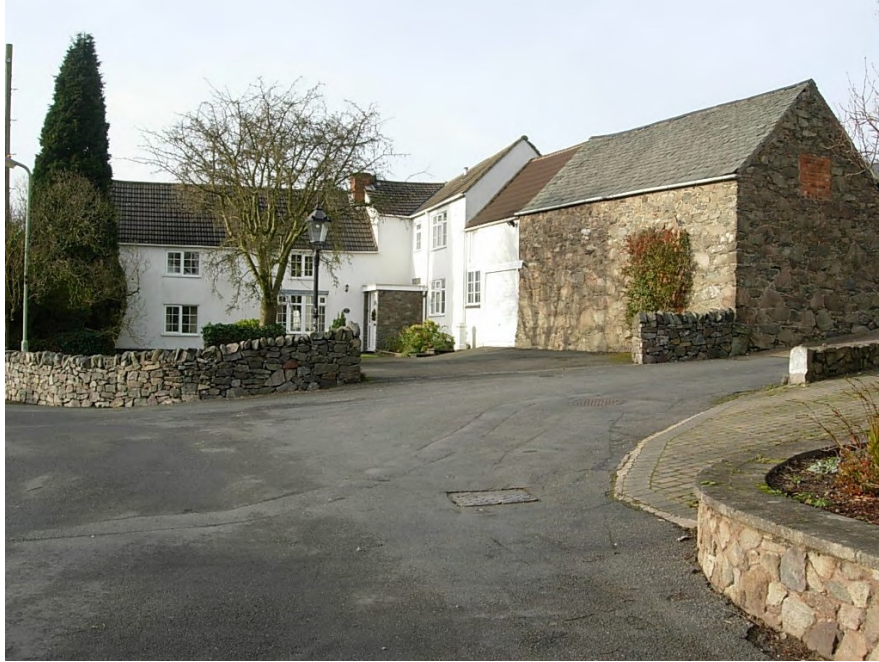
Quarry House and the stone outbuilding are a fine group of buildings on Queen Street although the concrete roof tiles are inappropriate.

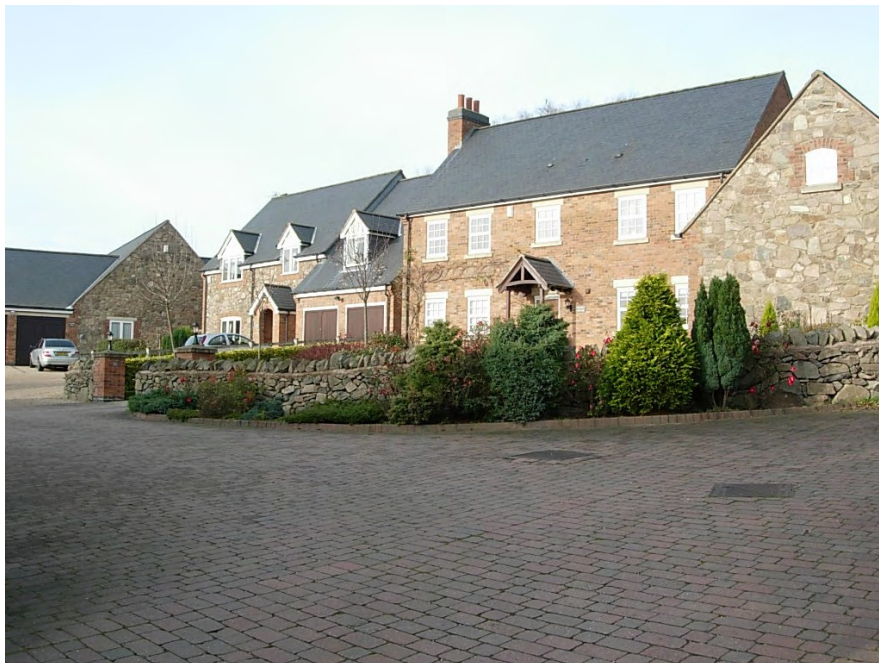
1 – 3 Quarrymans Court are modern dwellings that generally respect the traditional character of the village.

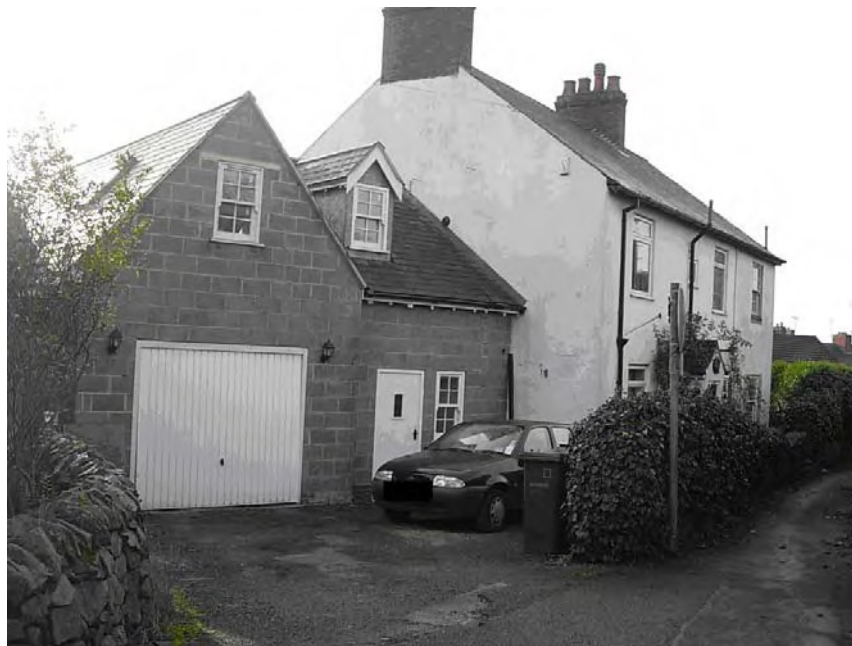
The extension to The Pieces on Queen Street needs to be completed with the block walls rendered to match the main house.

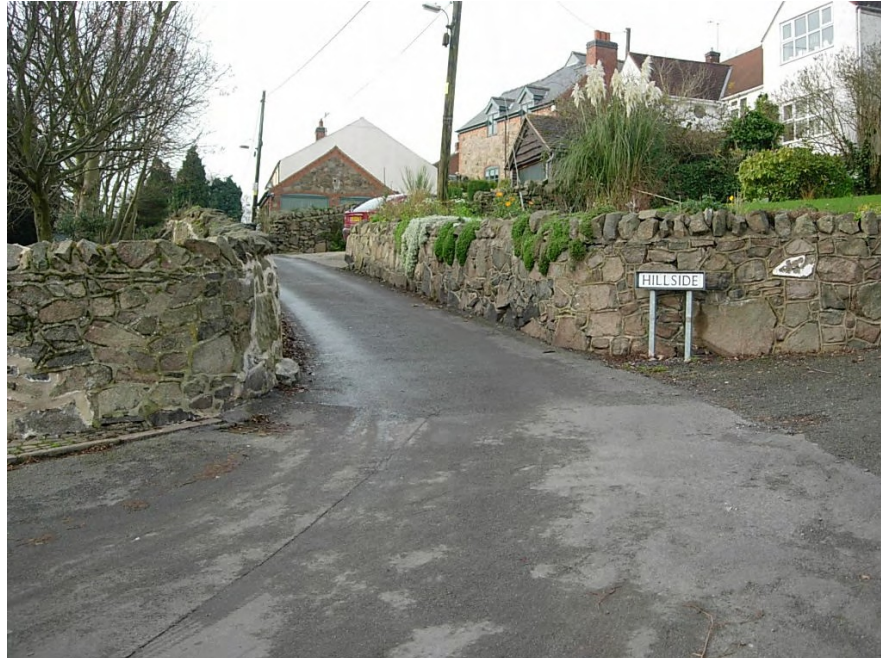
Hillside is an interesting narrow road flanked by granite walls at its eastern end.

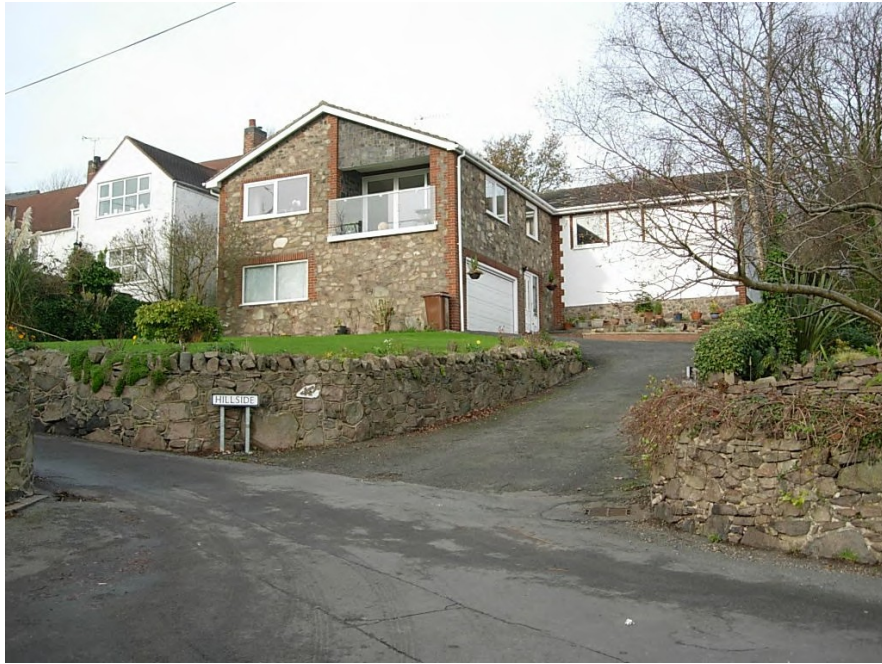
4 Hillside is a modern dwelling that does not reflect the traditional character of the settlement.

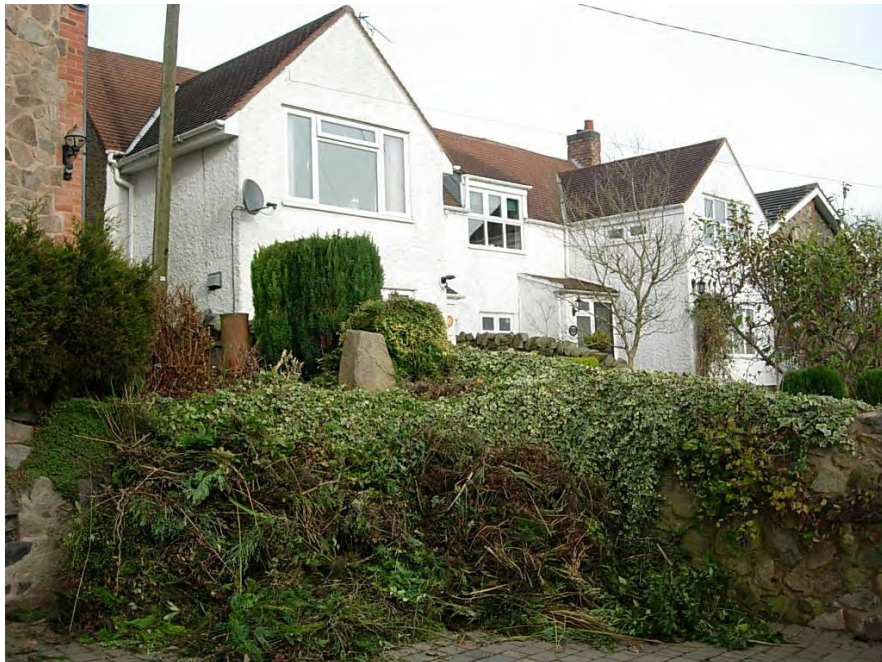
6 & 10 Hillside are well built rendered properties.

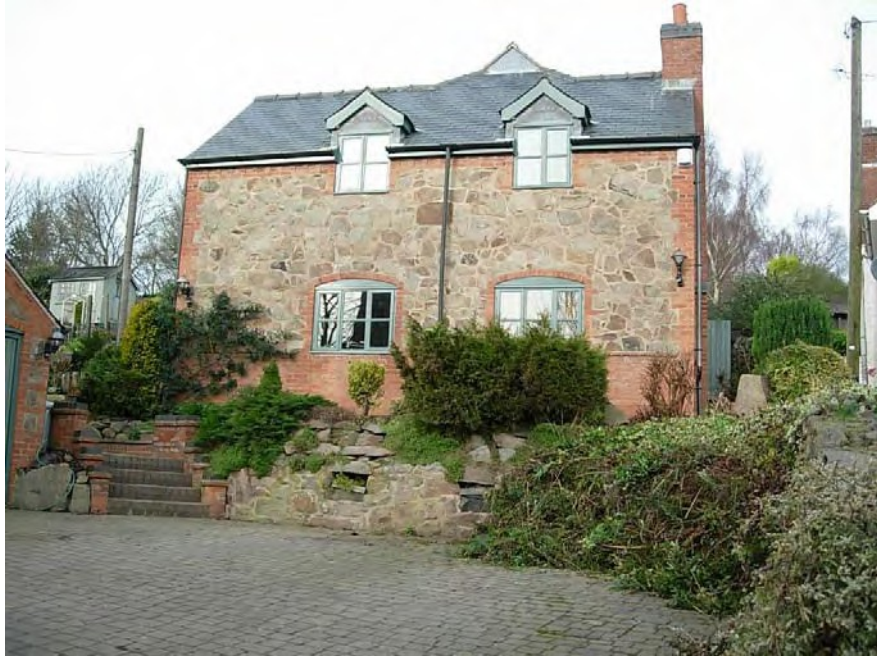
The partial use of stone on the front elevation at 12 Hillside helps its integration into the traditional street scene.

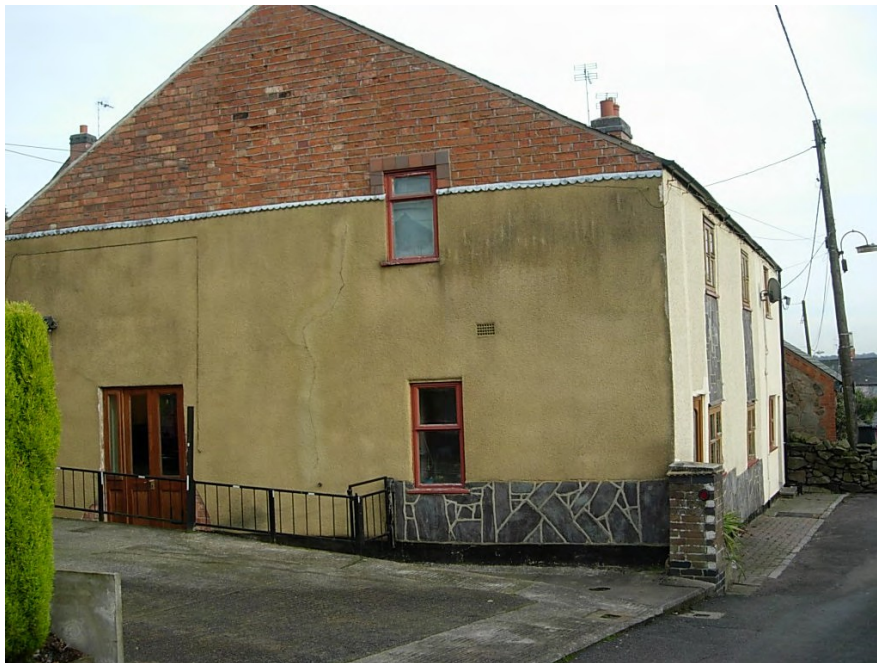
The modern render and other decorative features do not enhance the appearance of 18 Hillside which occupies a prominent position on the road.

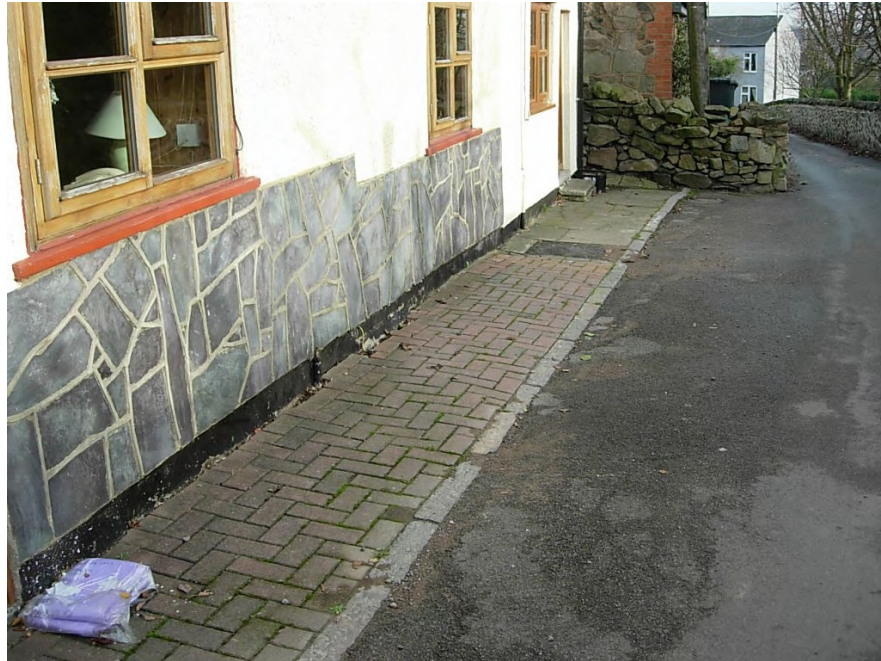
Granite sets would have been preferable to the concrete paviours fronting 14 & 16 Hillside. The slate decorative feature is also gives a cluttered appearance.

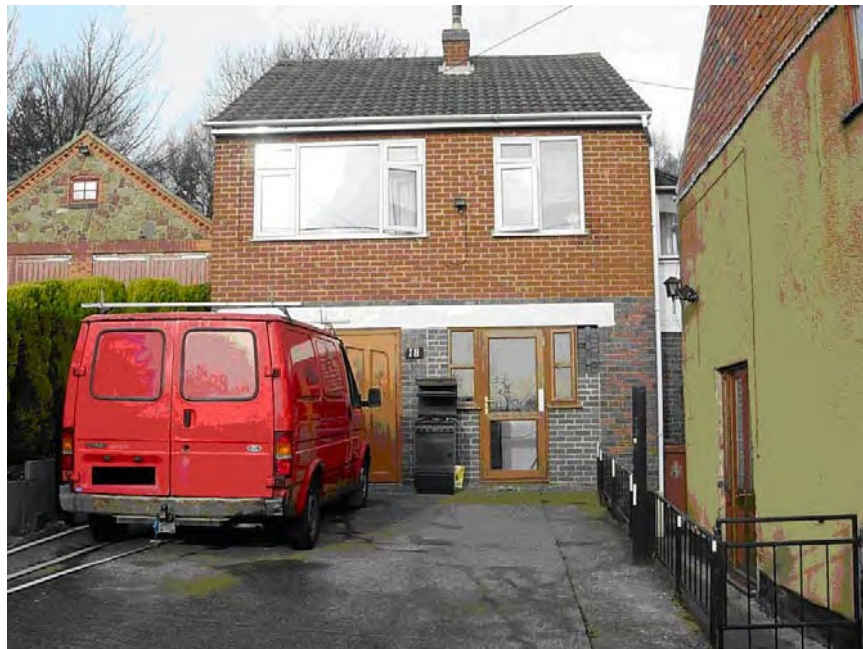
18 Hillside is out of character with the traditional character of the conservation area by way of its siting, modern design and materials.

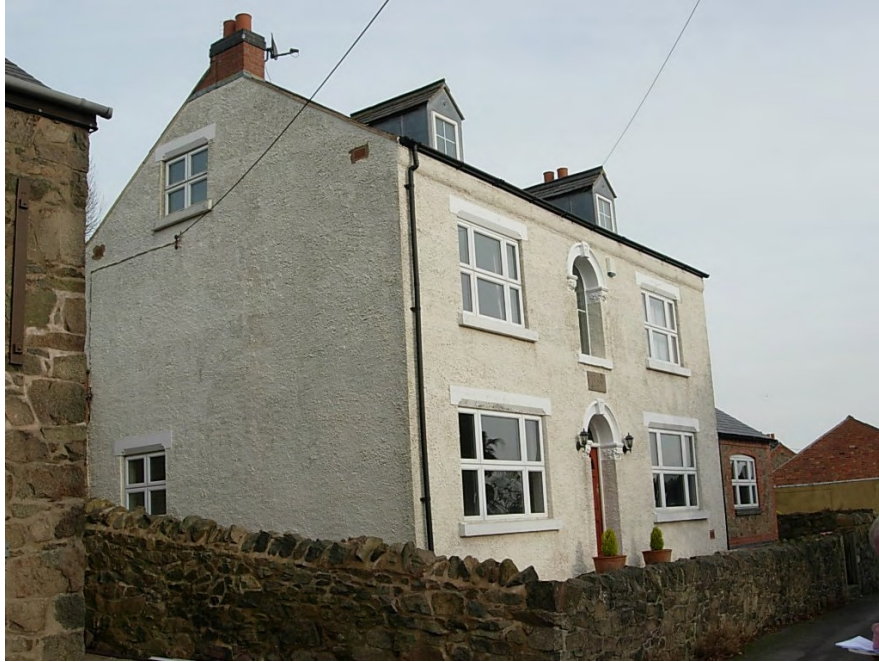
20 Hillside is an imposing property flanked by excellent granite walls.

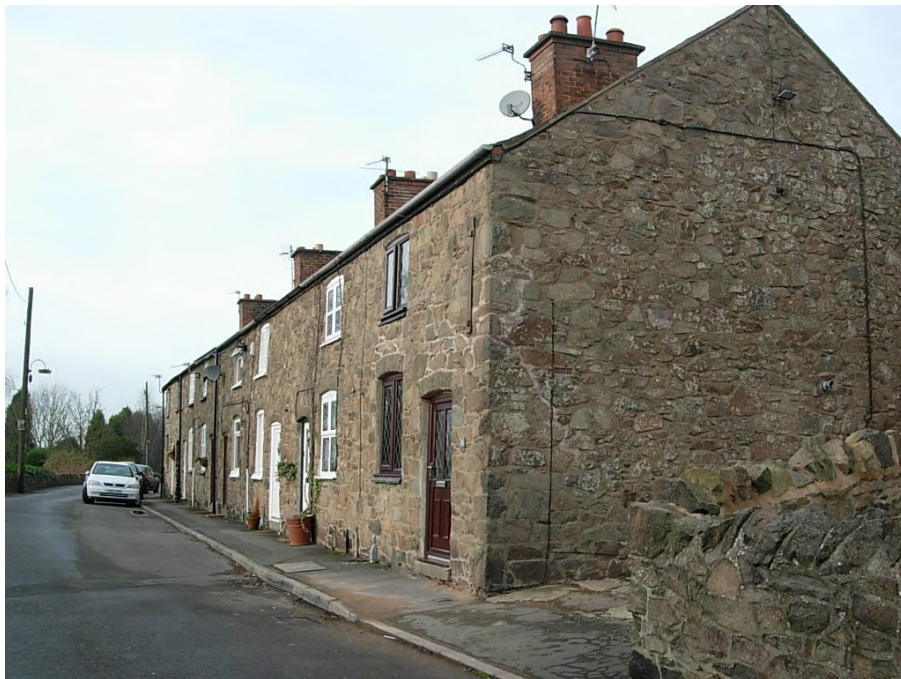
The terrace properties that run along the northern side of Hillside occupy a dominant position that give rise to excellent panoramic views to the south.

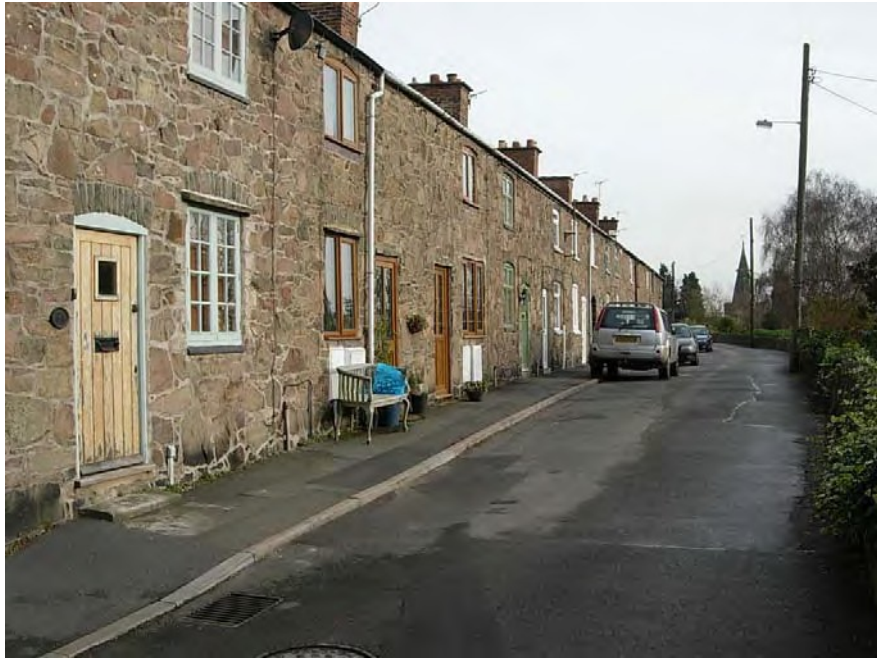
Many of the granite cottages that were once the homes of quarry workers have lost some of their traditional character because of the insertion of plastic windows, doors and guttering, and use of concrete tiles.

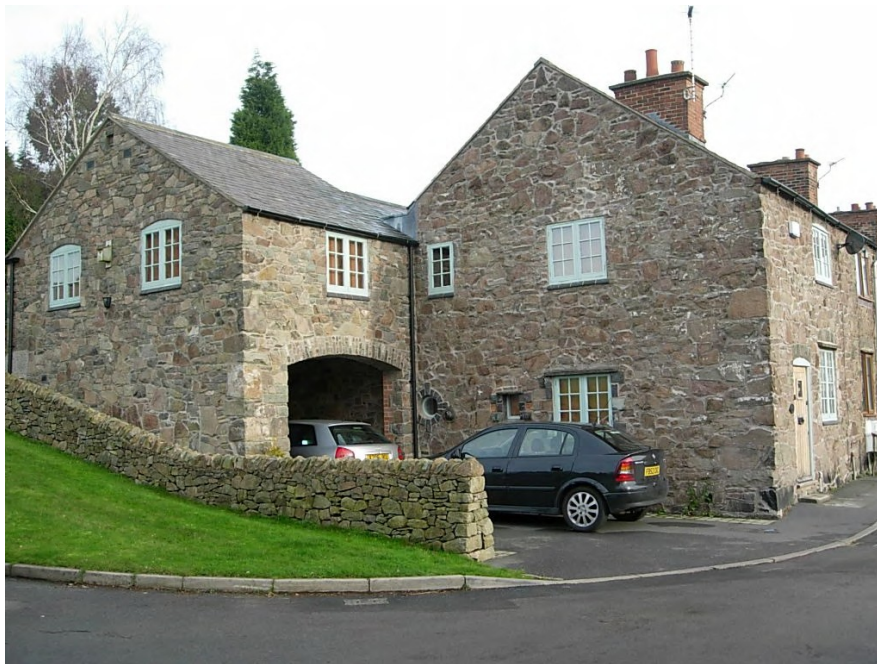
The extension to 62 Hillside shows how good quality design and use of traditional materials can improve the street scene.

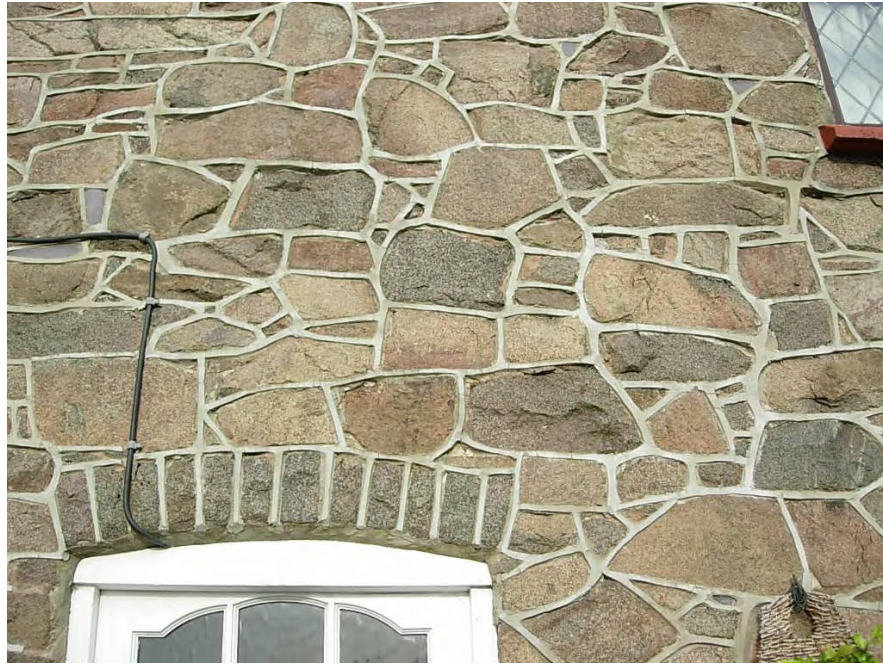
Raised pointing is not a traditional detail and has a detrimental affect on the stonework due to it being too prominent.

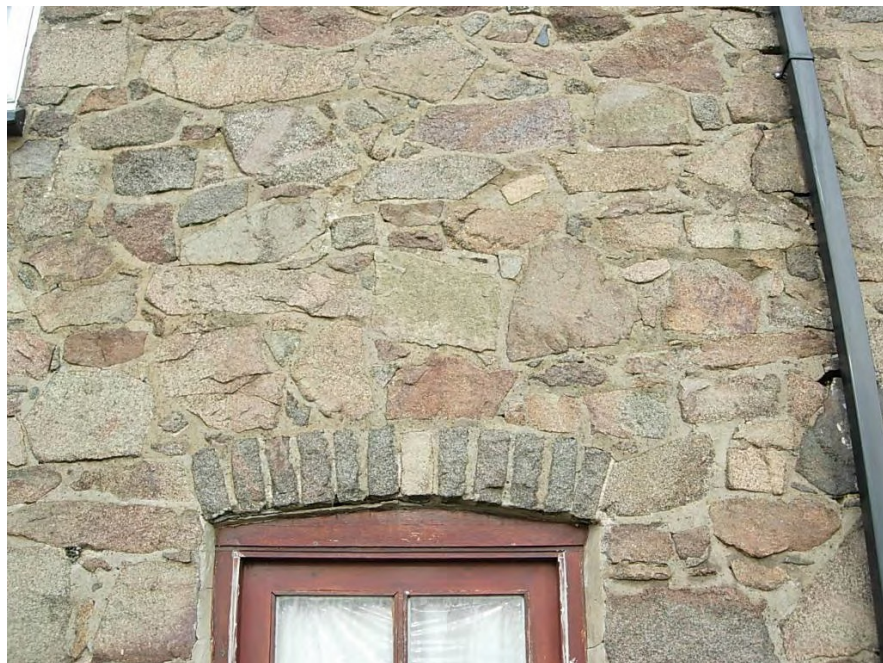
The traditional method of pointing has a more pleasing affect by not dominating the stone work.

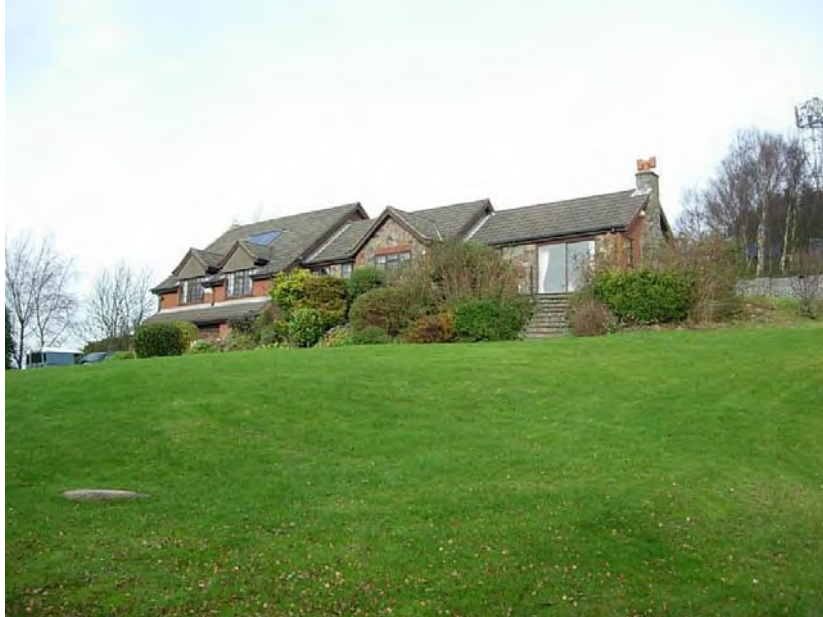
Although Denbar Lodge is not sited in the conservation area, it occupies a prominent location at the western end of Hillside. The modern bungalow does not reflect the traditional character of the village by way of design or materials.

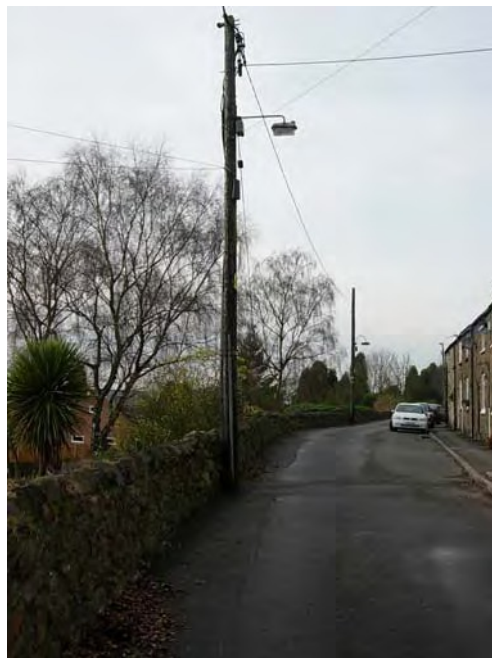
The overhead electricity cables running along Hillside are particularly unsightly and should be undergrounded and the timber posts removed. The existing street lights could be replaced with heritage lights hung from brackets fixed to the walls of the properties opposite.

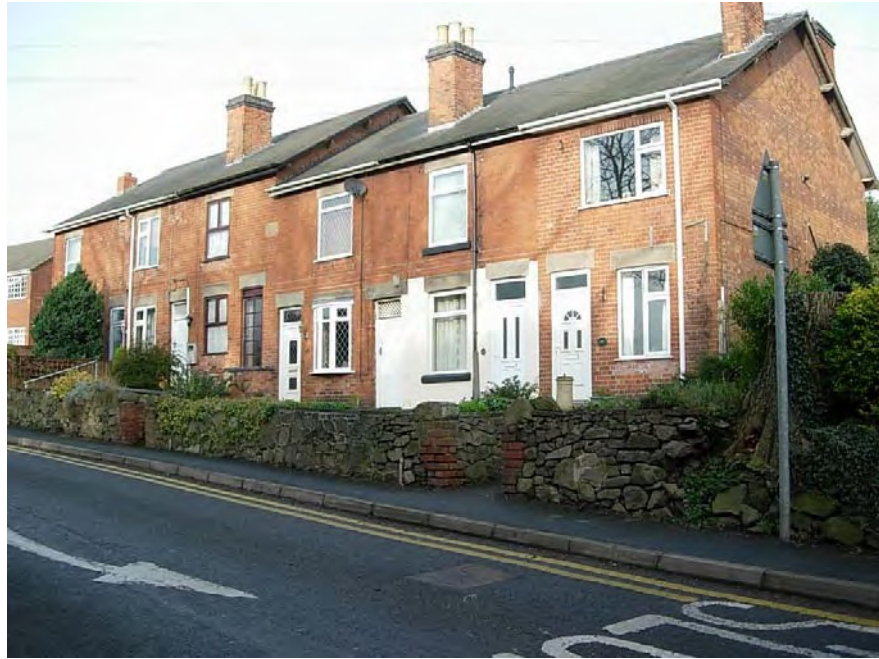
The unity of this block of terraced dwellings has been lost due to changes to the window openings and use of artificial materials.

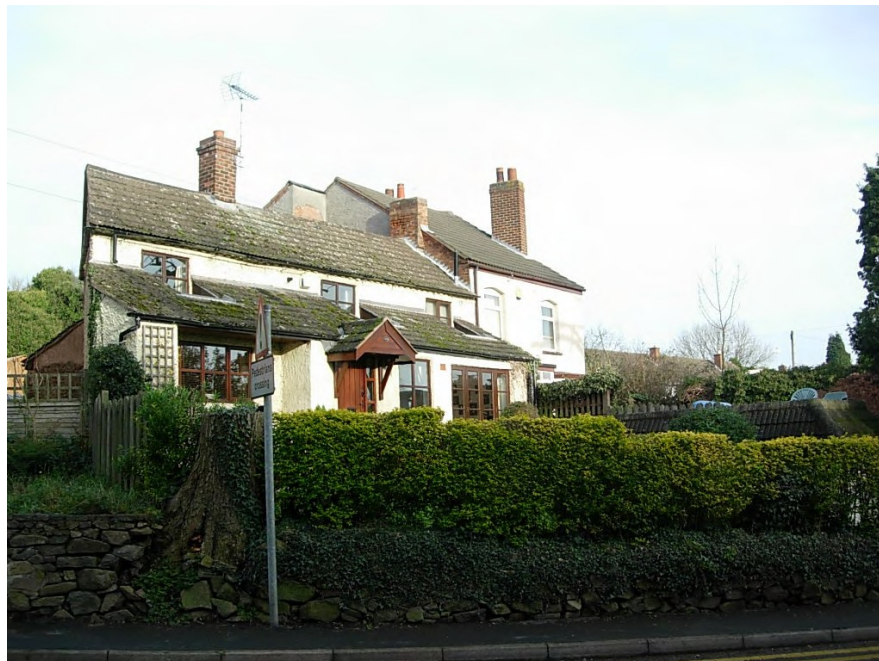
38 & 40 Forest Road, has an interesting array of roofs when viewed from the highway.

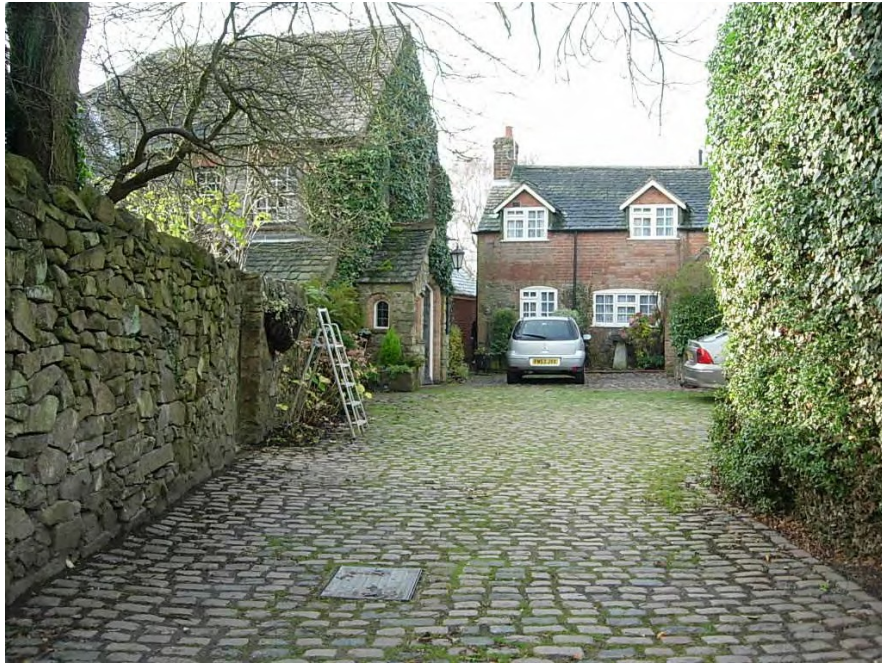
The access to this pleasant group of buildings at 27 Forest Road (the Manor House) is surfaced with granite setts.

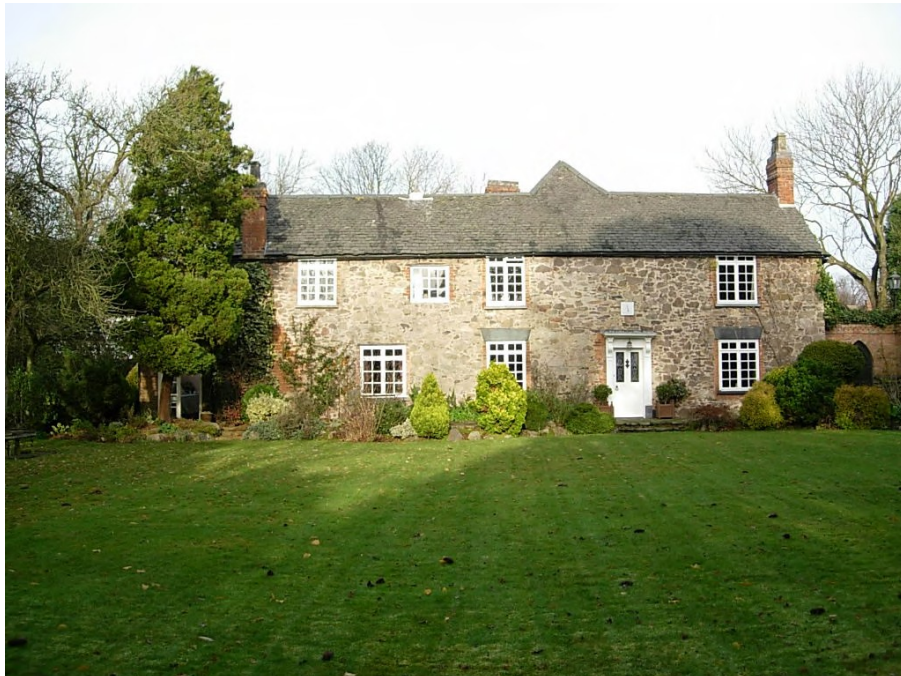
The southern elevation of the Manor House. This property that is sited in large grounds, still retains its traditional charm.

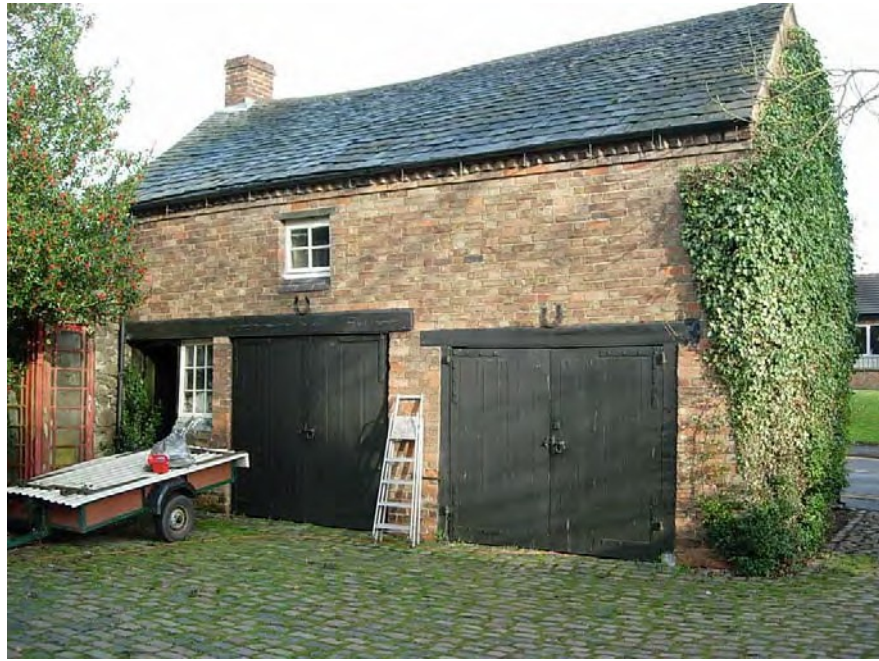
The outbuilding to the Manor House was once the property's Coach House.

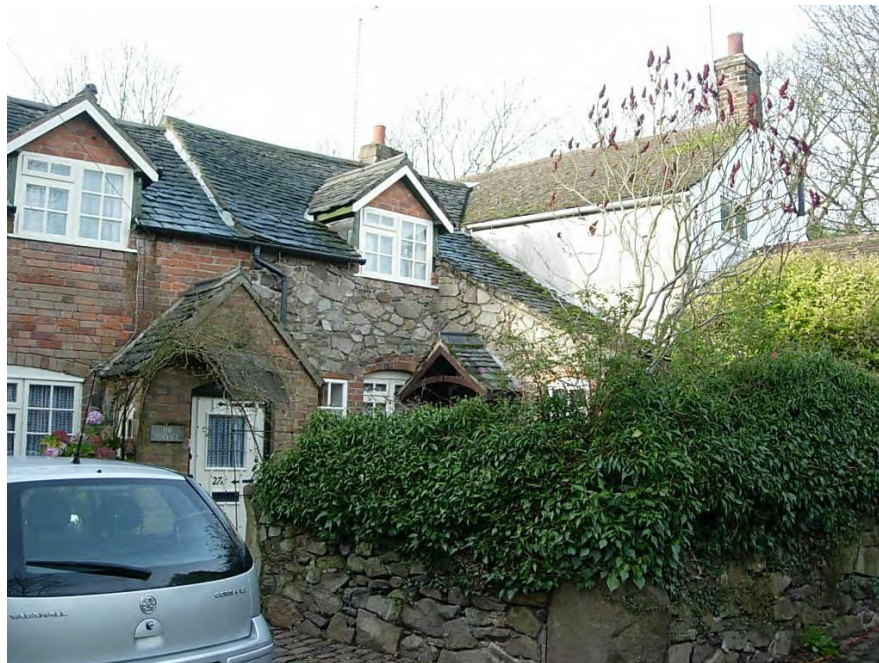
The former stable block to the Manor House has now been converted into a dwelling. The former groom's quarters can be seen on the extreme right of the photograph.

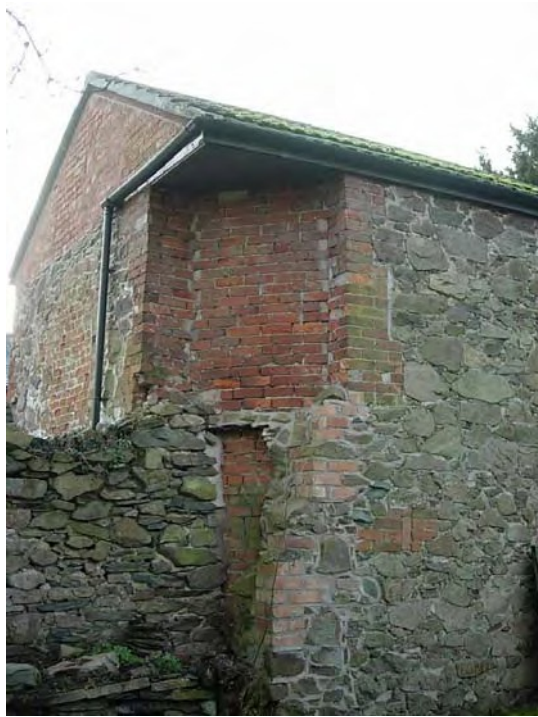
This building sited in the grounds of the Bulls Head Pub has an unusual gable. It appears that there was once a building fronting it.

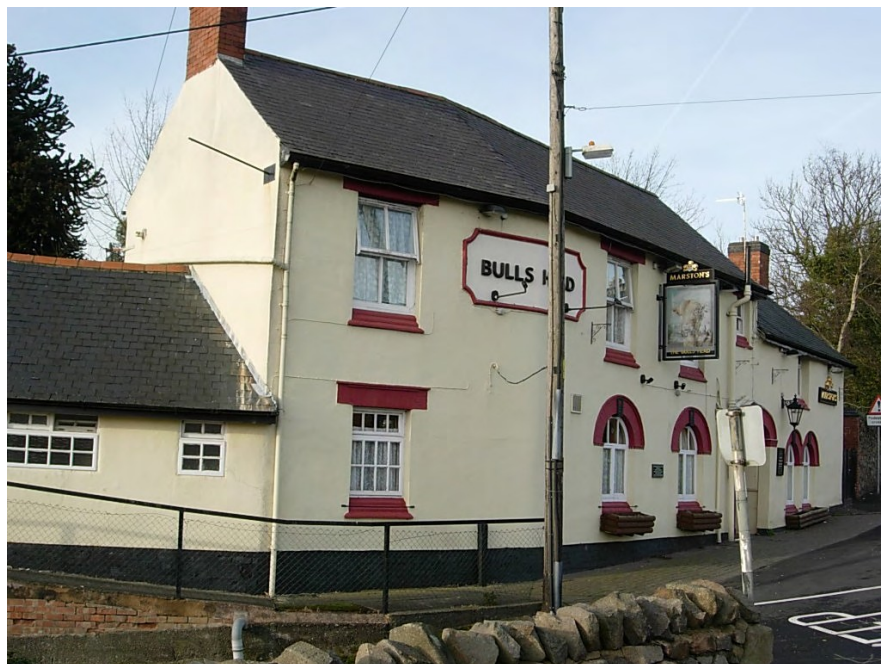
The Bulls Head Pub is an attractive property sited in a prominent position on the bend on Forest Road.

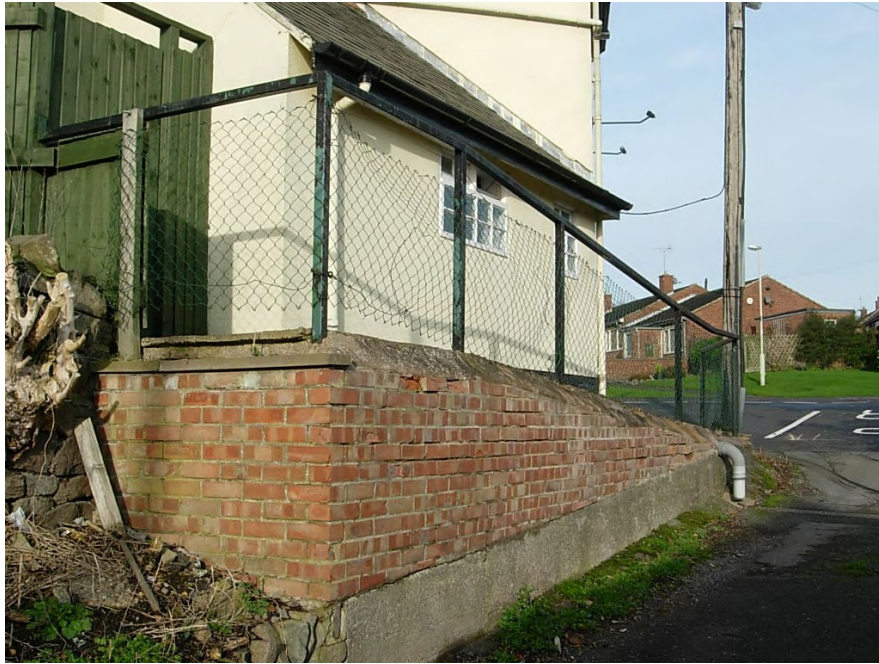
The wire mesh fence running up the ramp that accesses the Bulls Head's rear garden is unsightly. Consideration should be given to replacing it with traditional iron railings.

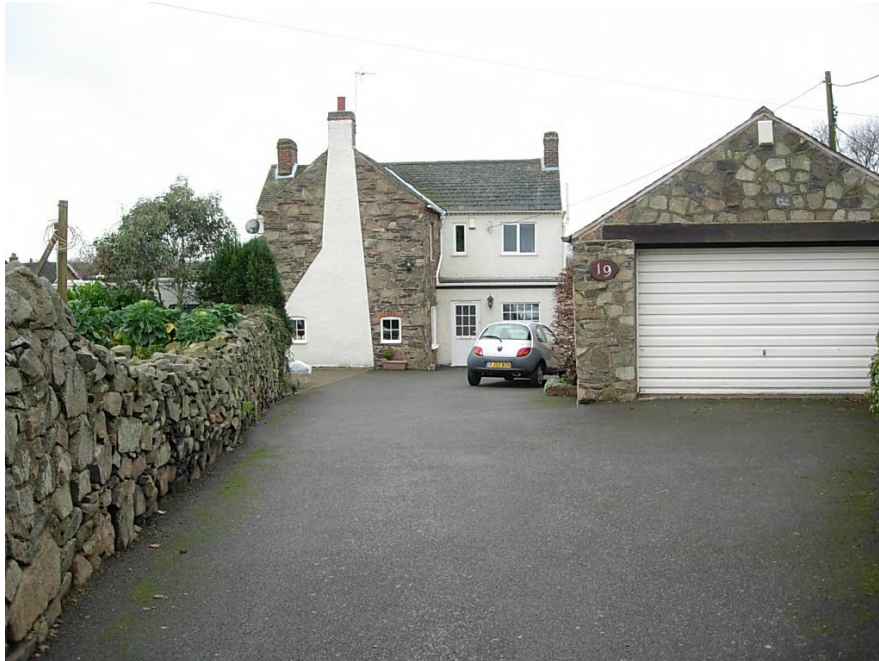
Views to 19 Forest Road would be improved if the double up & over garage door is replaced with two timber doors painted in a dark colour.

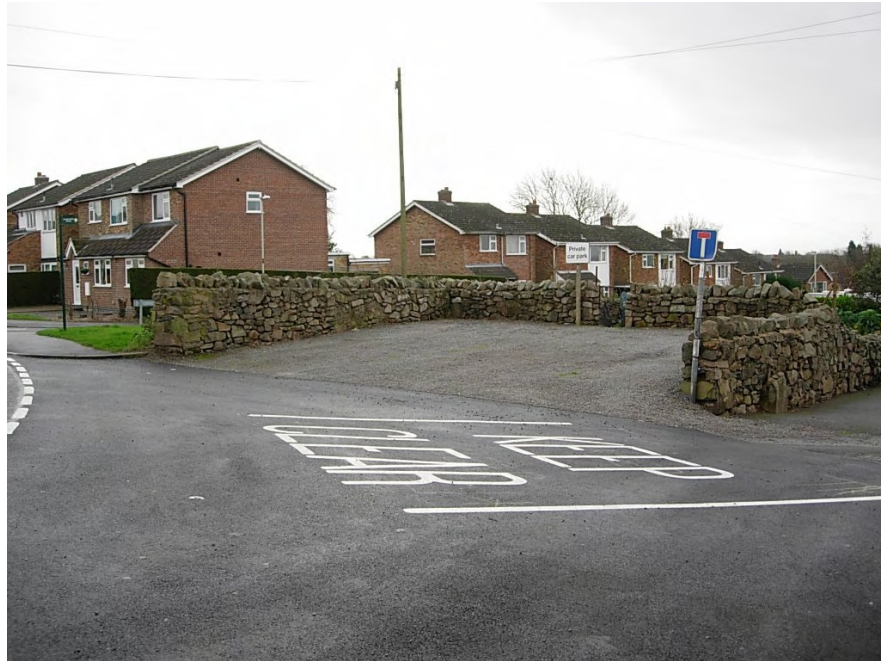
The parking area to the Bulls Head pub is flanked by stone walls and surfaced with granite chips.

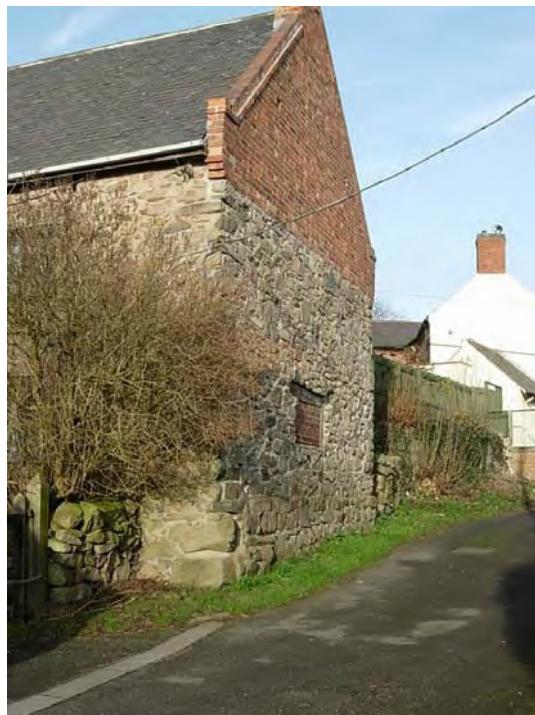
The gable end to Stepping Stone Farmhouse has been heightened utilising red bricks.

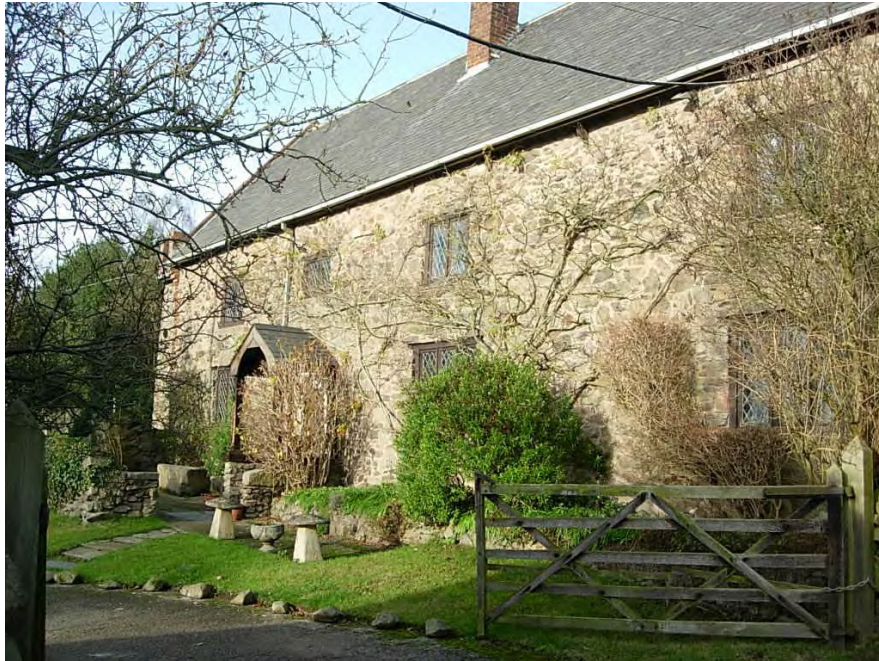
The mid 18C Stepping Stone Farmhouse is an attractive Grade 2 property built in Charnwood granite rubble and red brick with a slate roof.

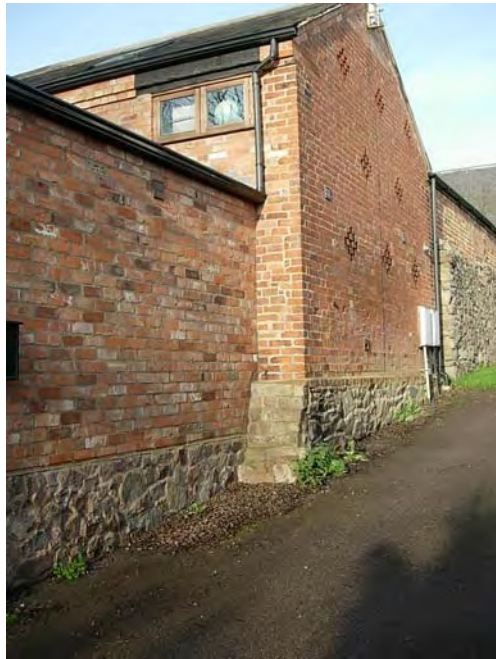
The outbuildings at Stepping Stone Farm have been successfully converted into a residence.
