NEWBOLD VERDON CONSERVATION AREA MANAGEMENT PLAN

PHOTOGRAPHIC RECORD OF NEWBOLD VERDON

January 2009

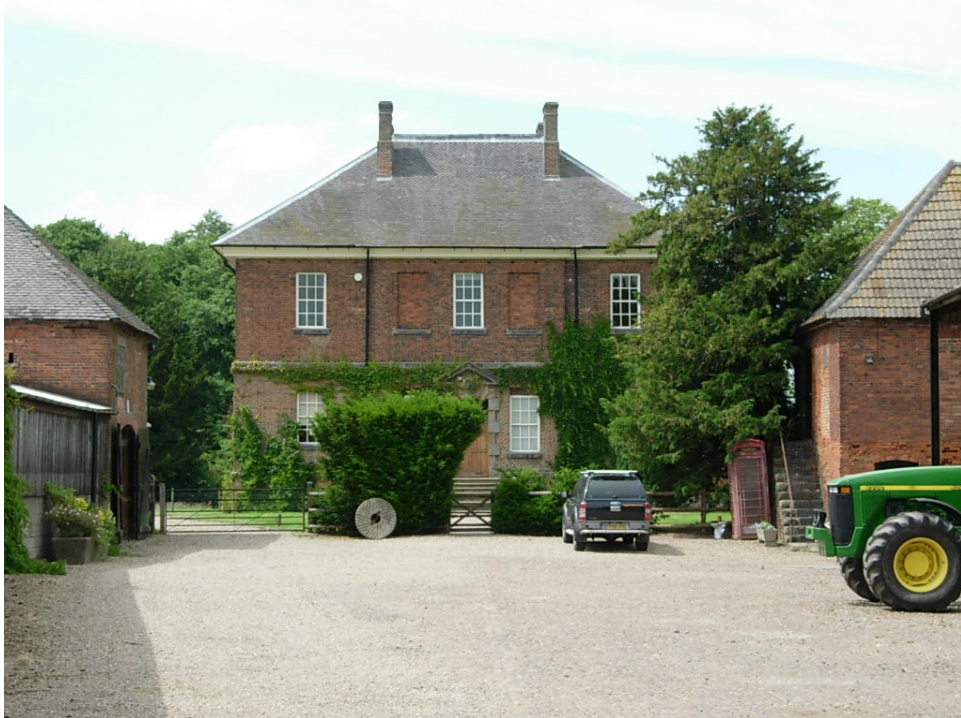
Newbold Verdon Hall is an excellent grade I listed property at the western end of Main Street

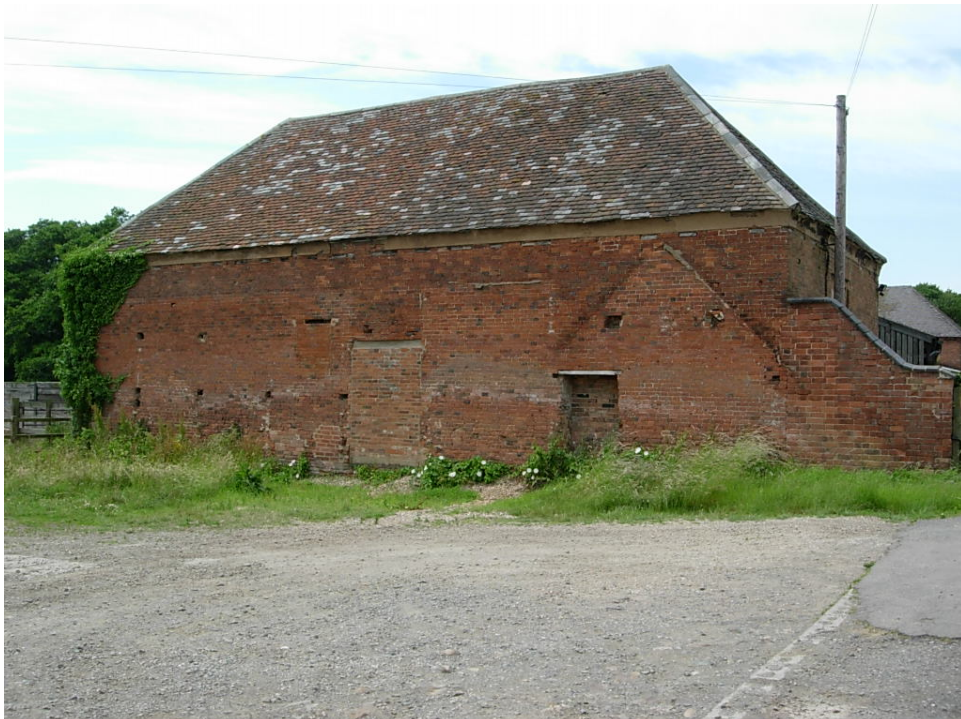
The listed pavilion at the south east corner of Newbold Verdon Hall forecourt is now utilised as a farm building. There is an excellent vista to the south into open countryside over the land fronting the pavilion

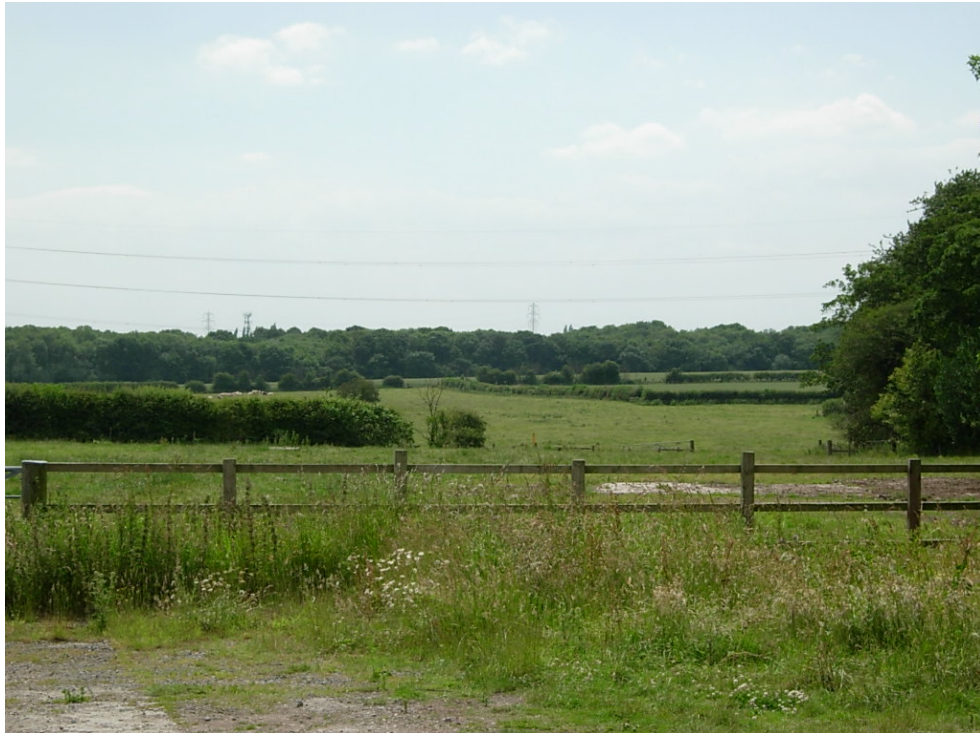
There is an excellent vista looking south into open countryside from the land between the pavilion at the south east corner of Newbold Verdon Hall and 2A Main Street

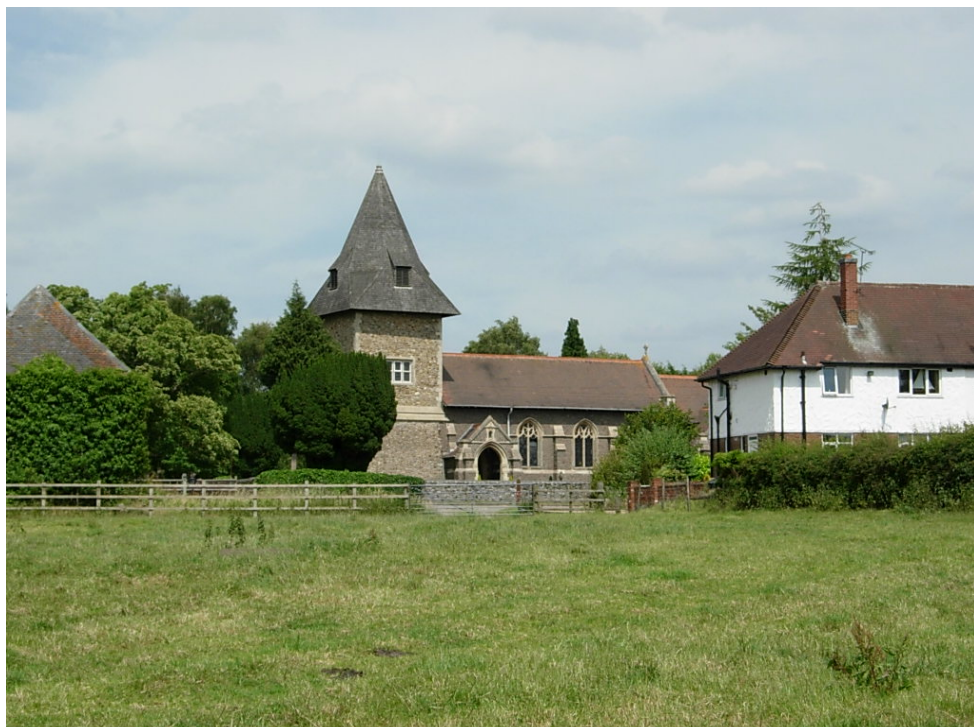
There is a pleasant view from the countryside into the conservation area towards the church

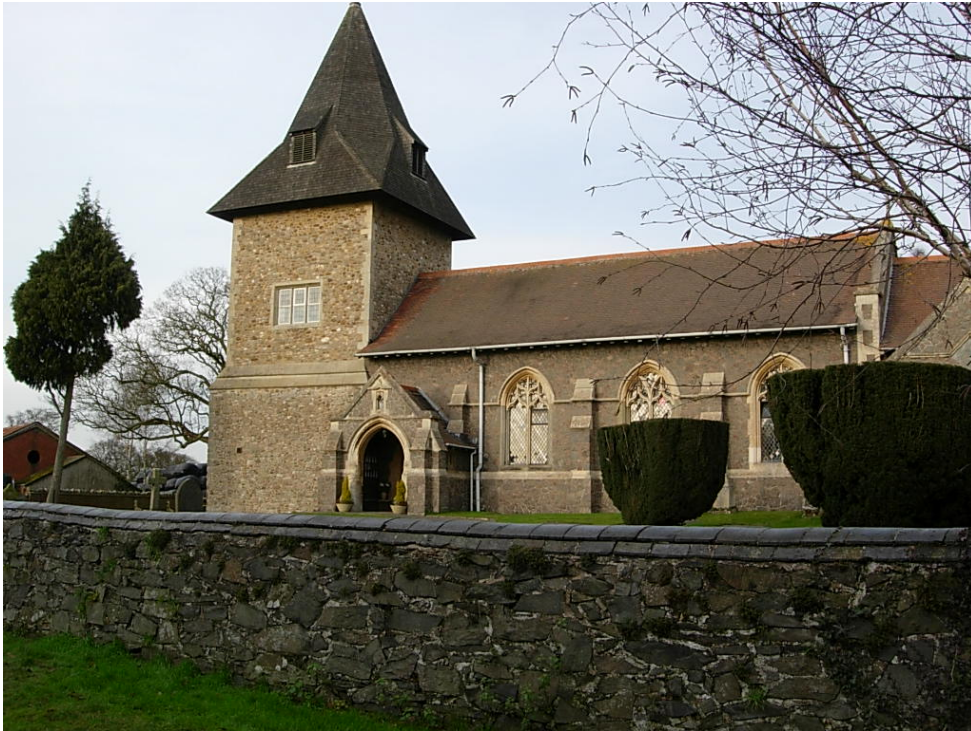
The listed Parish Church of St James's

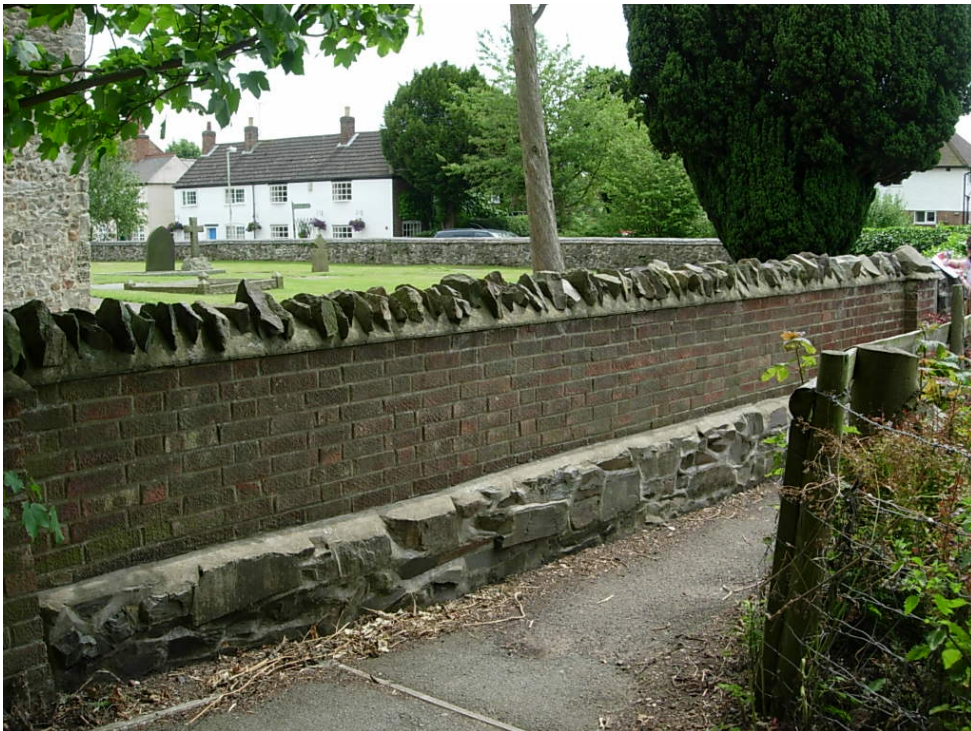
The modern wall bounding the footpath in St James's church yard could be improved by being replaced with a traditional stone wall with saddleback coping

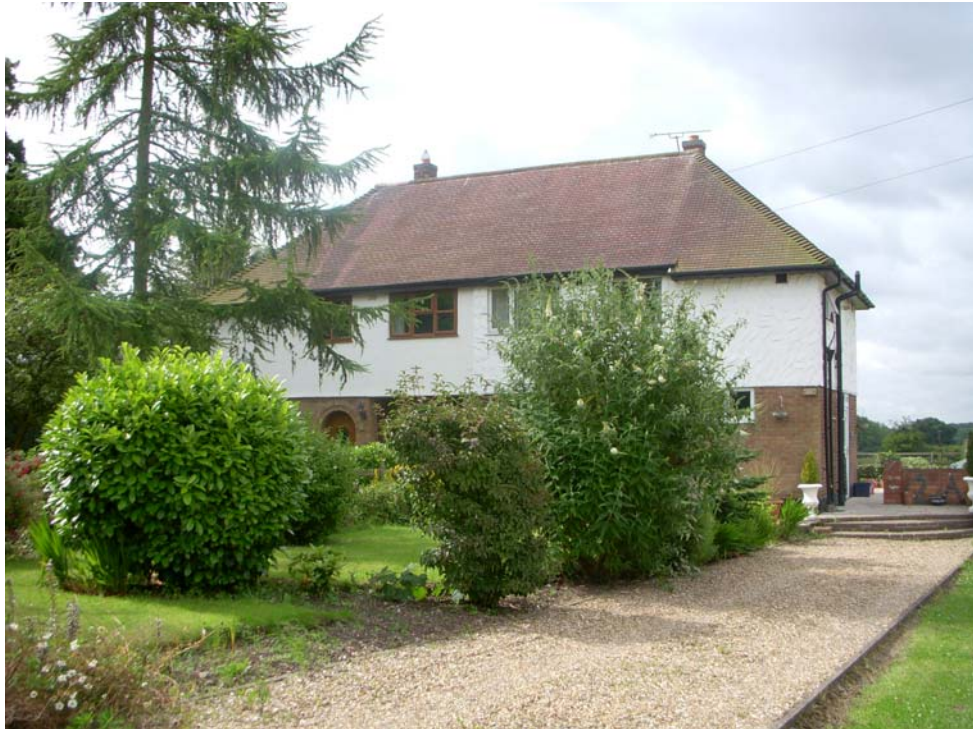
2A and 4A Main Street are a pair of semi-detached dwellings out of keeping with the character of the conservation area

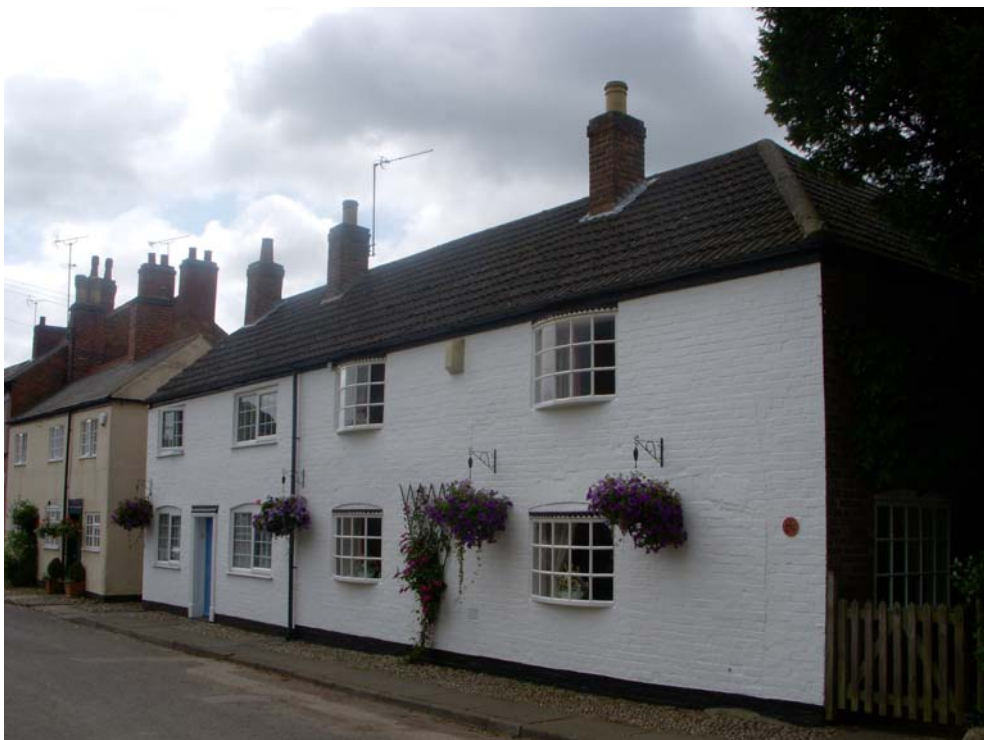
4 and 6 Main Street have had unsympathetic alterations including bow windows, replacement plastic windows with thick frames, and concrete roof tiles. The original cobbled surface outside the dwellings still remains and is fronted by a granite kerb stone

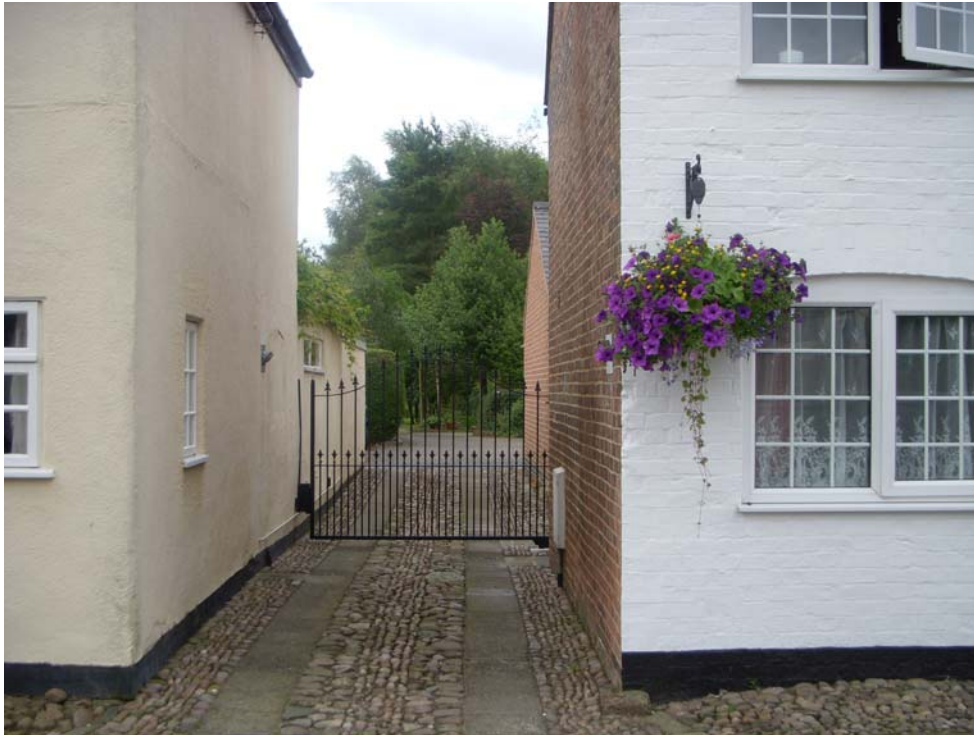
The cobbled driveway between 6 and 10 Main Street is a pleasant feature in the conservation area

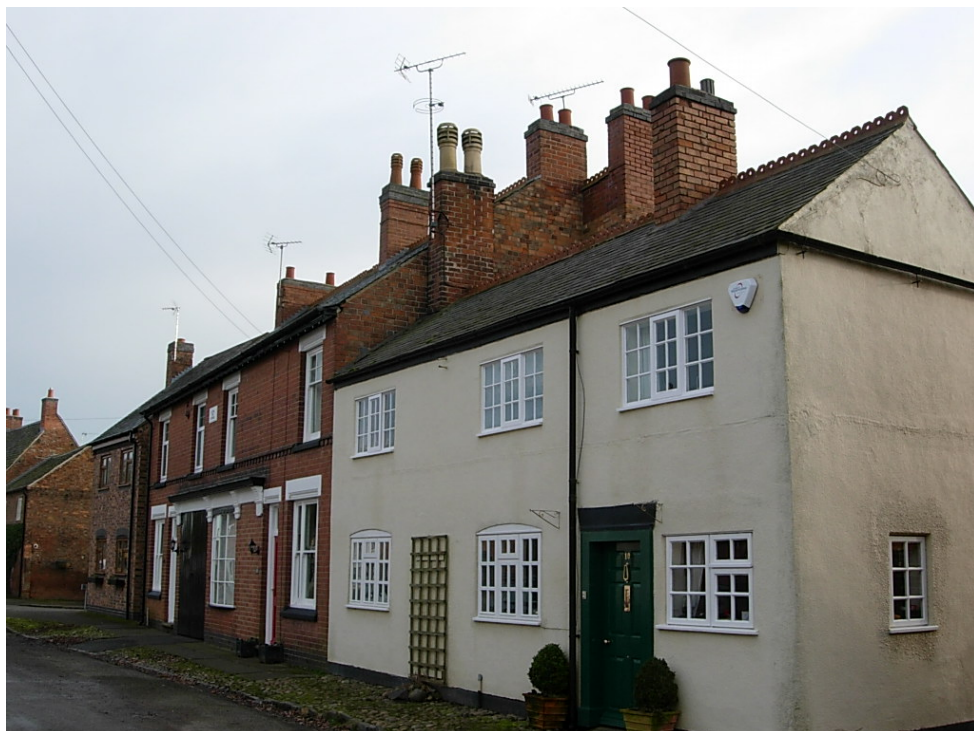
The group of dwellings at 10 to 14 Main Street have grandiose chimney stacks and interesting ridge detail. 12 and 14 Main Street are Victorian properties with sympathetic alterations. A hard landscaping enhancement scheme fronting the properties is to take place in the near future.

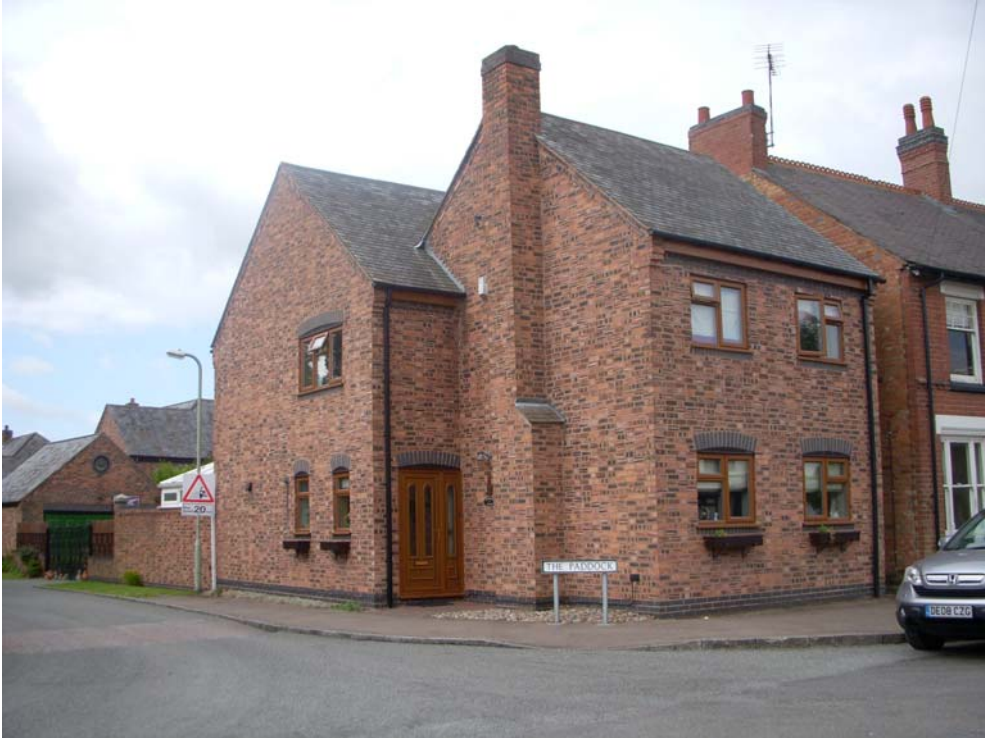
The modern dwelling at 2 The Paddock has attempted to fit in with the traditional design of the conservation area but it is an obvious anomaly on the street scene

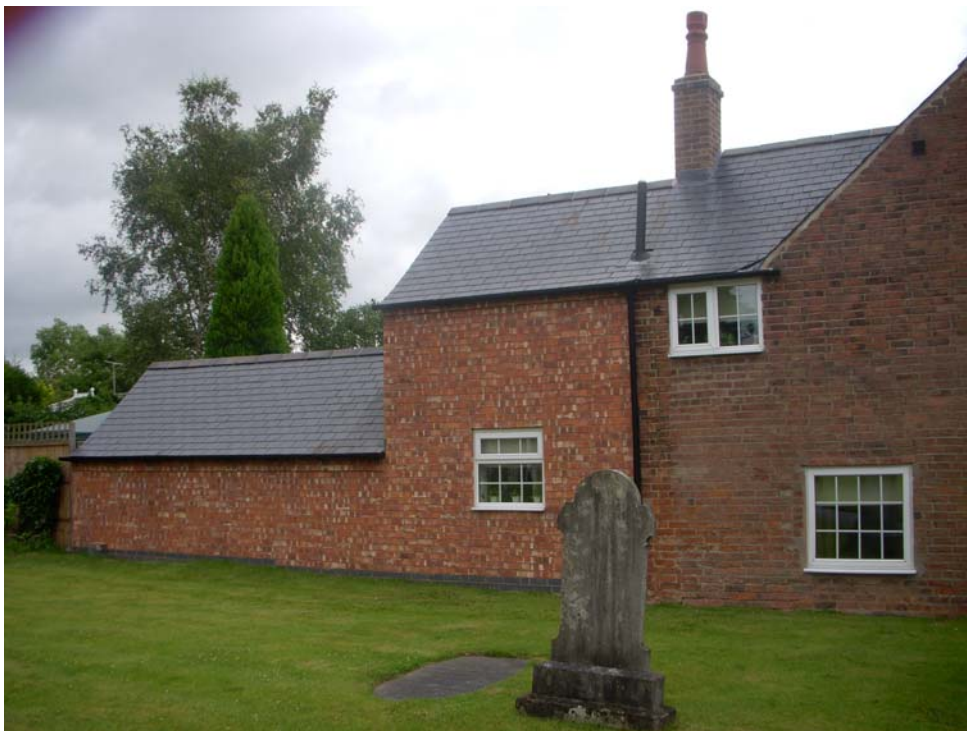
The modern extension to the rear of 1 Main Street adjacent to the churchyard is an excellent example of keeping with the traditional design of the conservation area

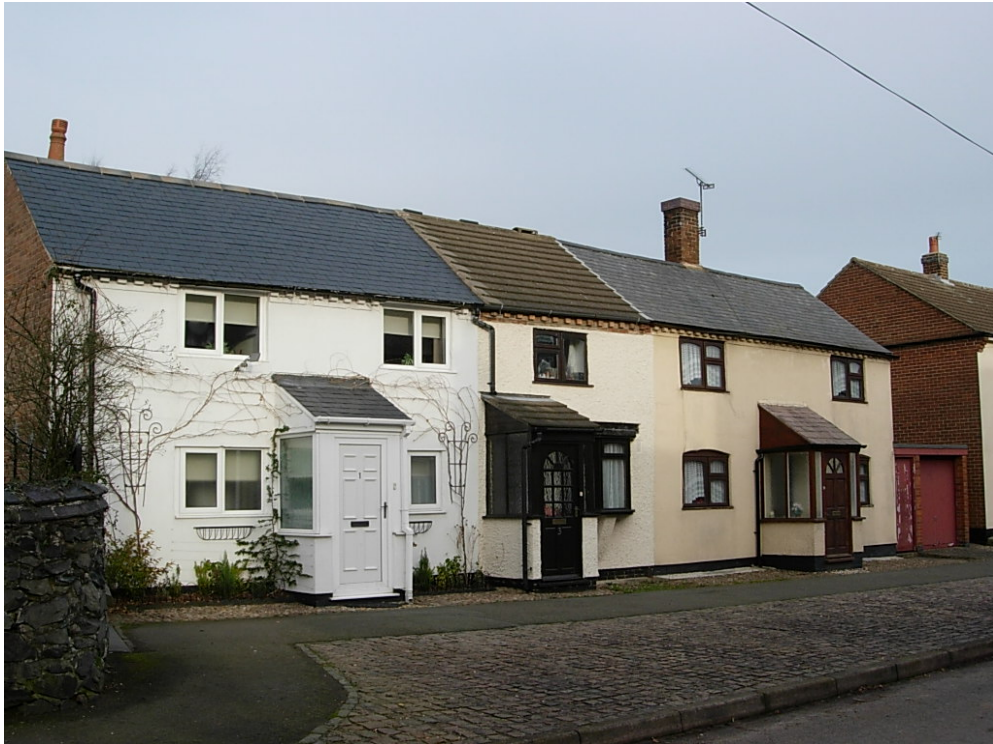
1 to 5 Main Street have been painted and rendered and have had unsympathetic modern additions including porches, plastic windows, and concrete roof tiles

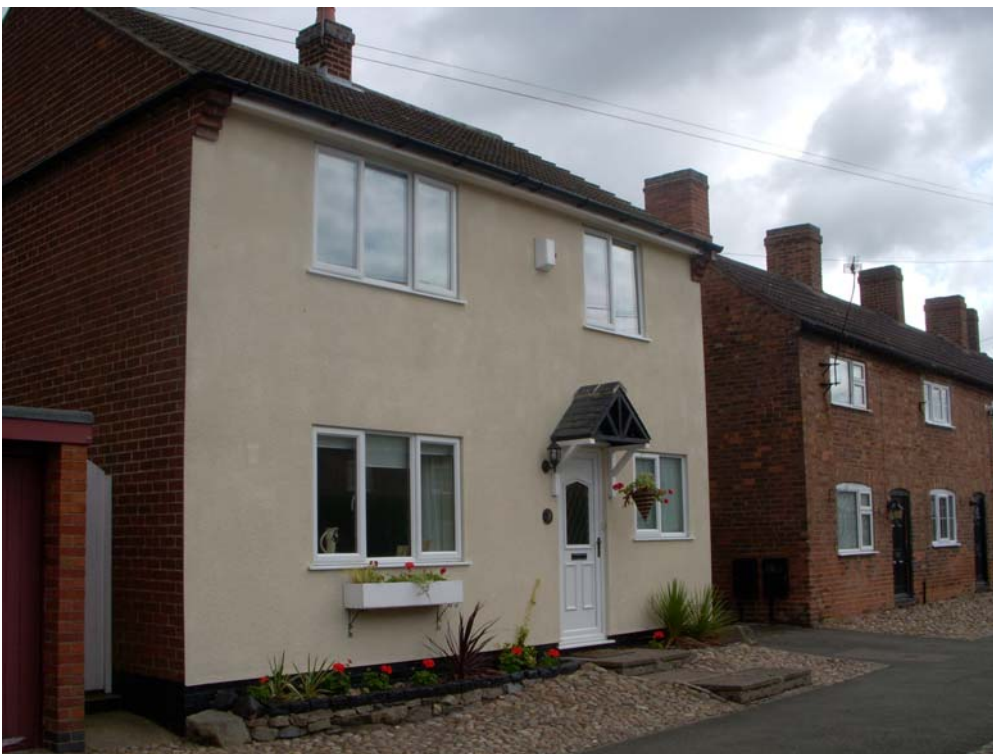
7 Main Street has not been built to the street line with the scale too large and the ridge and eave level too high

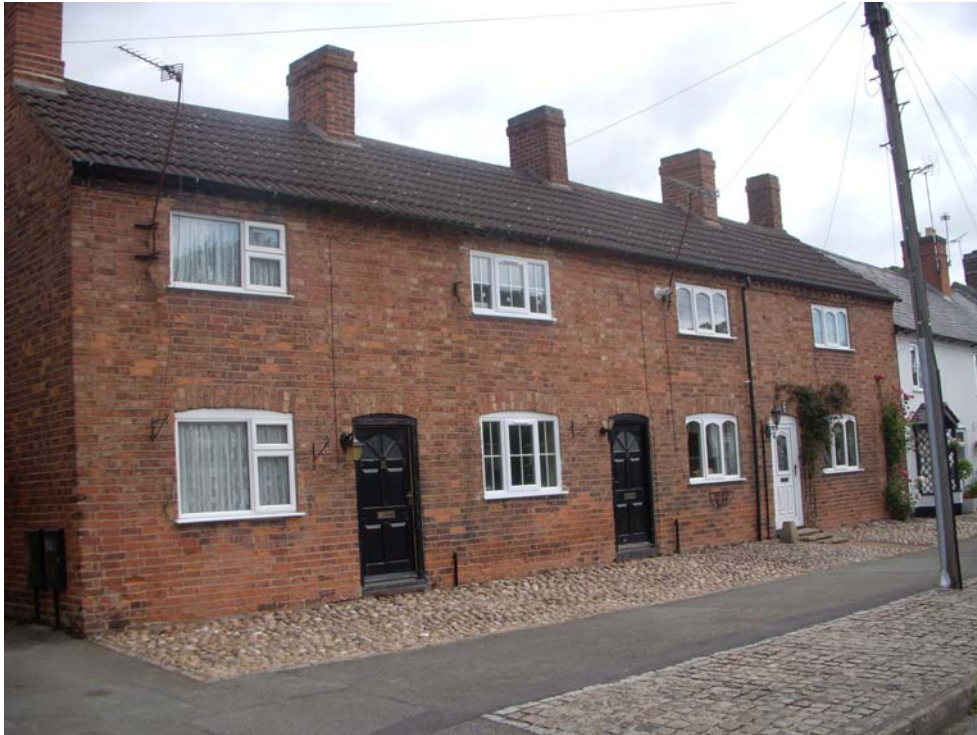
11 to 15 Main Street are traditional red brick cottages with interesting eave detail and simple chimneys. The cottages would benefit from the replacement of the concrete roof tiles and modern plastic doors and windows

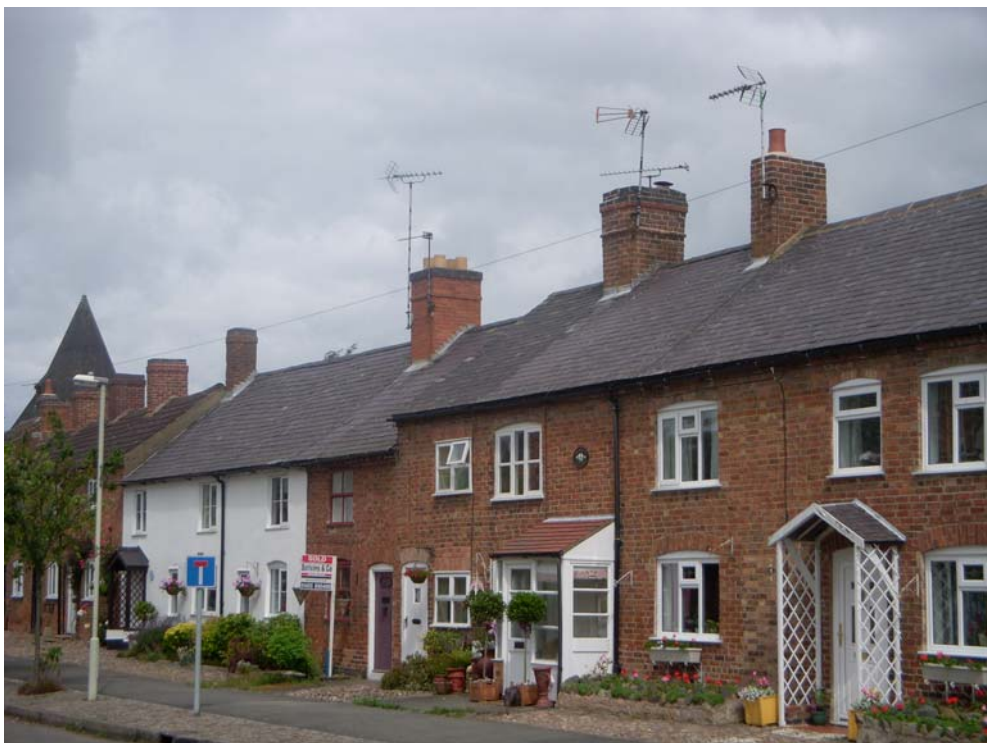
Some rustic features remain on the workers cottages along 21 – 33 Main Street

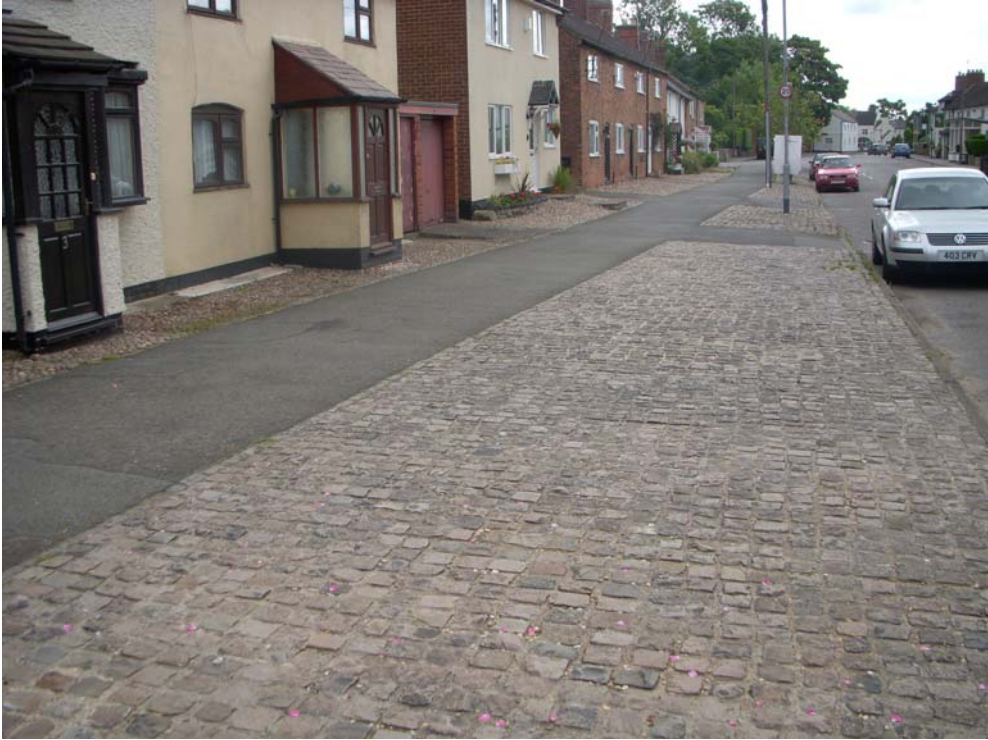
Granite setts and traditional cobbles front the cottages along Main Street provide a pleasant setting on the wide street scene

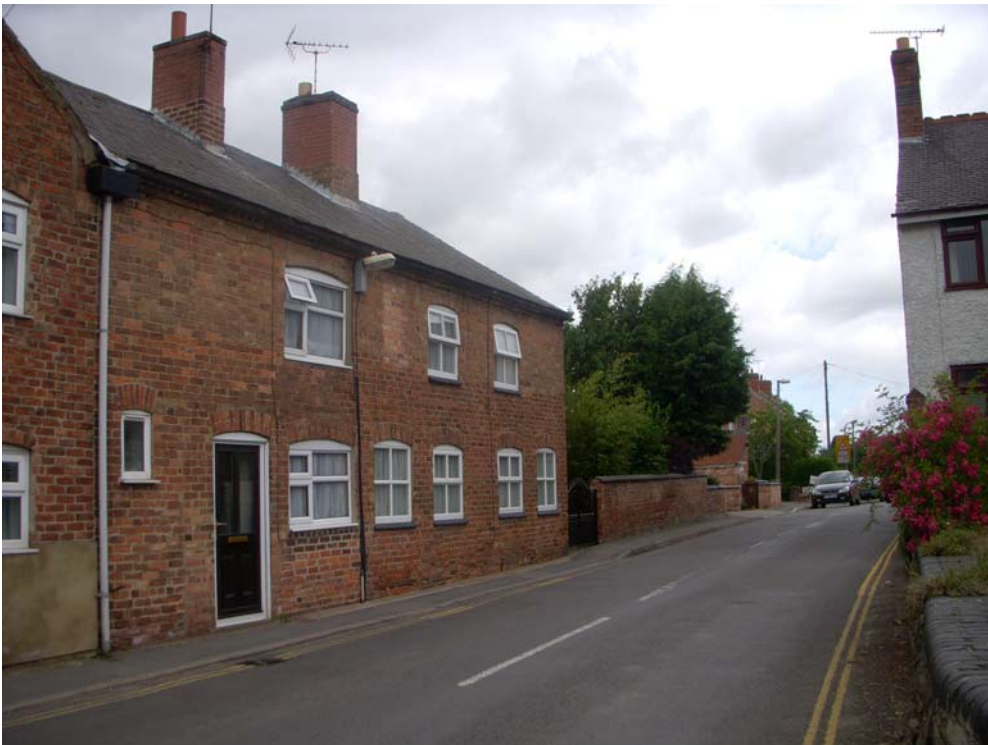
The windows at 1 to 5 Dragon Lane are modern additions with frames that are too large, though some are wooden. The modern wall adjacent to 5 Dragon Lane has been constructed in a traditional manner with reclaimed red brick

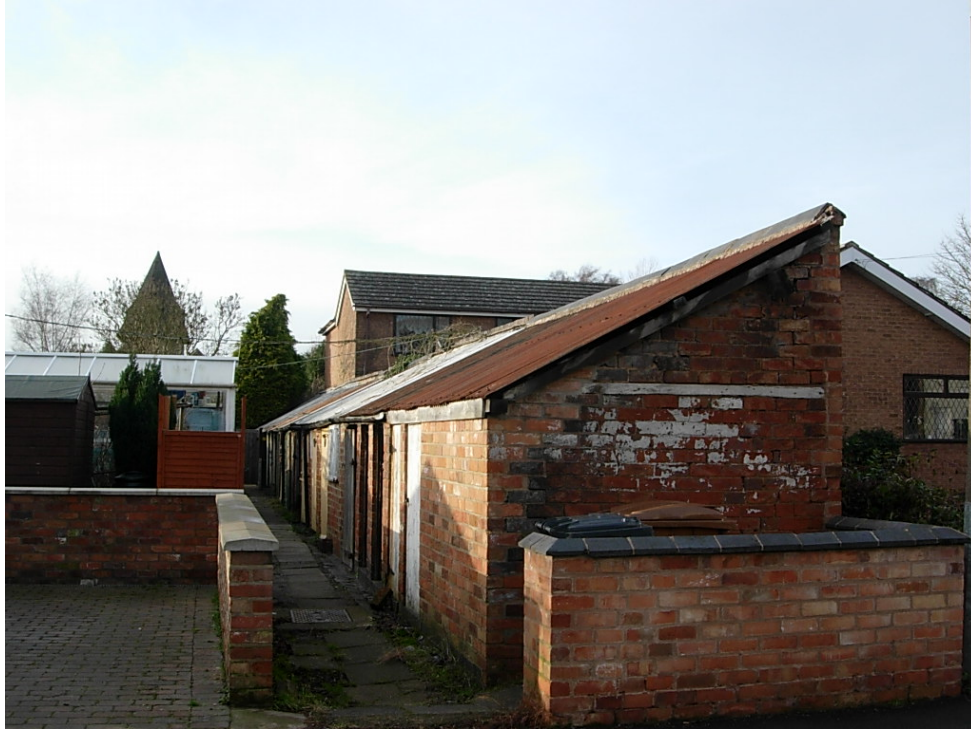
There is an interesting row of outside toilets and coal houses off Dragon Lane, servicing the rear of the cottages on Main Street

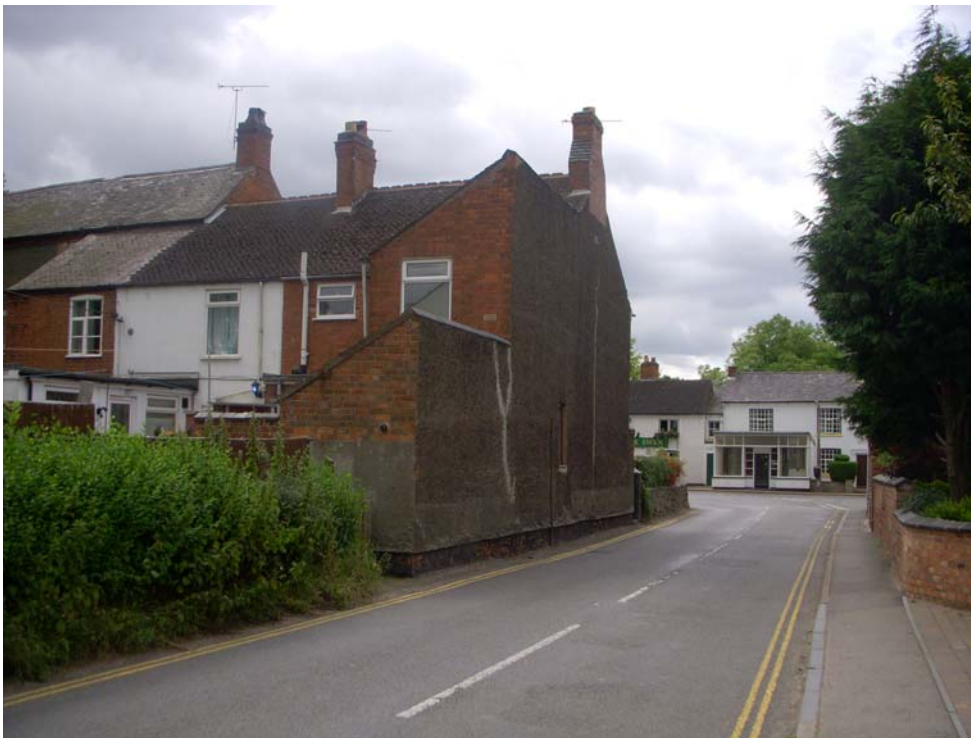
The view into the conservation area from Dragon Lane is dominated by the visually intrusive extension to 20 Main Street. The brickwork and render on 35 Main Street could also be improved

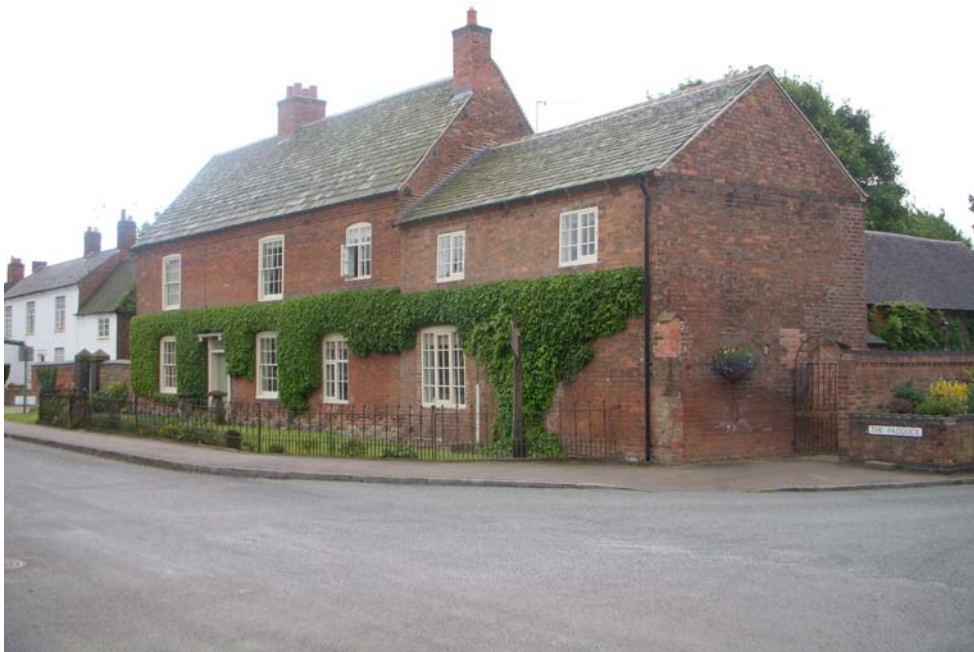
The listed Church Farm has interesting features including Swithland Slate roof tiles and a wrought iron fence along the front boundary. Modern alterations to the dwelling have been sympathetic to the character of the conservation area

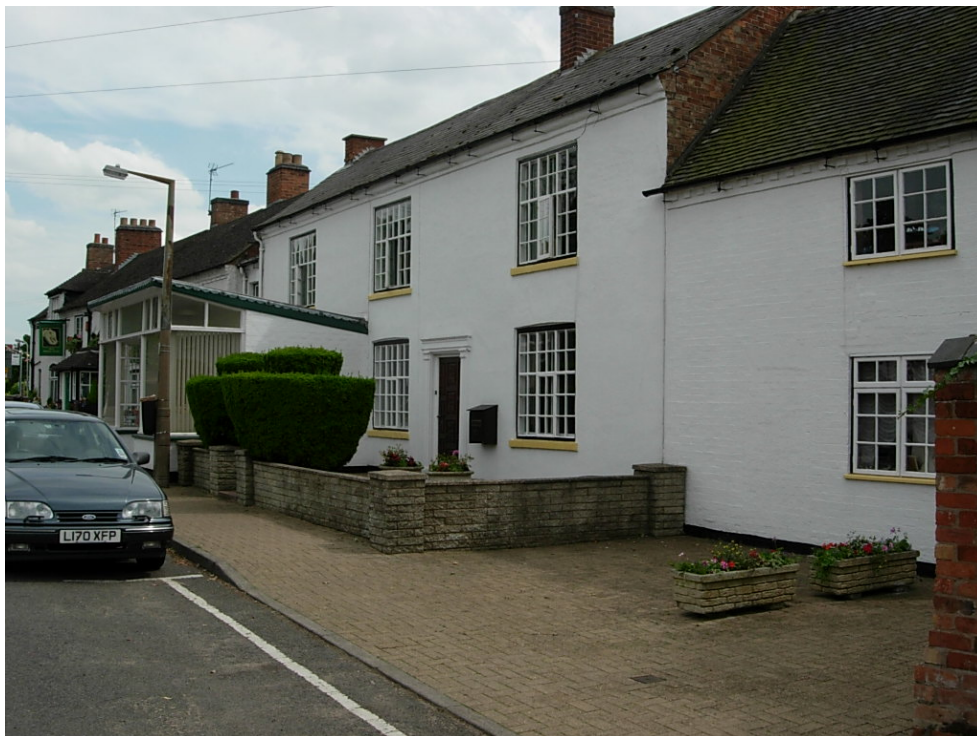
The frontage of 18-20 Main Street could be improved by the modern wall being replaced with a traditional wall, enhanced hard landscaping, and the removal of the 1950s office extension

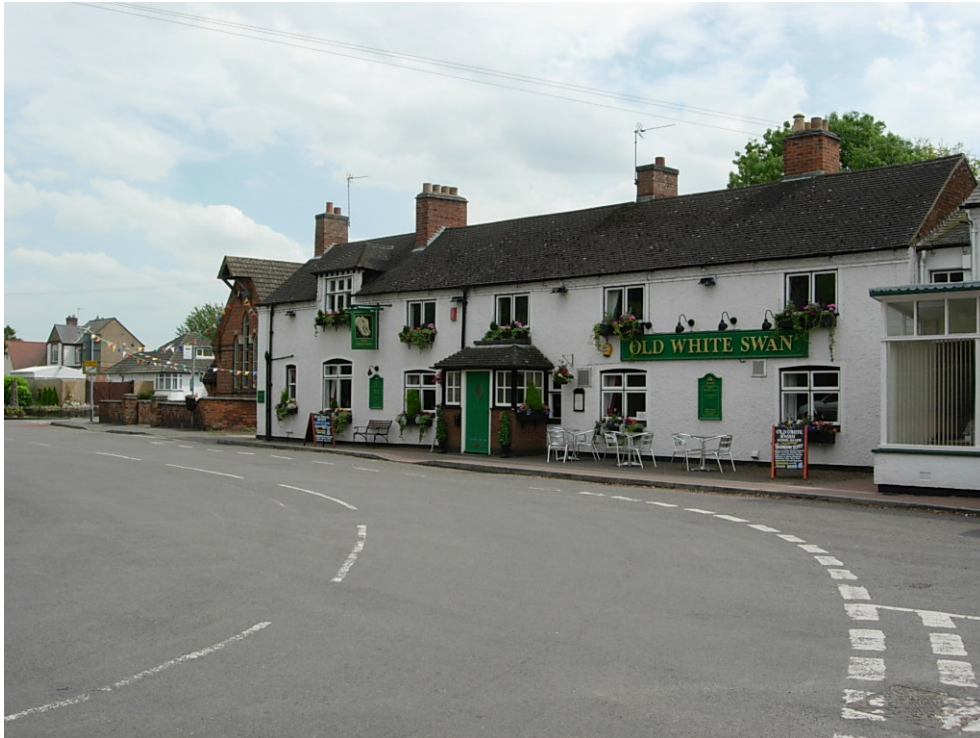
The Old White Swan public house on Main Street is a wide building on the bend of the road. The property could be improved with the concrete roof tiles being replaced with a traditional material

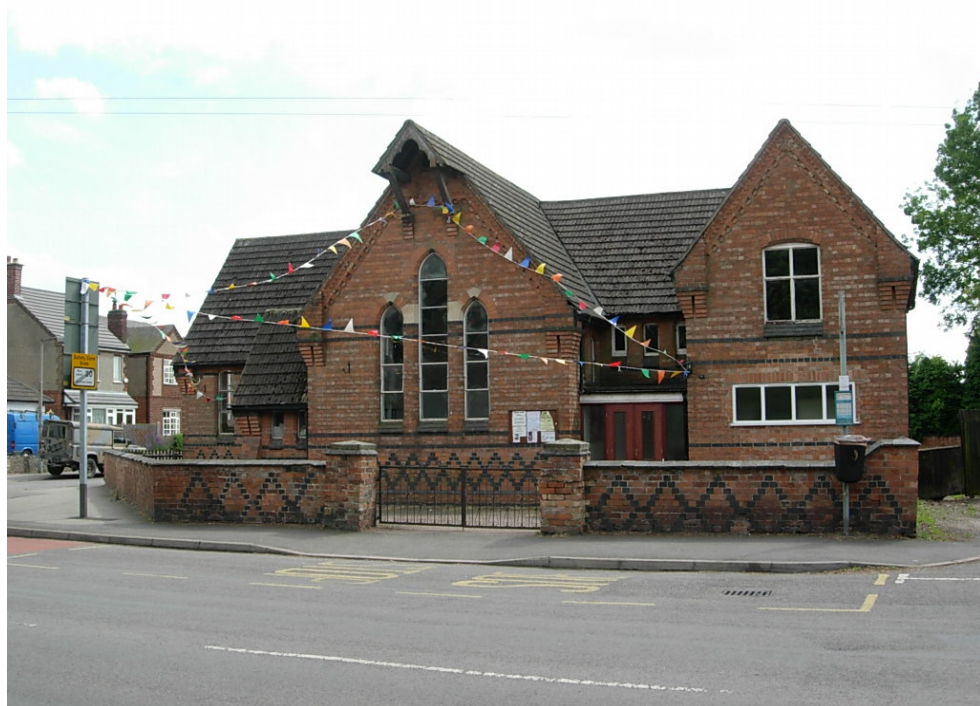
The Victorian School building is now used as a Church Hall. The building is set back from the road and has tall windows and gables, and decorative blue brickwork on both the building and boundary walls, and looks like a traditional village school

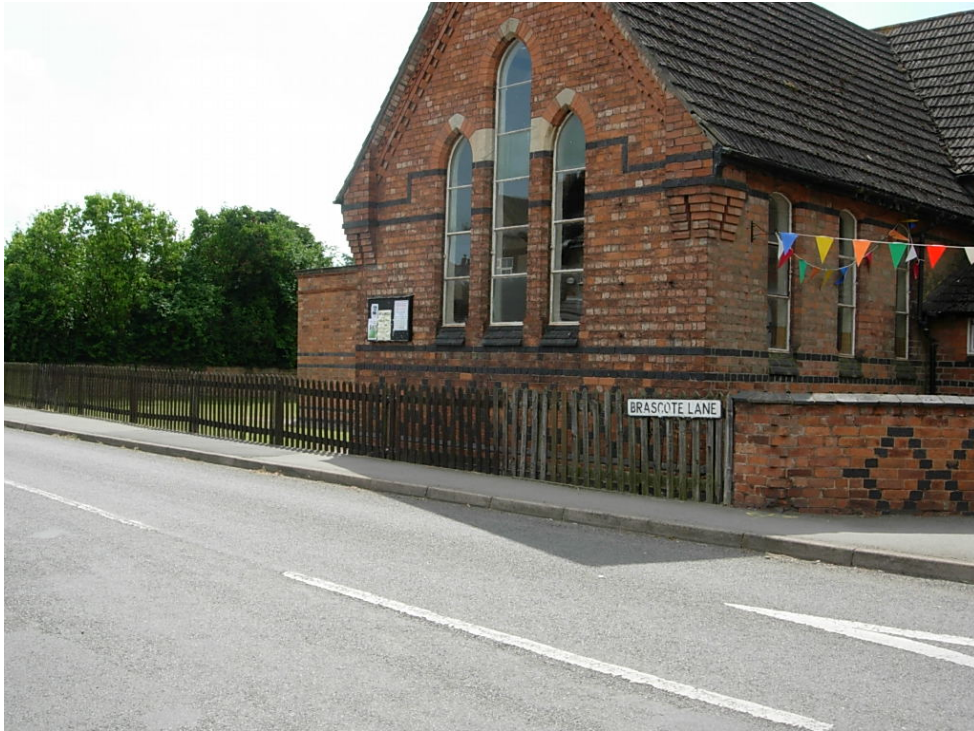
The Church Hall fence fronting Brascote Lane should be replaced with a brick in similar design and type utilised in the existing wall

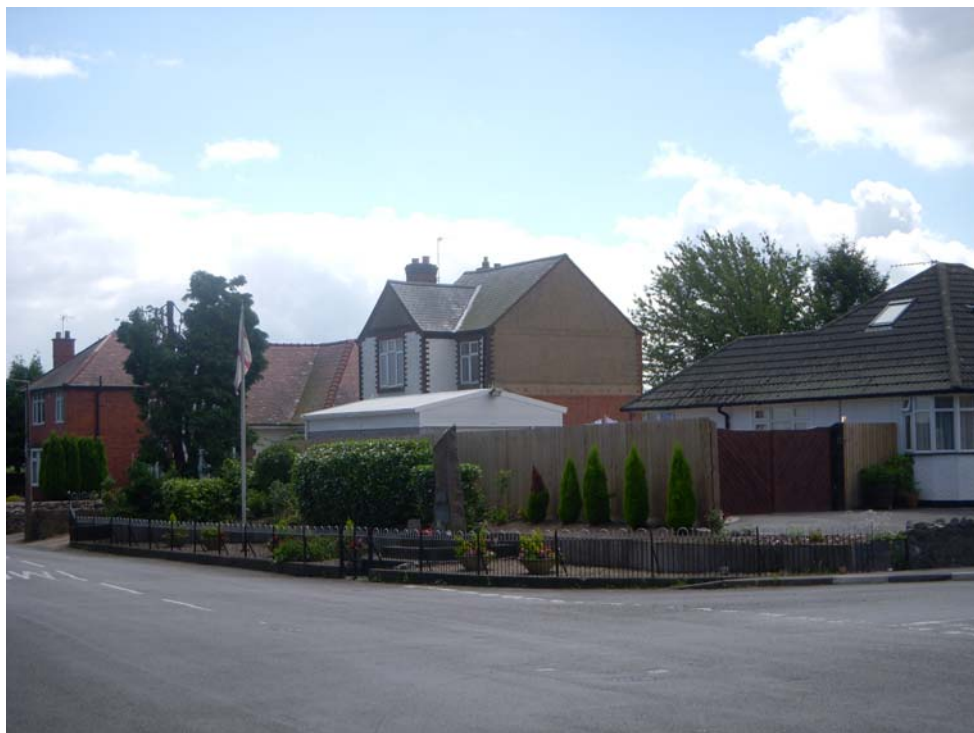
When looking towards the war memorial the unfortunate ground levels make the concrete sectional garage at 2 Brascote Lane too prominent. The war memorial could be improved with traditional hard landscaping and vegetation screening along the rear boundary

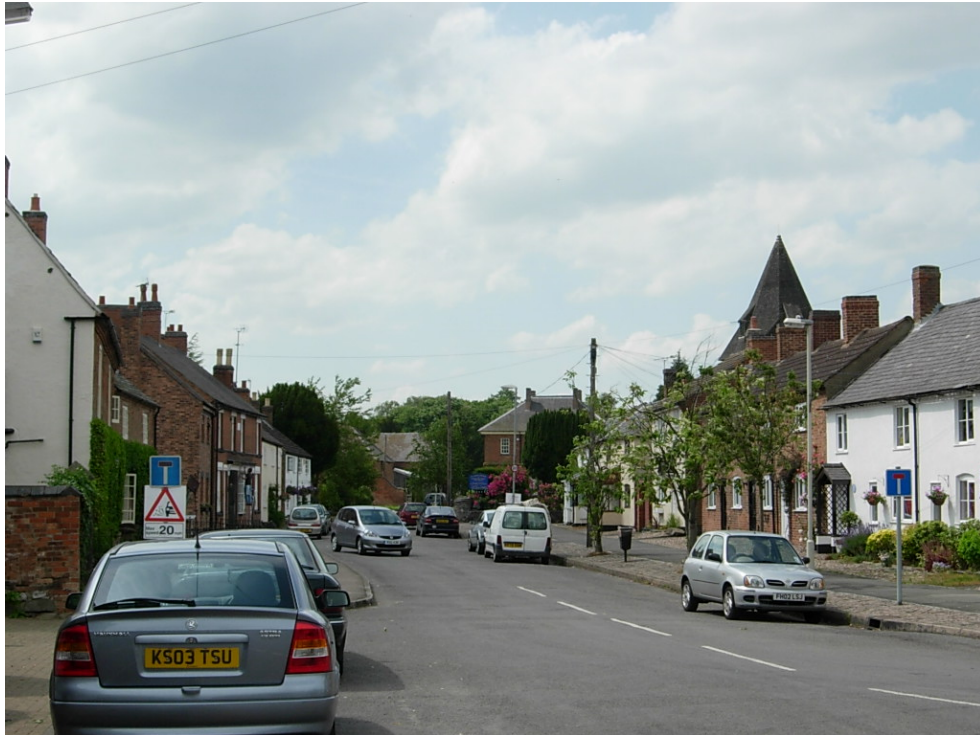
There is an excellent view towards the Hall and church tower along the wide street scene of Main Street

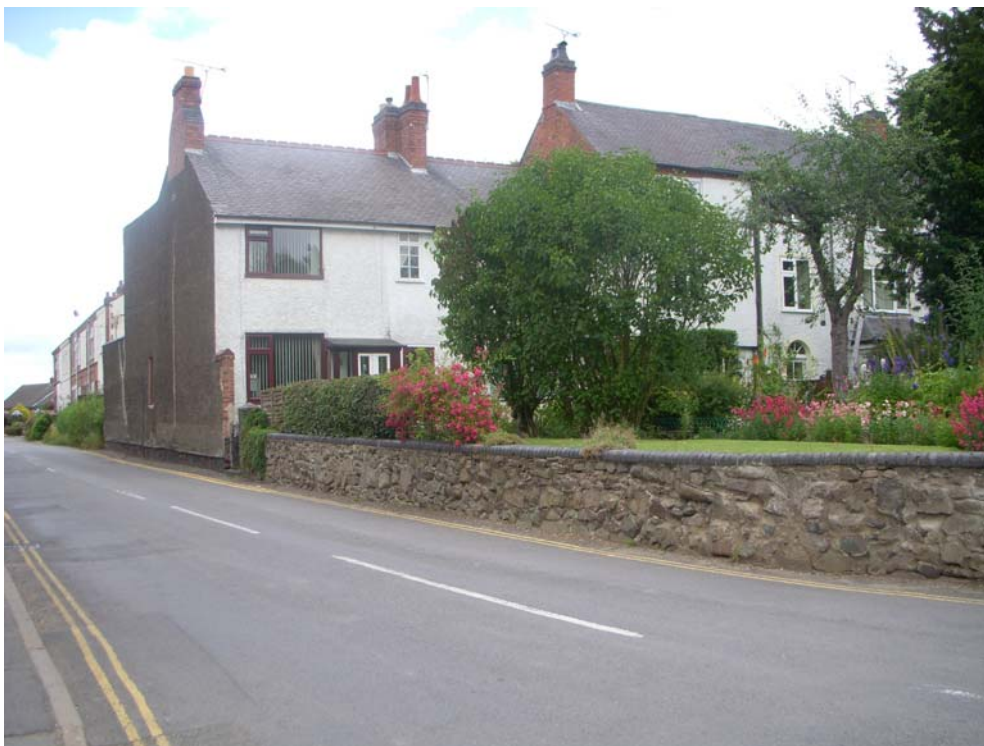
The stone wall with bull nose blue brick copings at the corner of Dragon Lane and Main Street is an important feature

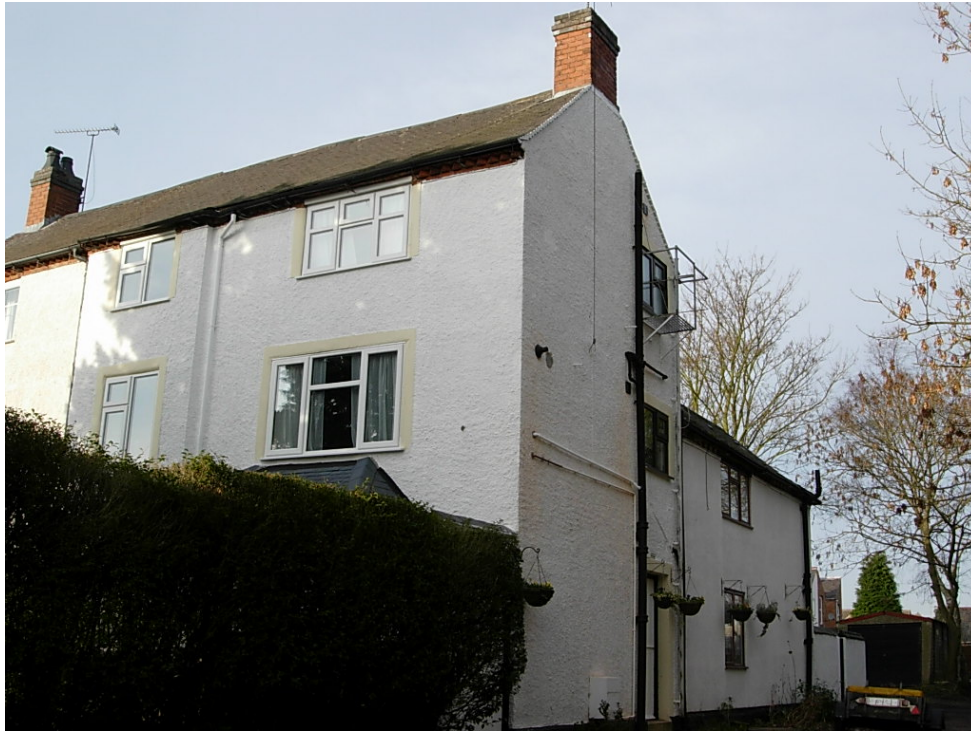
41 Main Street is an interesting three story property in the conservation area which could be improved by the removal of the plastic drainpipes and metal balcony

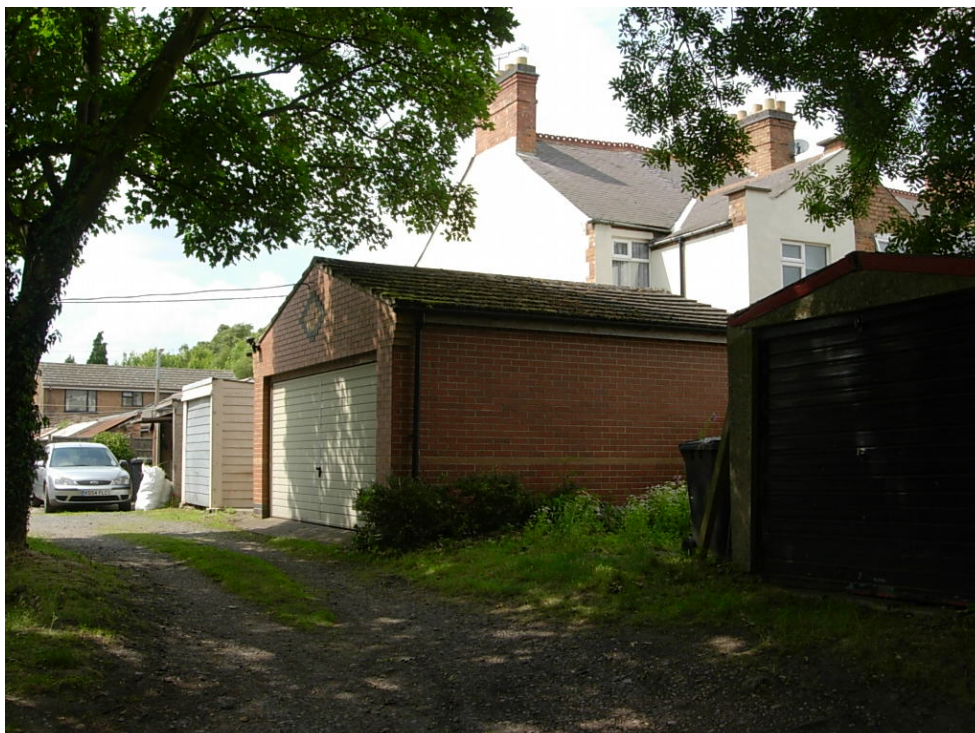
The large modern garages on Bells Lane are out of keeping with the conservation area
