NEWBOLD VERDON CONSERVATION AREA MANAGEMENT PLAN

PHOTOGRAPHIC RECORD OF NEWBOLD VERDON

January 2009

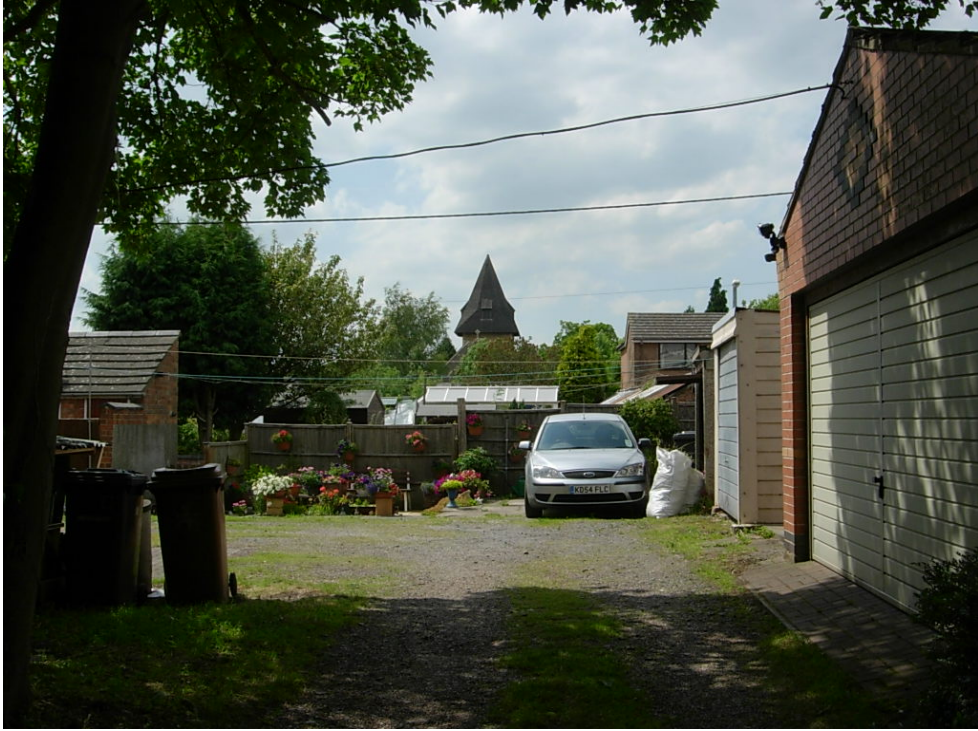
There is an important view at the rear of the garages on Bells Lane towards the church tower which should not be compromised

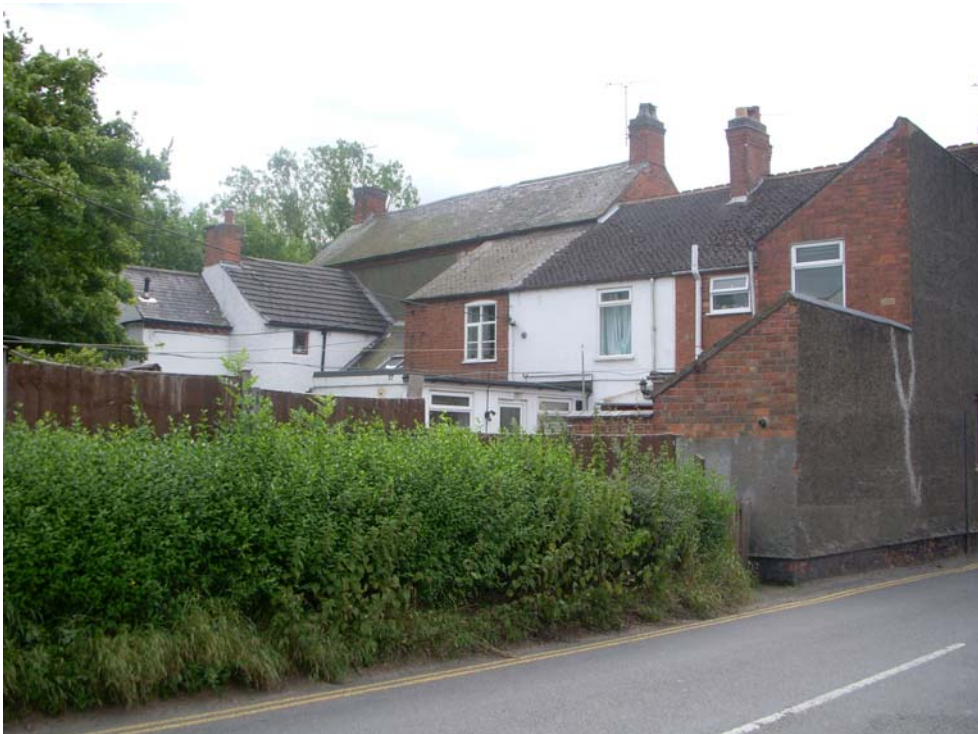
There are mixed floor levels at the rear of the properties on 35 to 41 Main Street

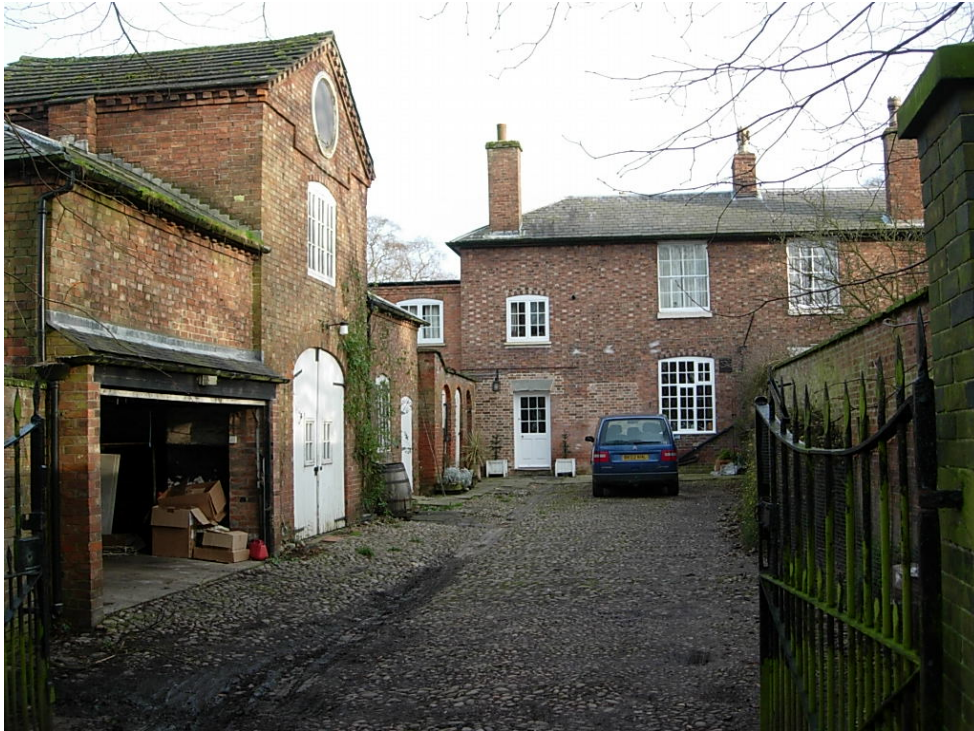
There is an important view from Bells Lane towards the grade II listed old Rectory. The use of the outbuilding as a double garage does detract from original rustic charm of the building.

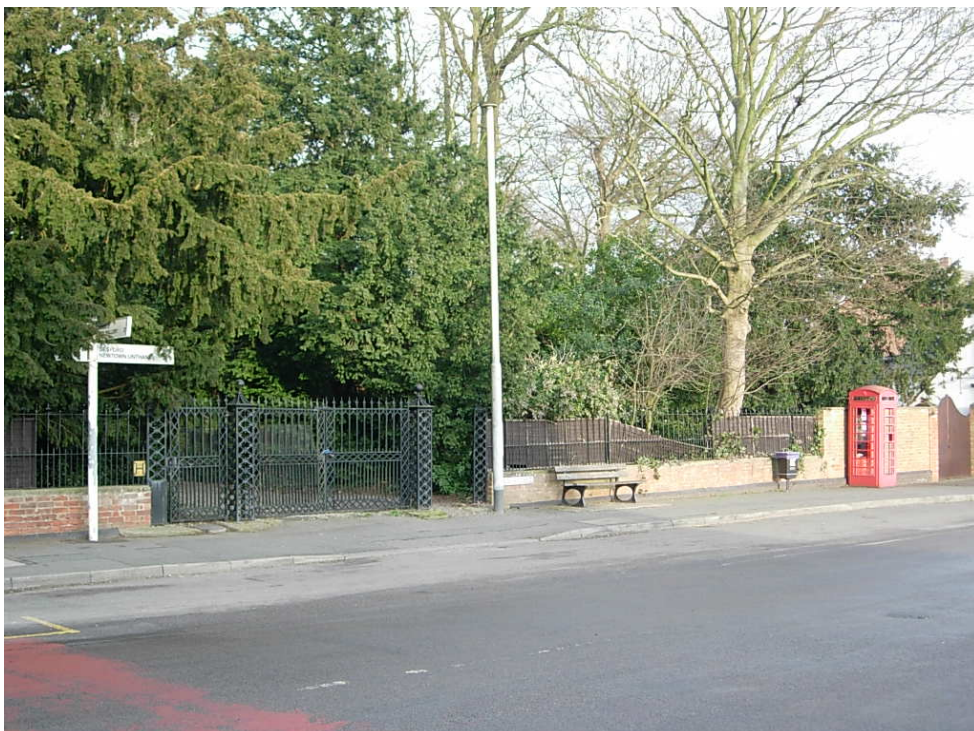
The Old Rectory is bounded by red brick walls with decorative wrought iron entrance gates which are grade II listed. The red K6 telephone box outside the Old Rectory is also grade II listed

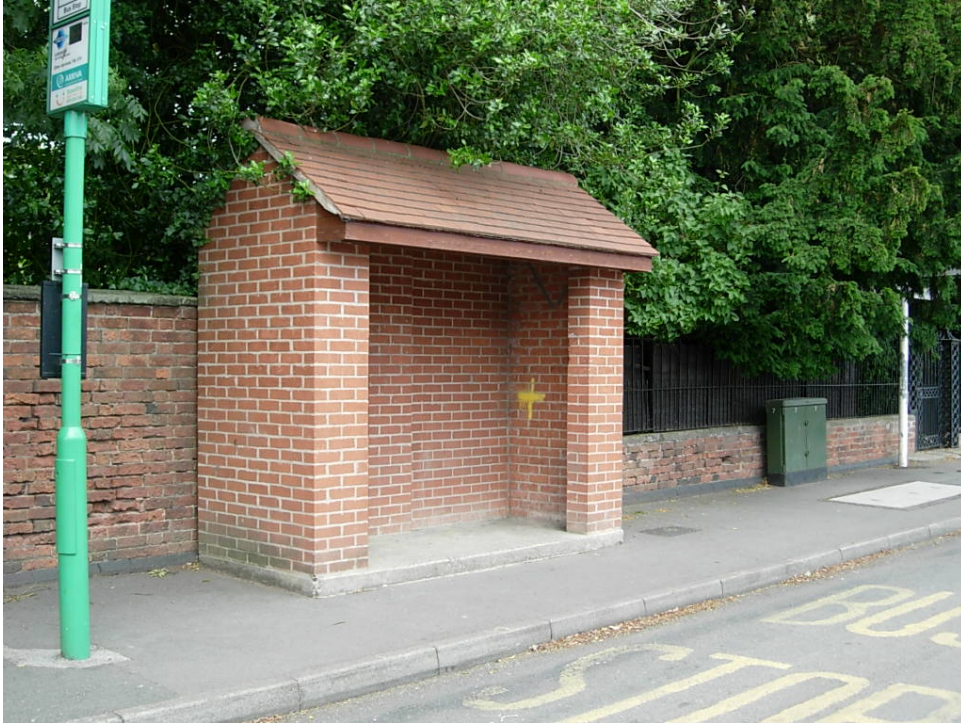
The bus shelter outside the Old Rectory has been built with traditional red brick

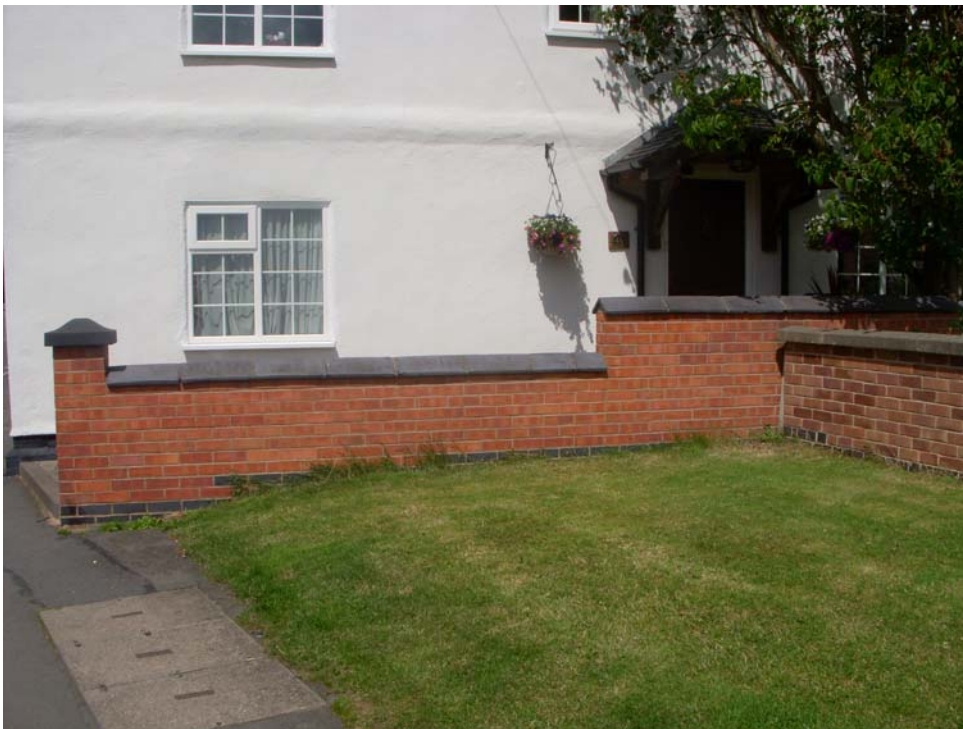
The modern wall adjacent to 49 Main Street has been rebuilt in a traditional style

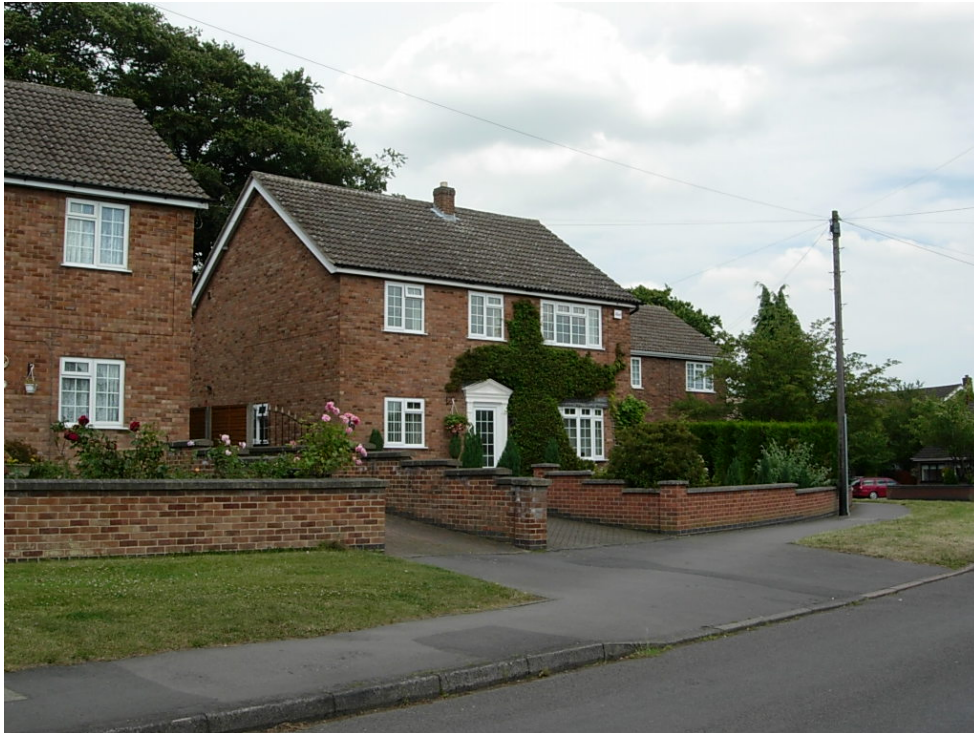
The detached dwellings at 51 to 55 Main Street are set back from the street with large front gardens enclosed by modern walls which go against the traditional feel of the conservation area

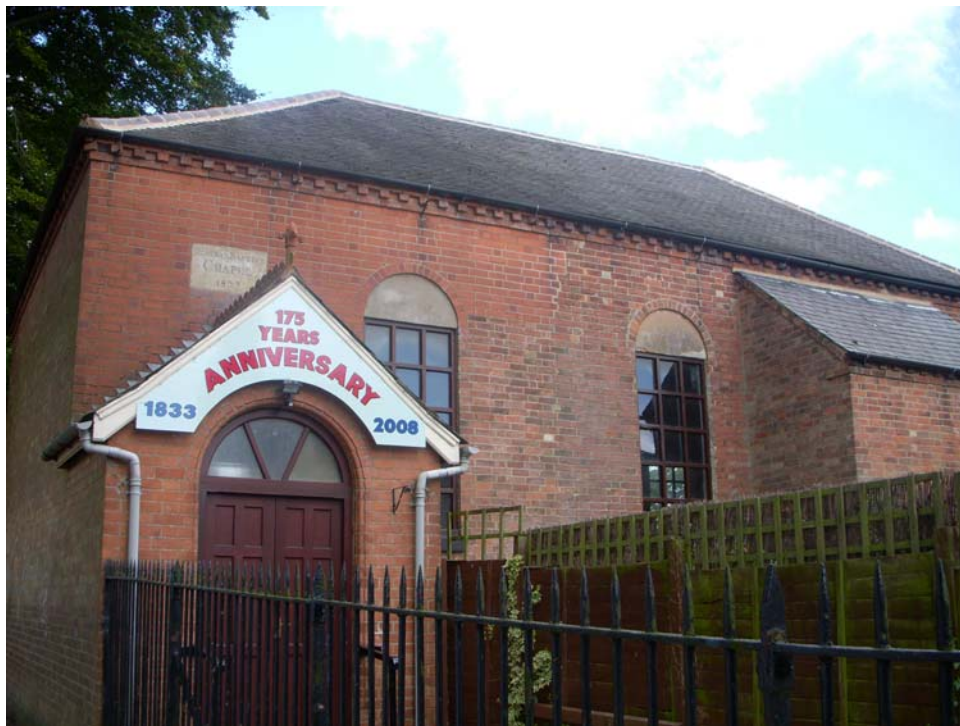
The frontage of the Baptist Church is accessed from Mill Lane. The church would benefit from some minor maintenance including painting the metal fence to the rear of the church bounding the recreation ground

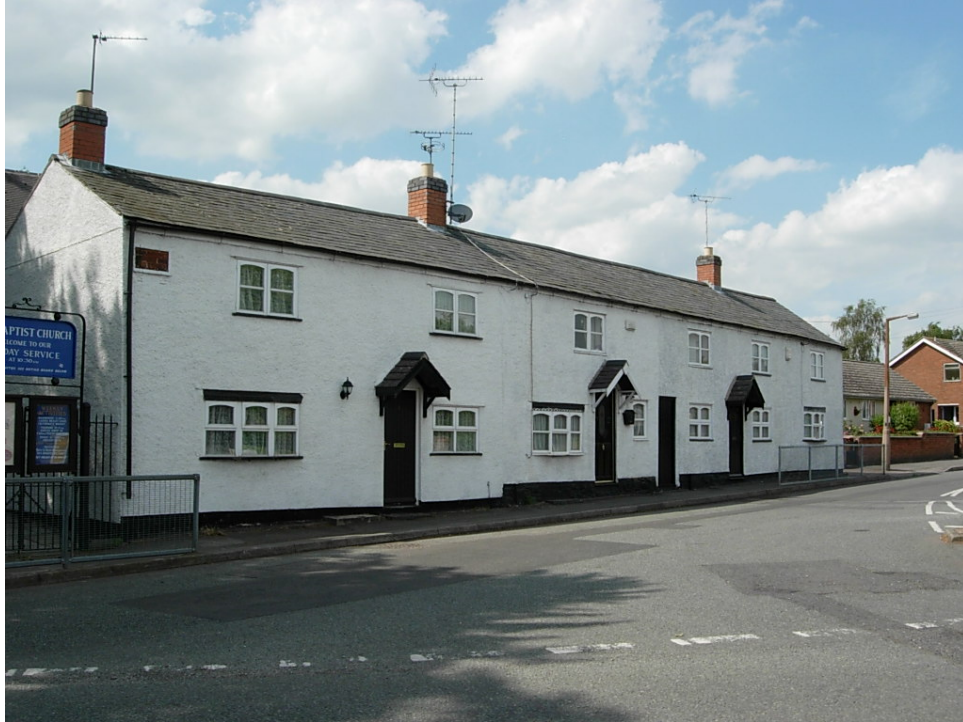
The traditional character of the cottages at 1 to 7 Mill Lane has been compromised by the addition of wooden canopies, modern and bow windows and a satellite dish

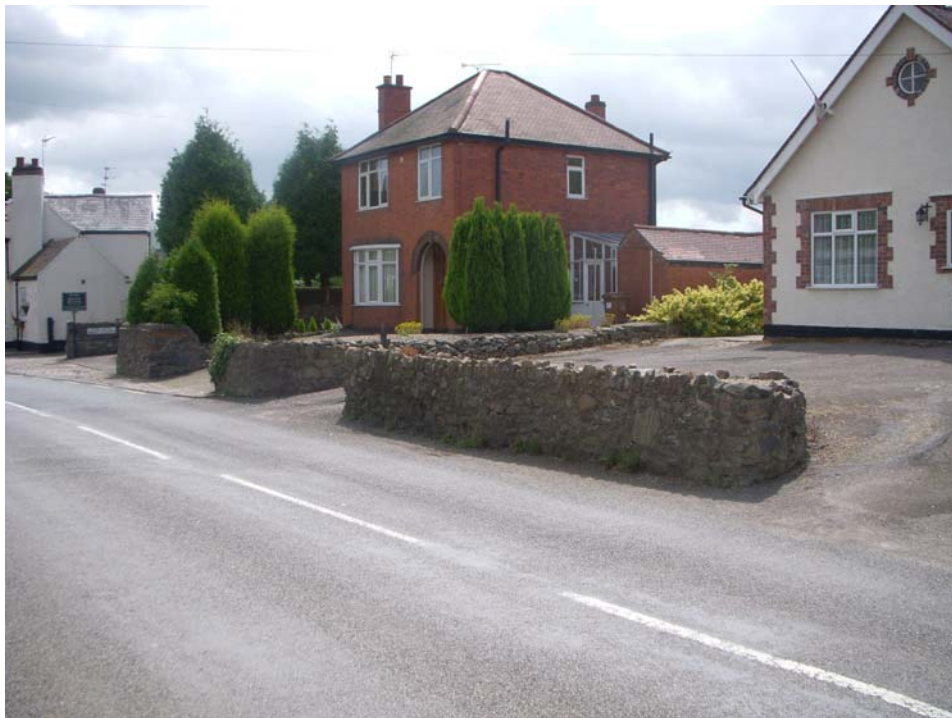
Only the boundary along the road fronting the properties at 26 to 30 Main Street is in the conservation area, but the open frontages and design and setting of the dwellings detract from the character of the conservation area

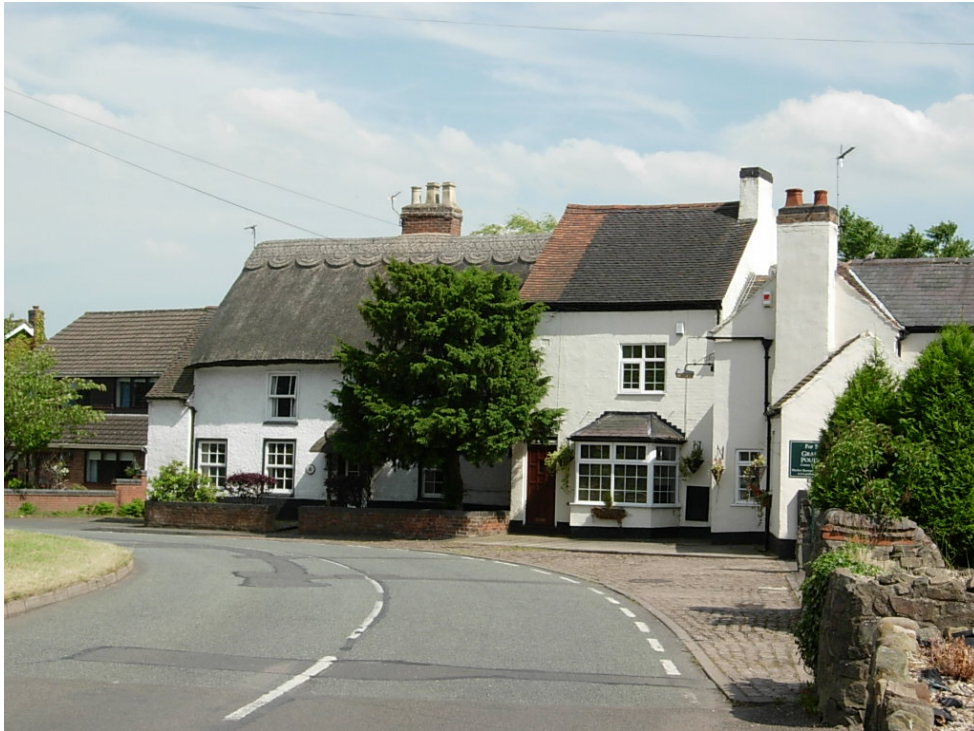
32 to 36 Main Street is an attractive group of properties which may be seen from a number of vantage points along the road. Cob Cottage (No. 36) is grade II listed with a thatched roof, and the properties are fronted by traditional granite setts

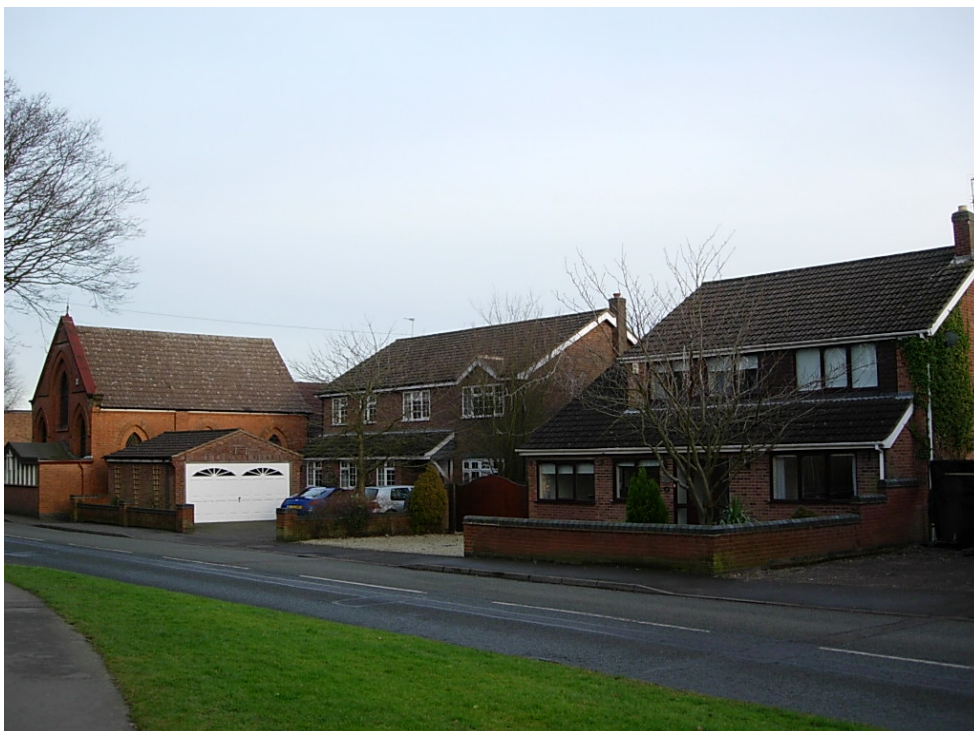
The modern dwellings at 38 and 50 Main Street detract from the traditional feel of the conservation area. The large double garage at 50 Main Street hinders views of the Methodist Church

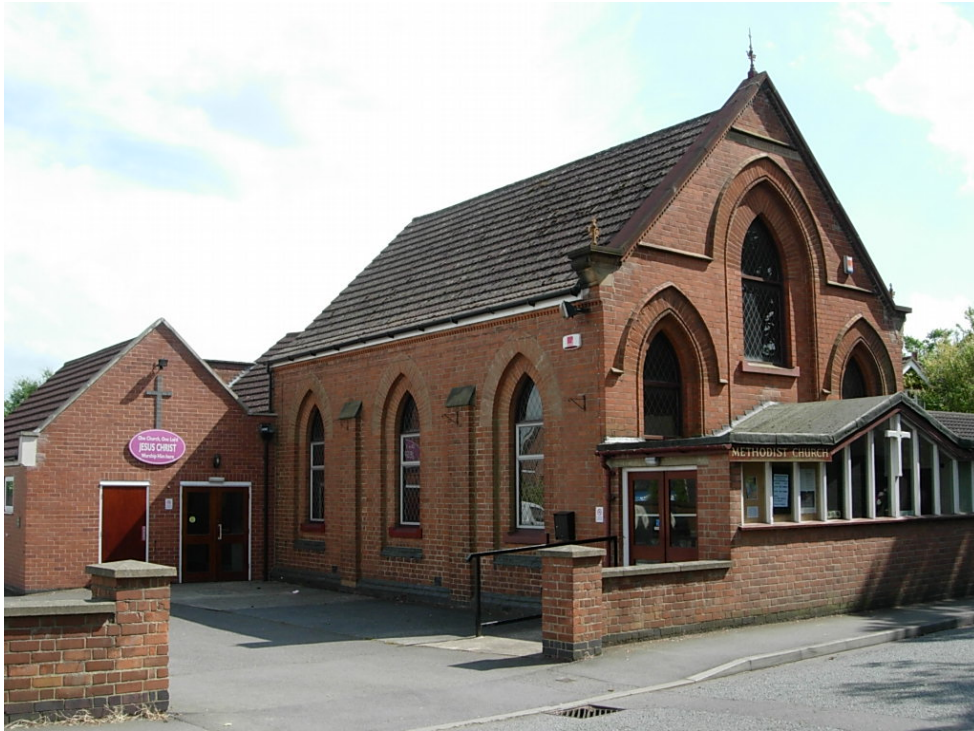
The Methodist Church on Main Street has some excellent brick detail on the original building, but is spoilt by the 1970s foyer extension on the front

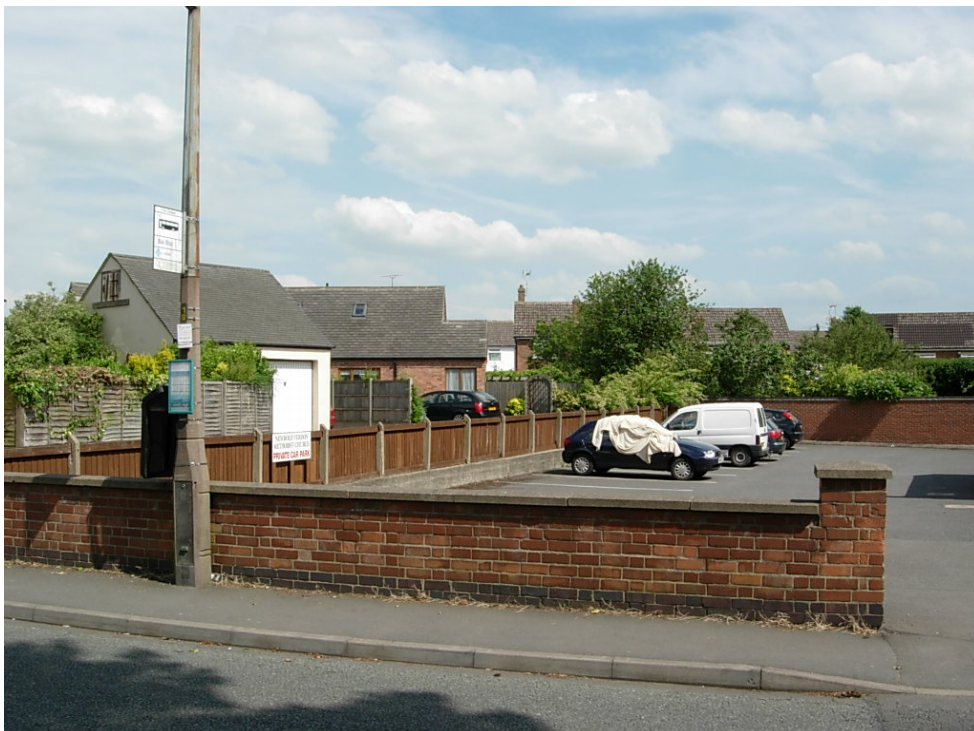
The modern brick wall and wooden fence bounding the Methodist Church car park could be improved by being replaced with a traditional wall. The concrete lamppost could also be replaced with a traditional feature

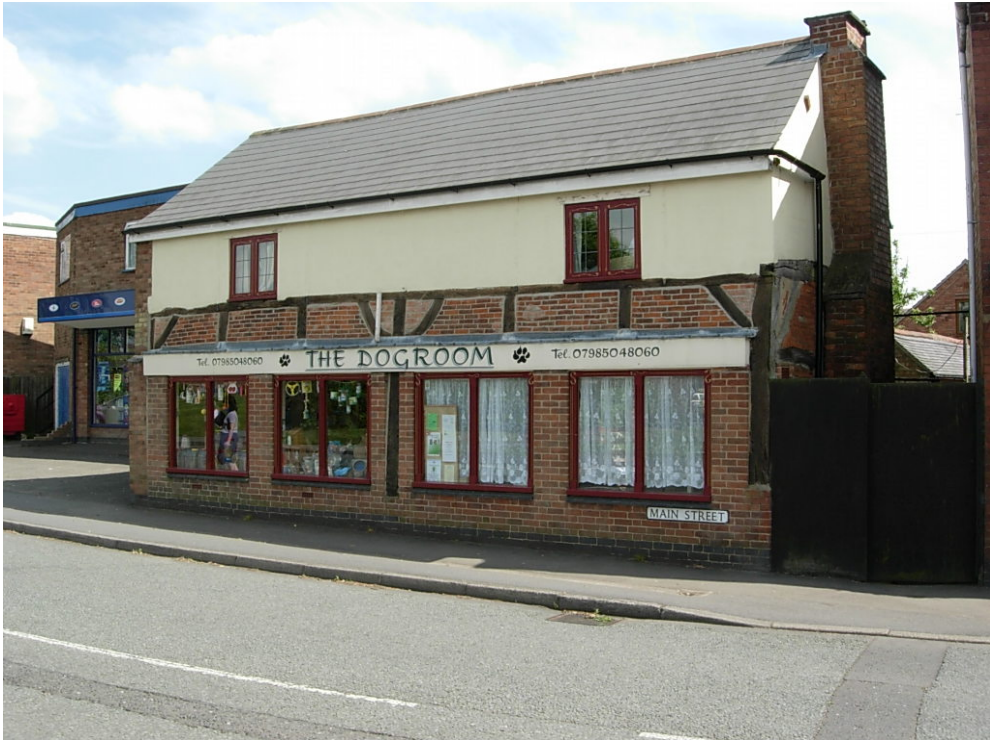
Although not in the conservation area, 62 to 64 Main Street is an interesting building with the original timber frame still remaining

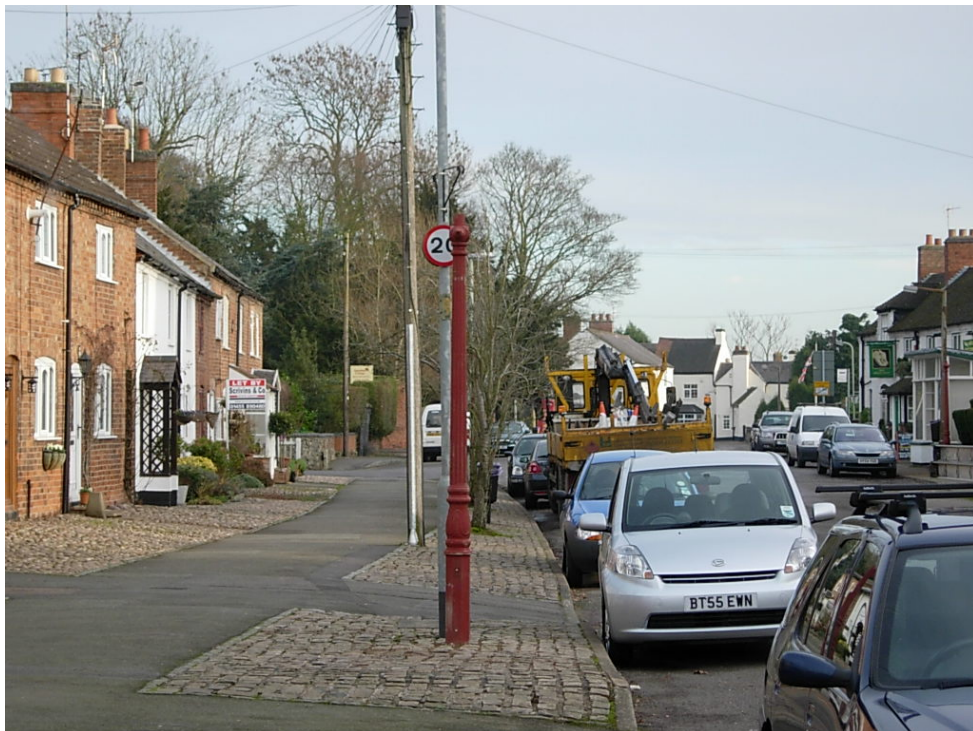
As part of the Environmental Improvement Programme (EIP) heritage cast iron lamp posts have been installed, replacing their modern counterparts
