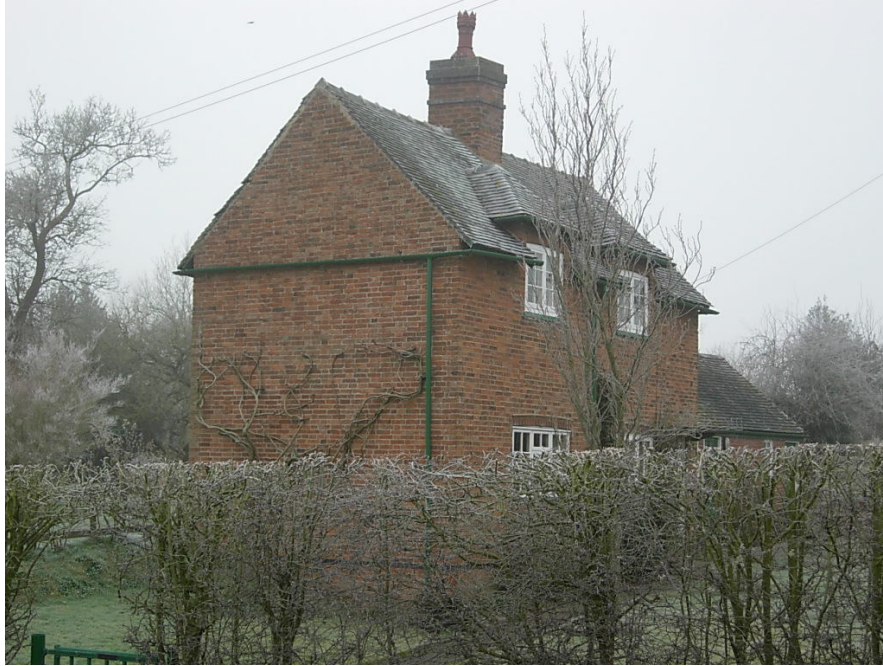
Chatsmoth sited on a large plot at the corner of Main Street and The square displaying hipped dormers on its front elevation.

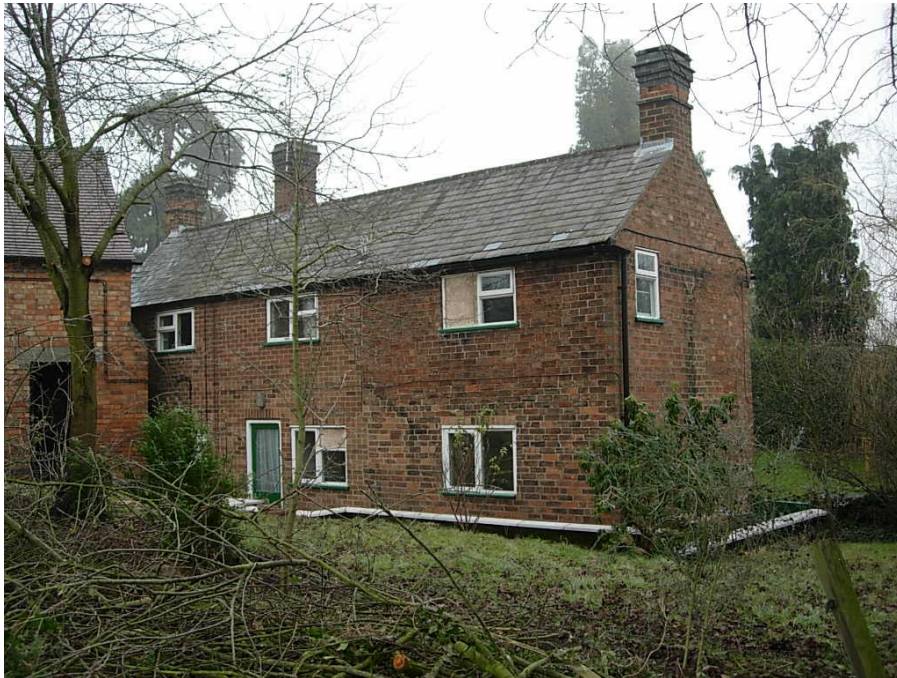
Rear elevation of The Old Post Office showing the prominence of re-constituted wall copings. The introduction of re-constituted building materials in parts of the conservation area is starting to have a negative effect on its character.

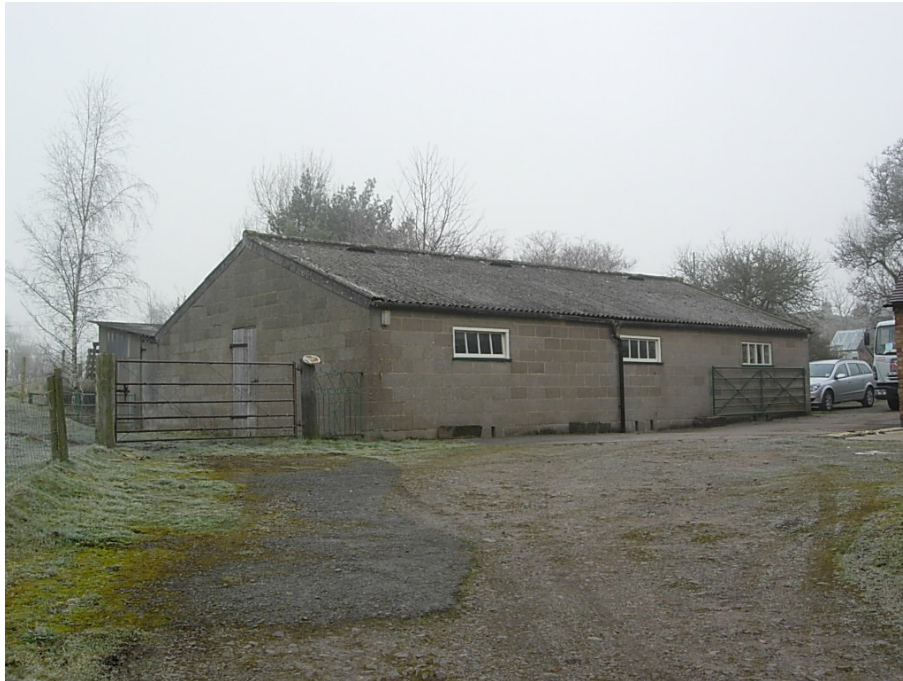
This building built in concrete blocks was formerly a piggery.

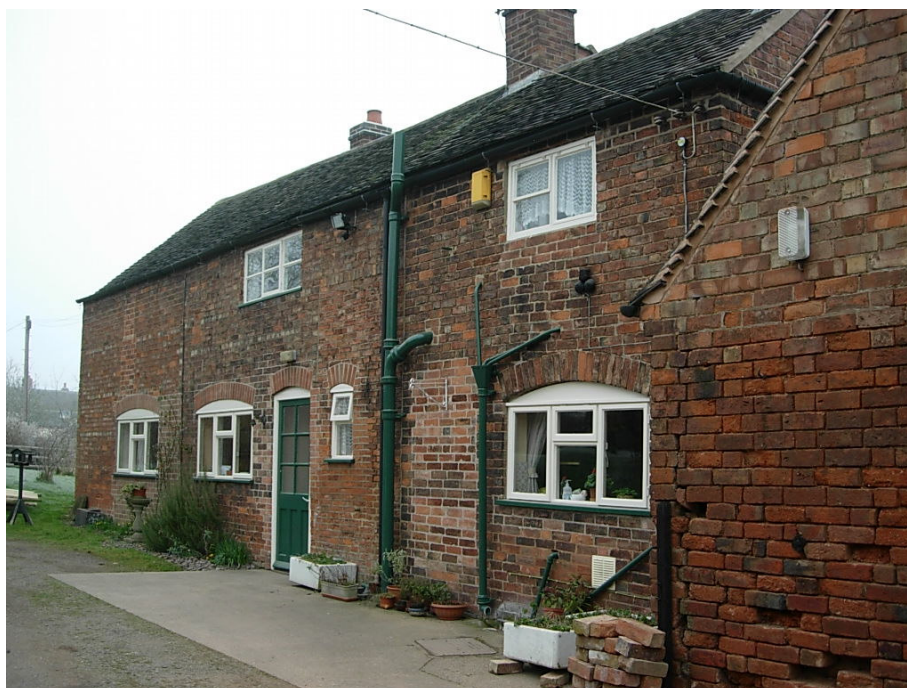
Rear of The Old Bakery showing numerous alterations that have taken place to the dwelling. The blocking up of doorways and openings with an inappropriate brick type has had a detrimental visual impact on the premises.

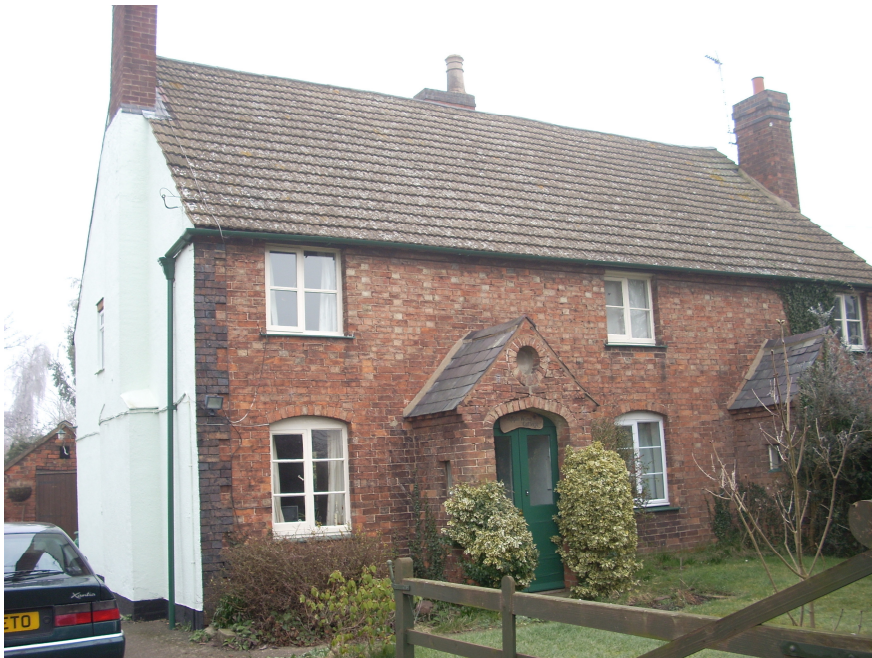
Applewine Cottage and Sunnyside Cottage sited at the end of The Square. The use of concrete roof tiles tends to spoil the character of these properties.

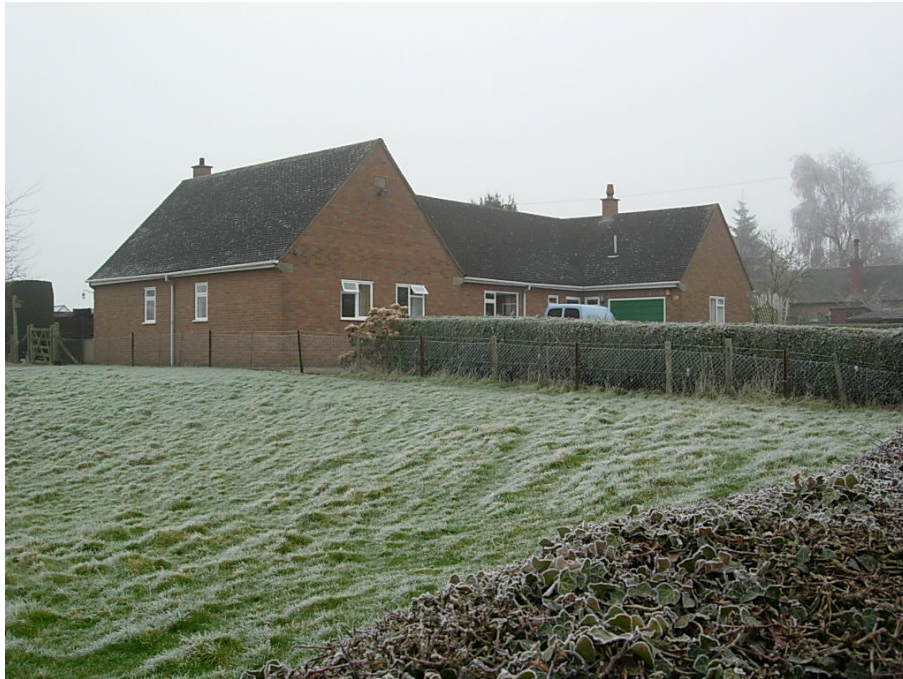
The property known as The Bungalow is a modern dwelling that is totally out of character. Unfortunately, the dwelling is visually prominent on Main Street but being single storey and of modern design and materials, it tends to have a detrimental visual impact on the conservation area.

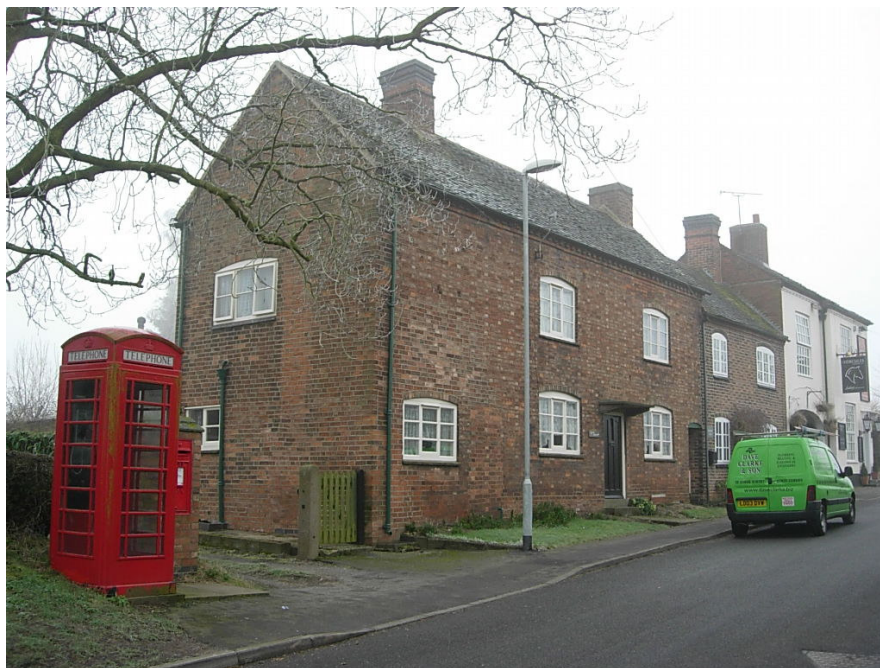
These two red brick properties are Grade 2 listed. Mount Pleasant and Church View are early C19 properties with plain tiled roofs. This group of buildings, although modernized still retain their traditional characteristics. The K6 telephone box designed by Sir Giles Gilbert Scott is also listed.

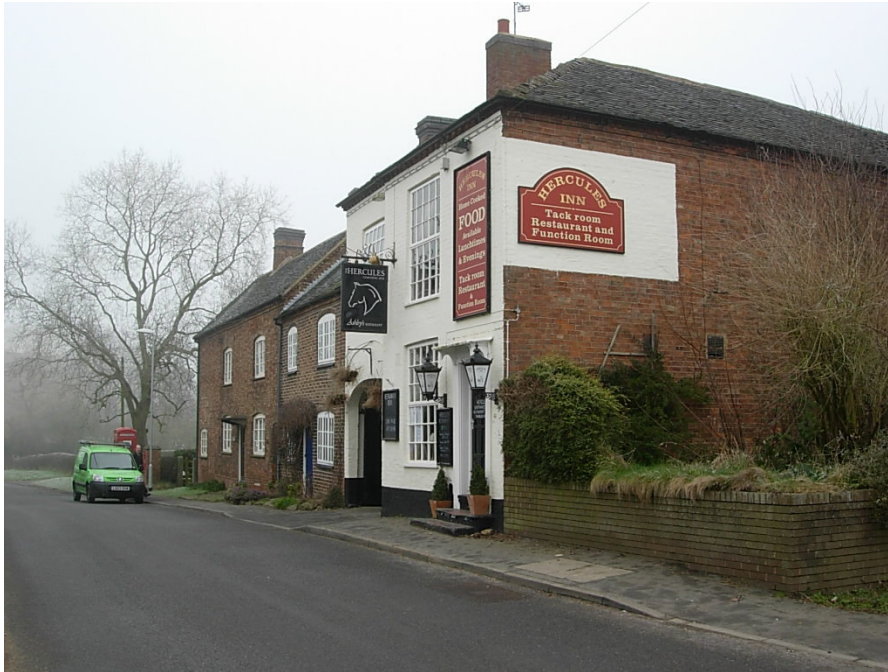
The Hercules Inn that is also early C19 has a plain tiled hipped roof with the bricks on its front elevation painted white. This historic group of properties is very pleasant having differing roof heights.

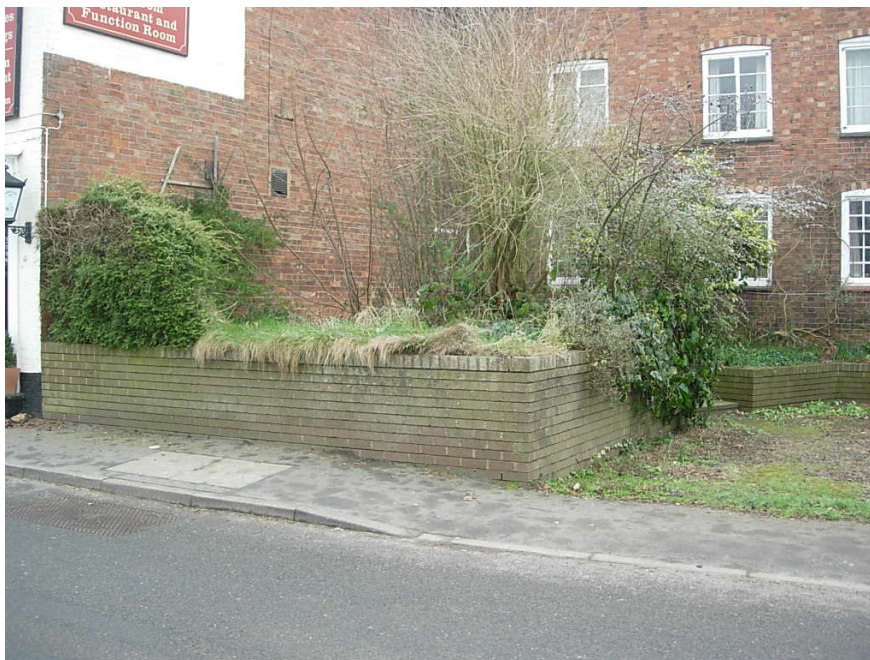
The listed grade 2 property to the south-west of the Hercules Inn has a doorway built with a round headed archway and hipped roof. The property would benefit visually if the modern brick wall was to be replaced with a traditional wall.

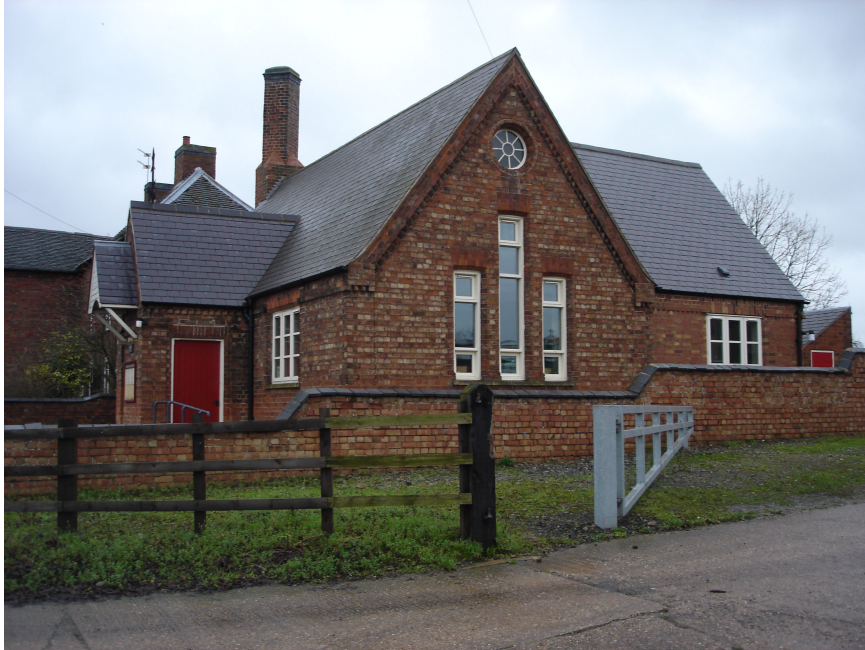
Sutton Cheney's Church Hall has a fine traditional boundary wall.

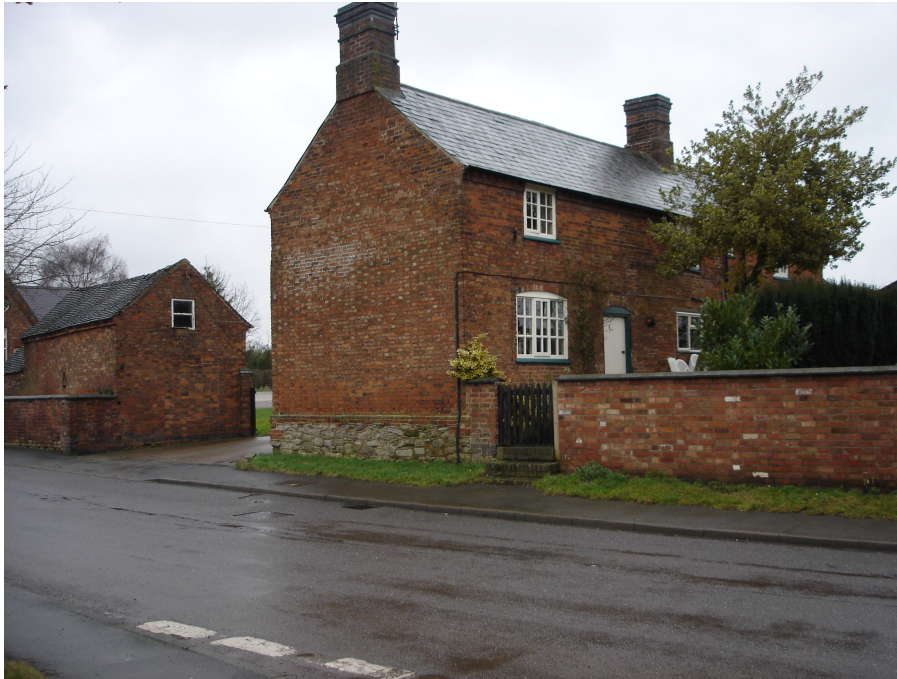
Ivy Lodge, a venacular building that has its gable end fronting the carriageway.  
A traditional boundary wall to the property runs along Main Street.

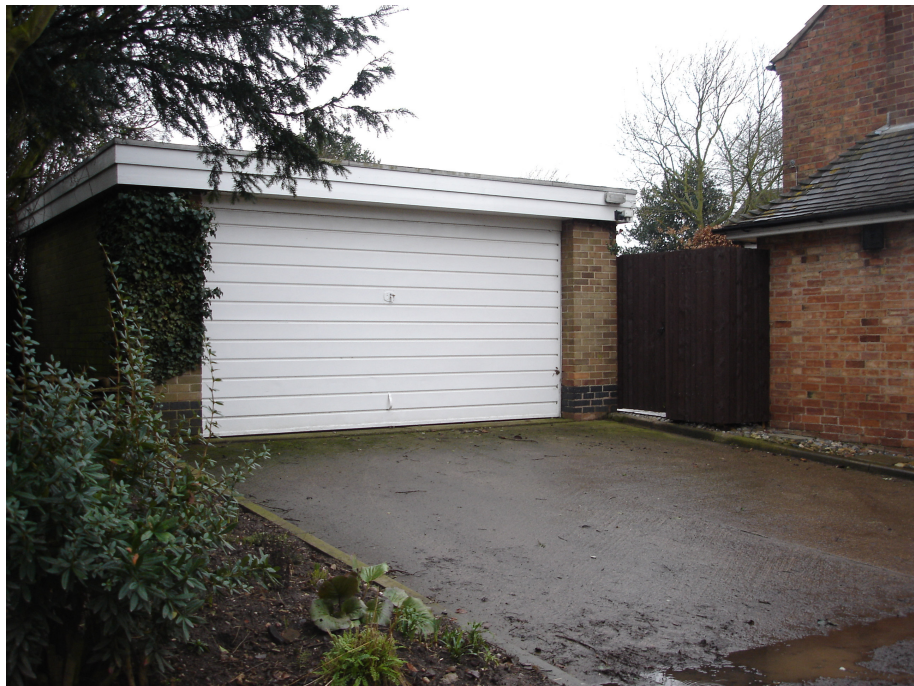
The flat roofed double garage adjacent to Keepers Lodge is unsympathetic to the traditional character of the conservation area.
