Hinckley & Bosworth  
Borough Council

**Bilstone Conservation Area Appraisal and Management  
Plan**

**Photographic Record**

**October 2012**

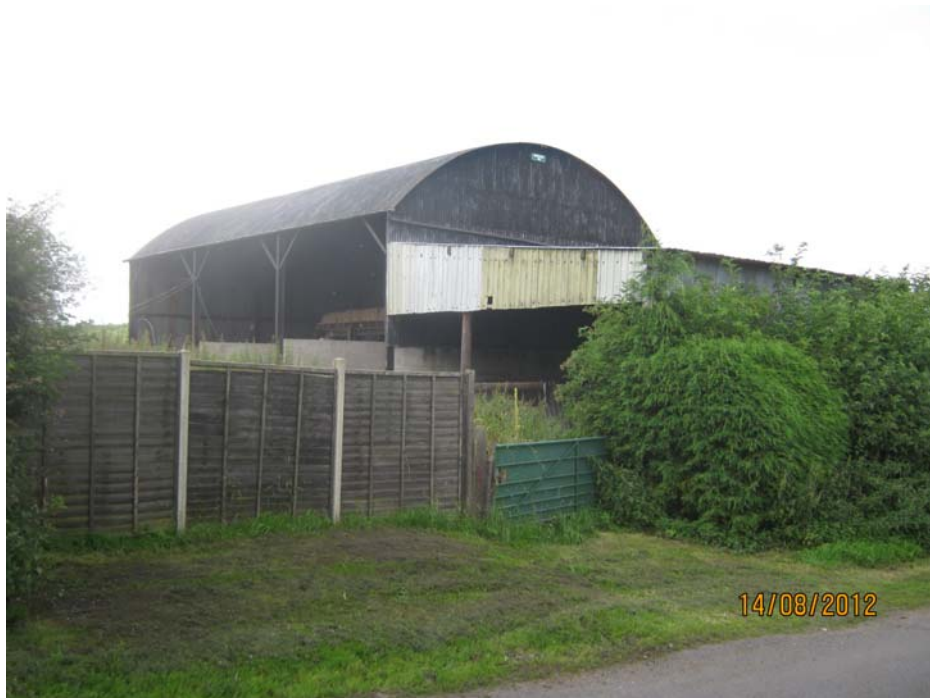
The large Dutch Barn at Deans Farm is a prominent feature that adds to the rural charm of Bilstone. Unfortunately, the fencing is out of character and consideration should be given to replacing it with traditional fencing such as a post and rail agricultural fence and hedging.

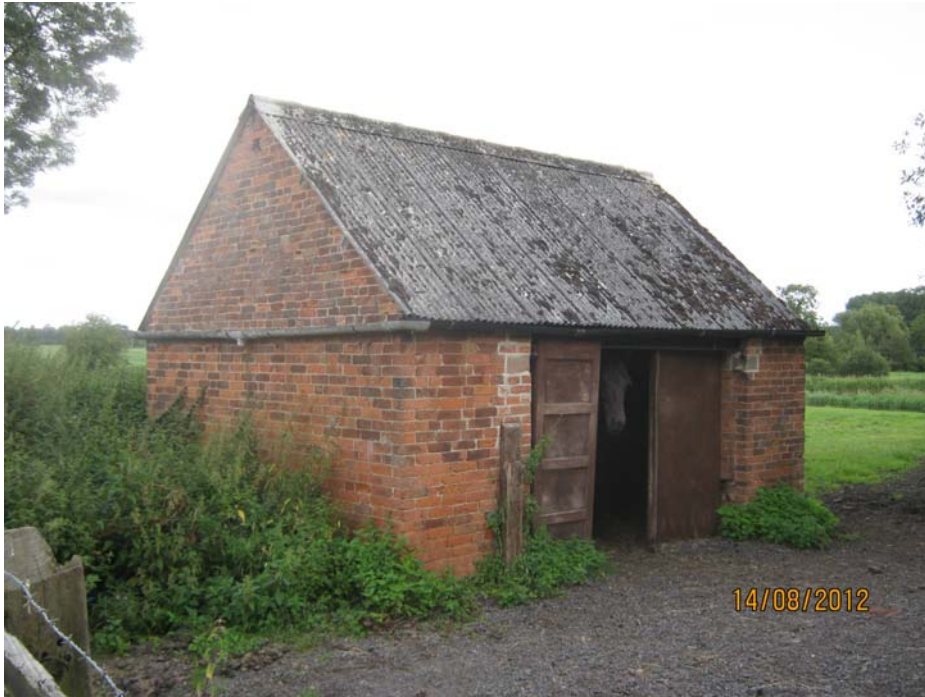
This quaint outbuilding to the rear of Drove House is spoilt with the use of a non-traditional roofing material.

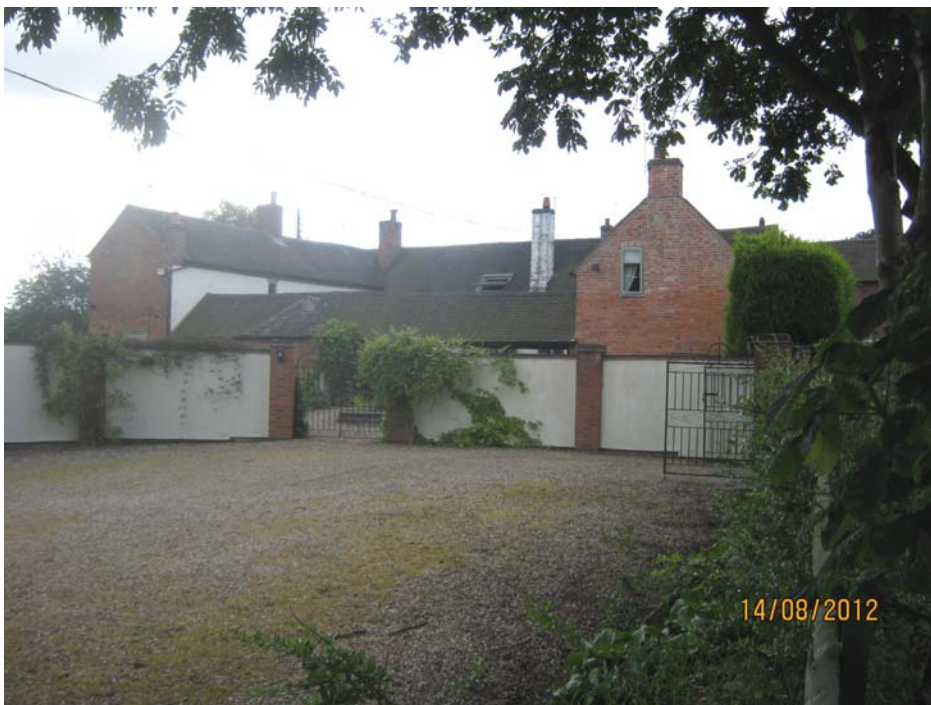
Rear of Drove House showing rear service buildings that once contained pigsties; coal houses and earth closets.

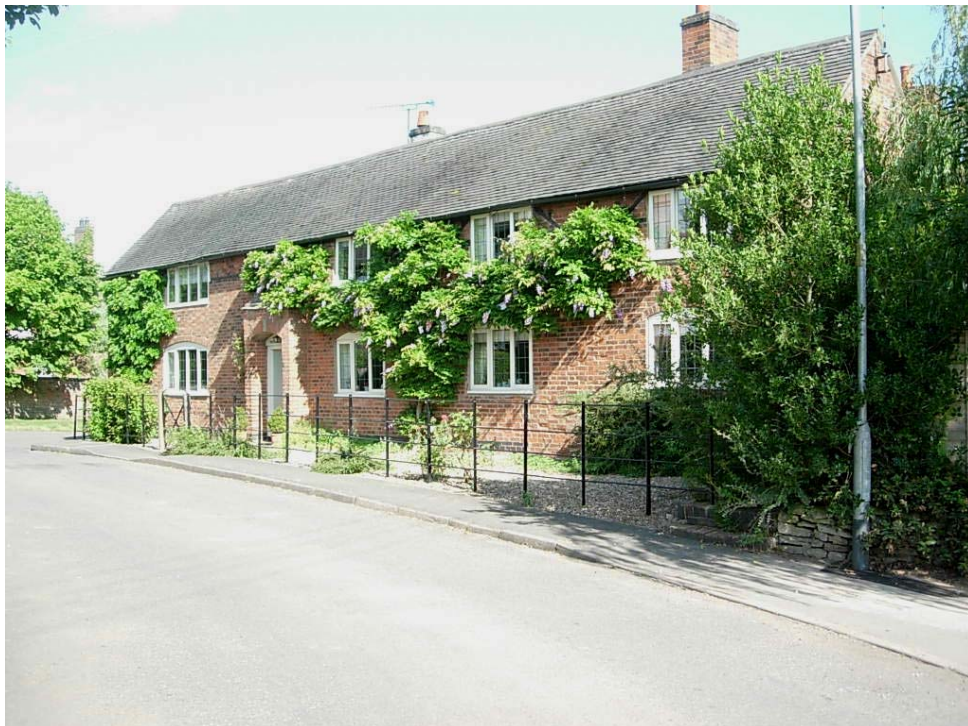
Drove House is fenced by pleasant agricultural fencing which adds to the rural charm of the village. The property, that once comprised five small agricultural brick & tile dwellings, has now been converted into one dwelling. Unfortunately, this has resulted in the loss of the original door openings.

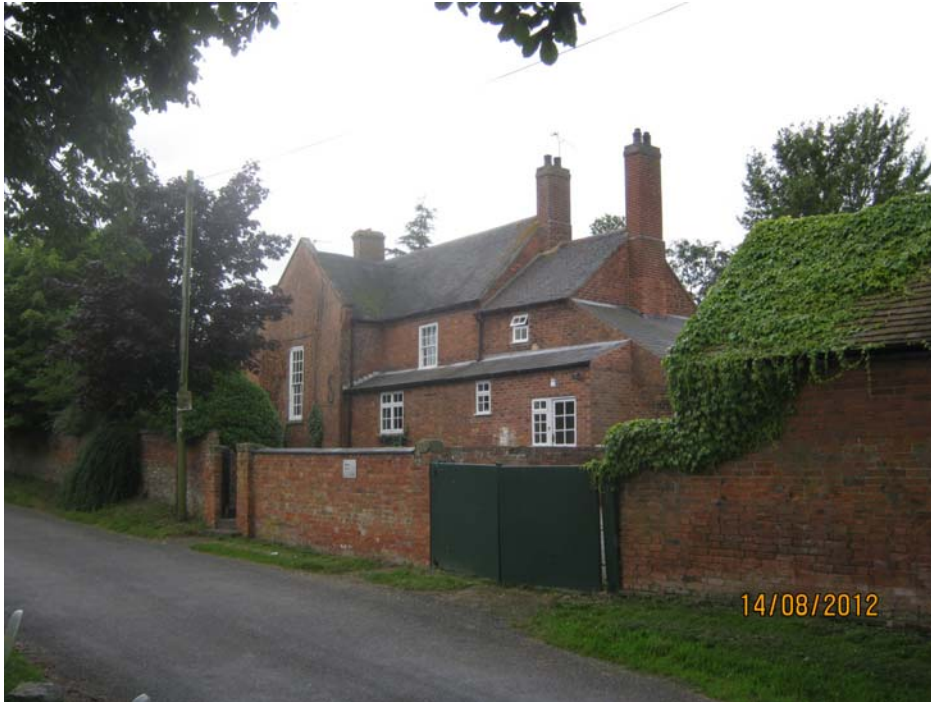
Dean's Farm on Main Road is a large imposing brick & tile farmhouse with prominent chimney stacks sited close to farm related outbuildings. The property has been extended on several occasions since it was first built.

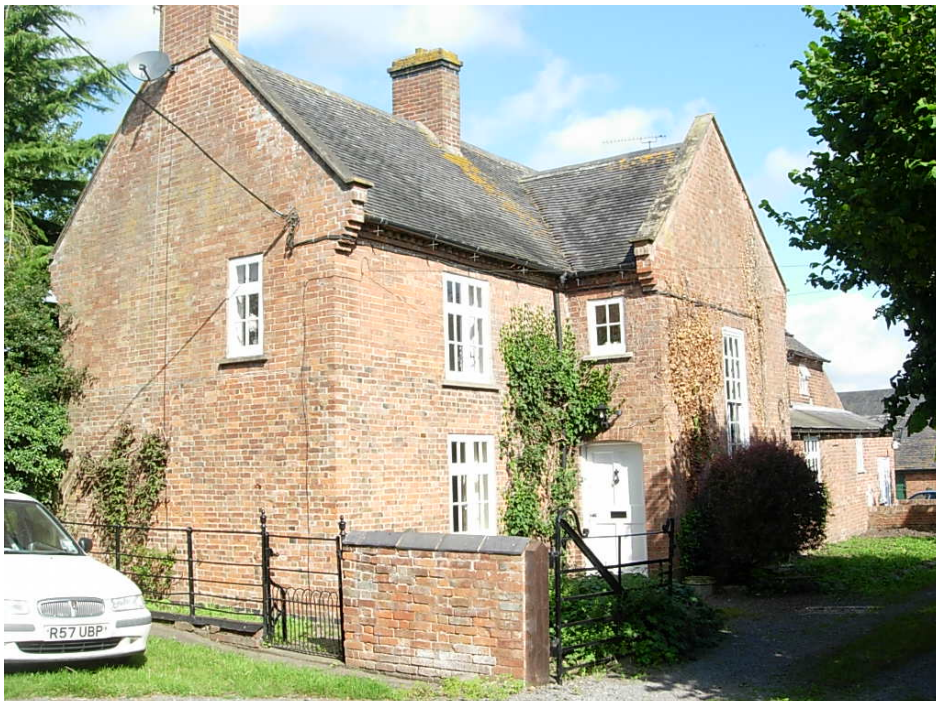
Dean's Farm looking south westwards showing its prominent corbelled gable ends and Georgian style windows

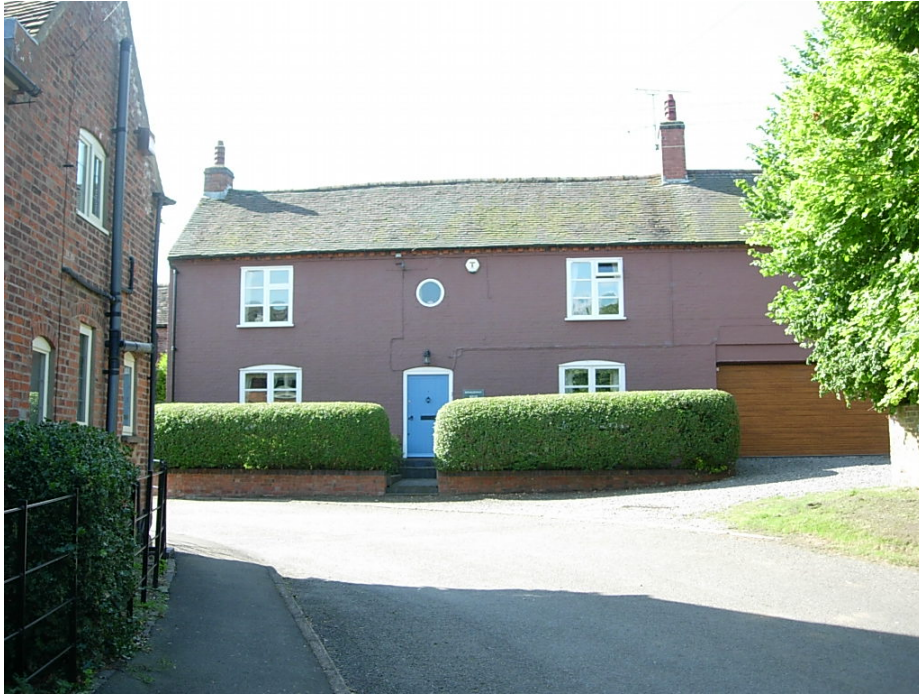
Ronaldsway House terminates views looking south along Main Road. The property has been extended in the past with, unfortunately, the bricks on its front elevation painted brown. The extension on the end of the property built with common bricks has a double garage door which is out of scale and character with this vernacular property.

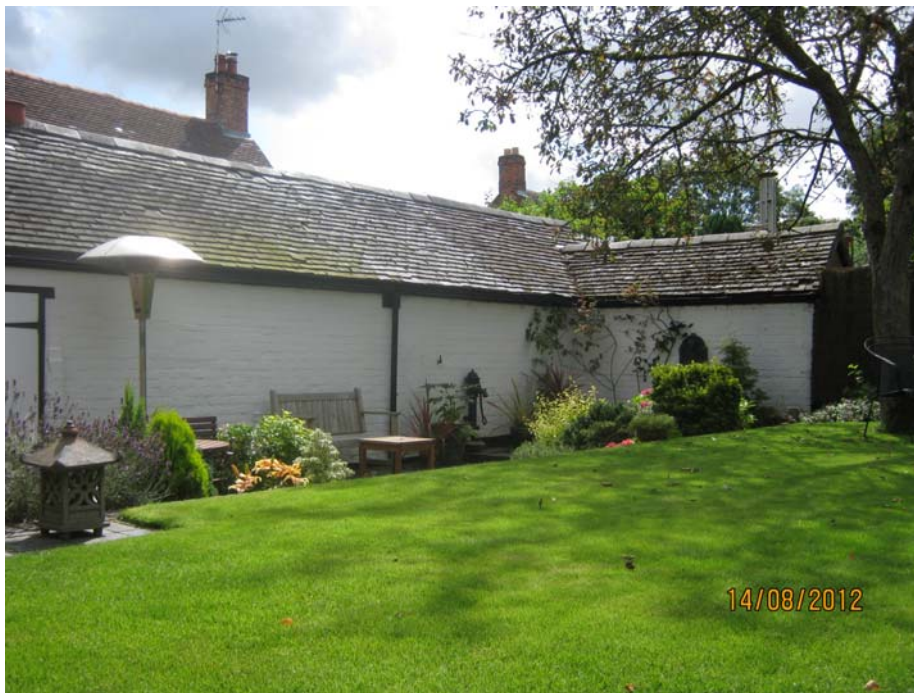
Brick and tile out-buildings situated to the rear of Ronaldsway and 25/27 Main Road adds significantly to the character of Bilstone. The out-buildings once comprised coal houses, wood sheds, pigsties, a privy & pump.

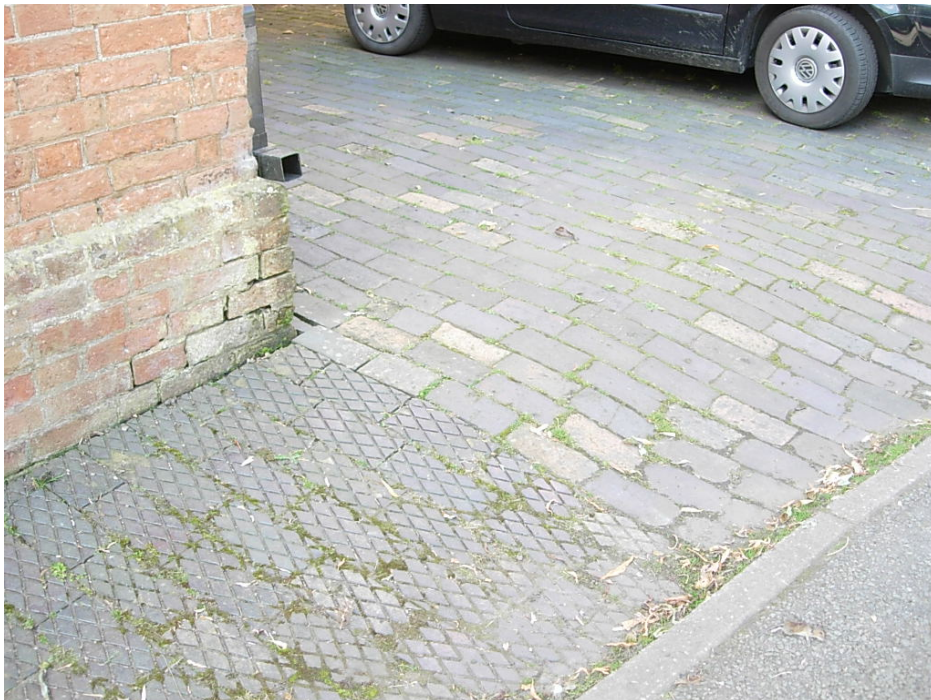
The diamond pattern and plain brick pavers which form two different ground treatments used at 25 Main Road enhance the rural character of Bilstone.

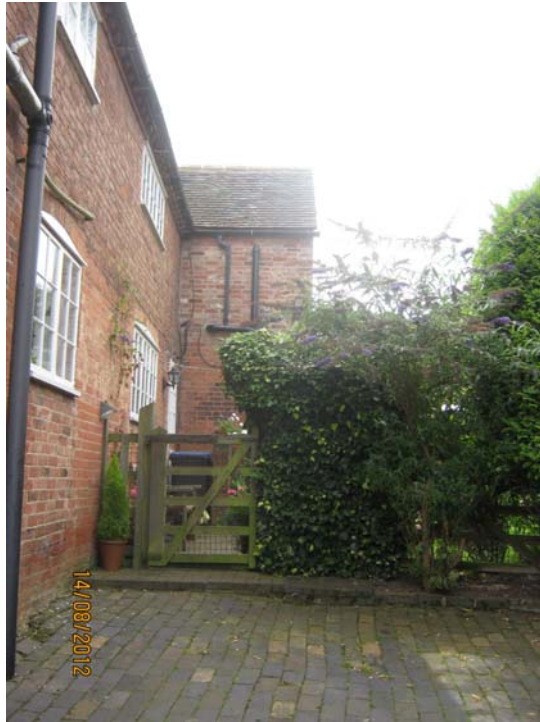
The rear extension to 27 Main Road is acceptable being in scale and character with the main property using traditional materials.

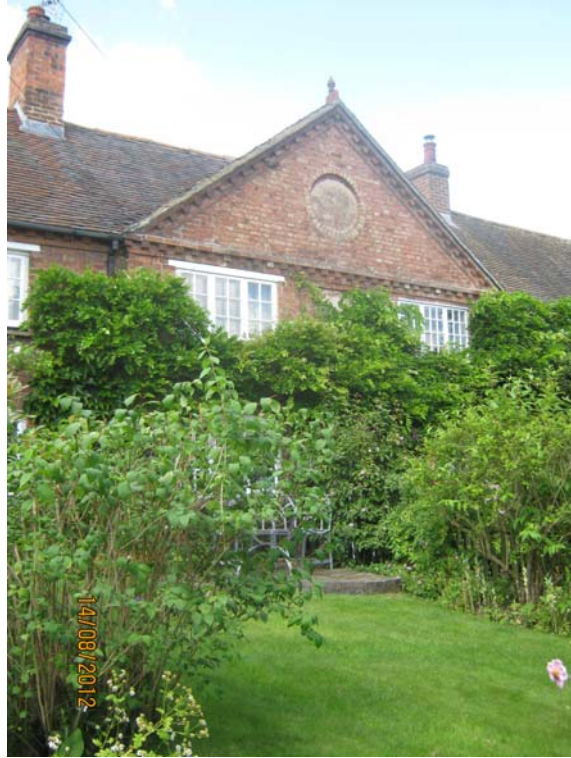
25 Main Road has a delightful brick pediment feature on its front elevation. The property was once used as a chapel until 1805.

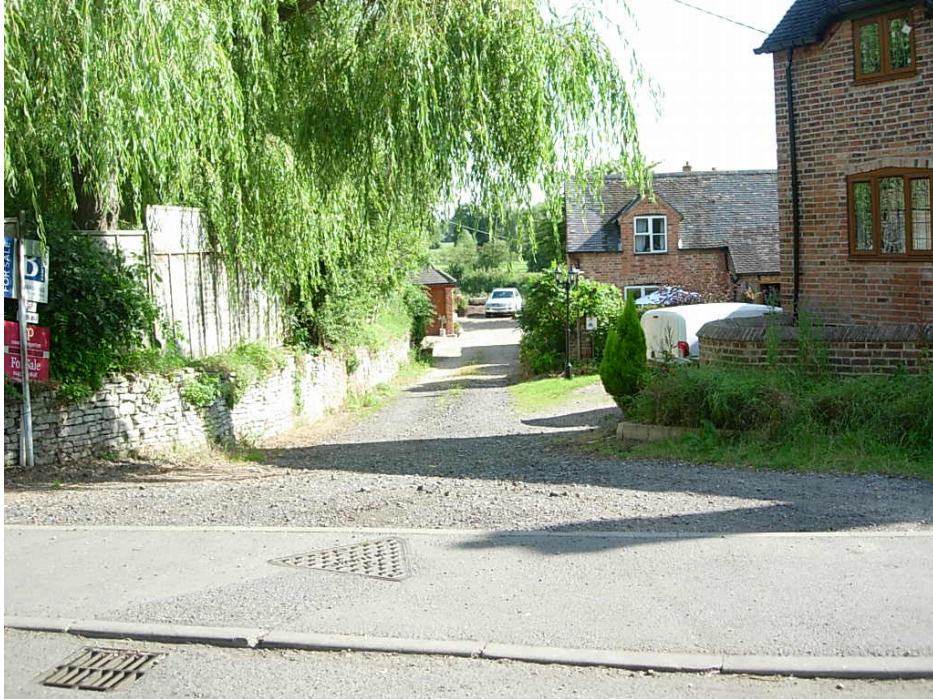
View looking down Mill Lane from Main Road. The Lane is a narrow graveled track that runs to Bilstone Mill. The pavement running along the carriageway tends to urbanize the street scene and their further construction should be resisted.

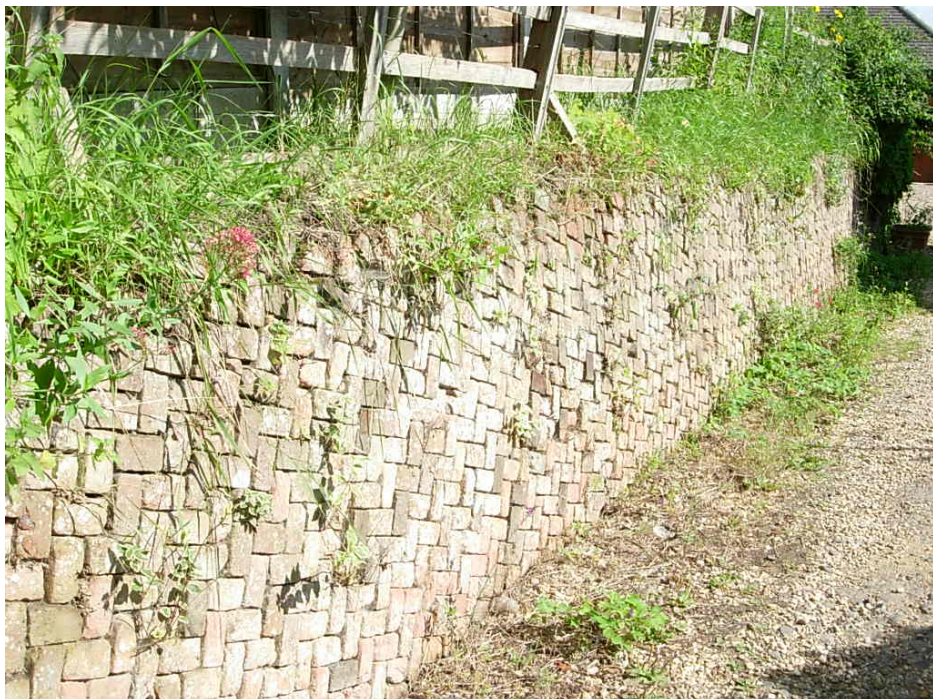
The boundary wall running down Mill Lane is of unusual construction adding interest along the lane.

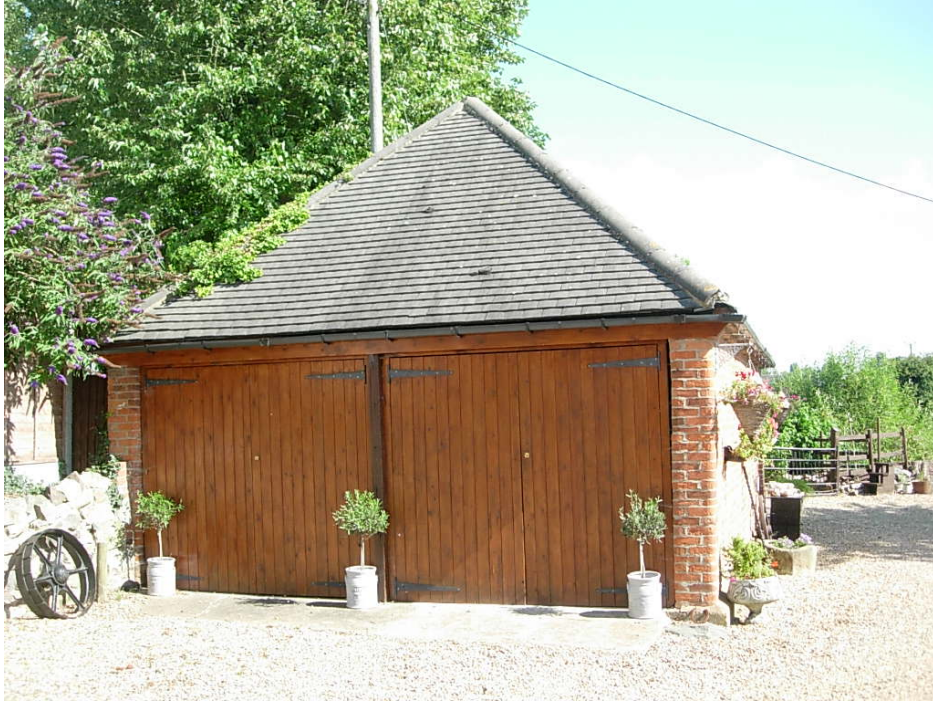
This double garage on Mill Lane is acceptable in design terms with the use of two timber doors rather than one single up and over door.

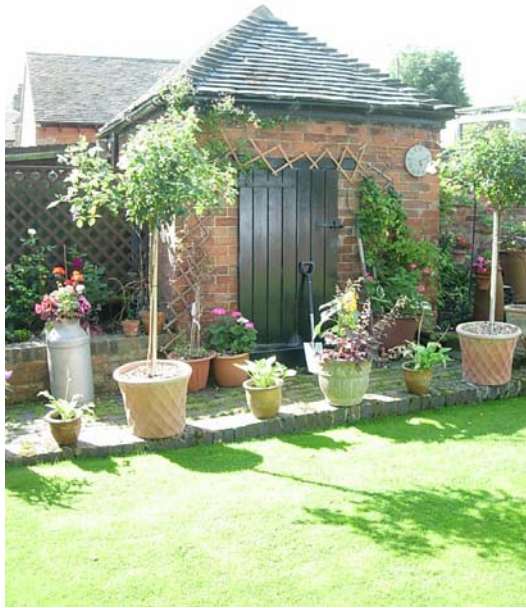
This quaint out building at The Old Barn residence adds considerably to the rural character of the village. Every effort should be taken to keep these important small outbuildings buildings.

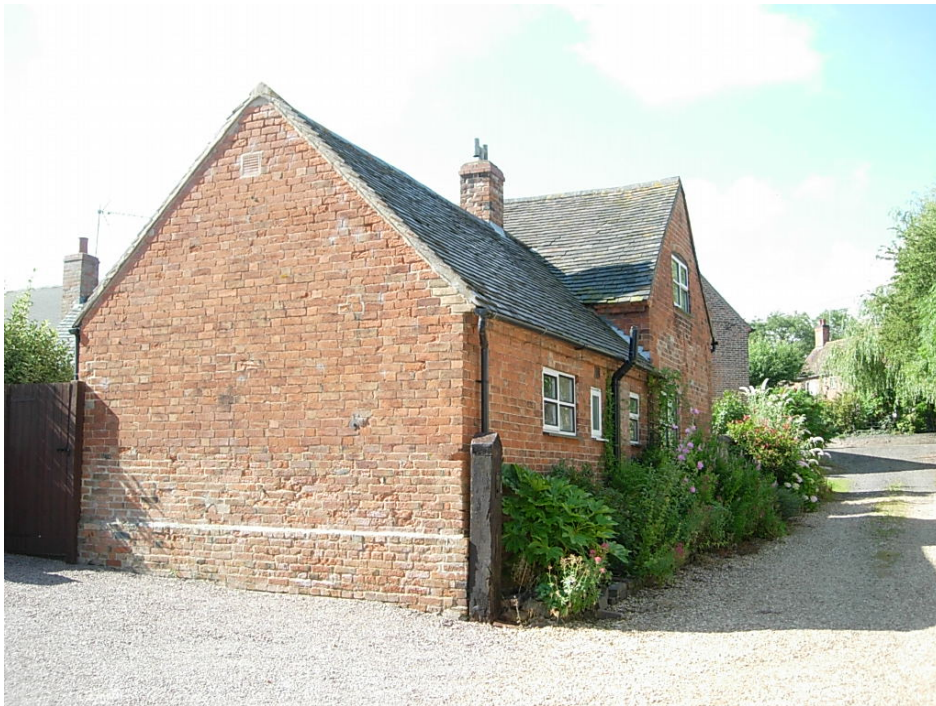
The northern elevation of The Old Barn has a roof gable which is characteristic of principal buildings in the village. Hipped roofs are restricted to small outbuildings.

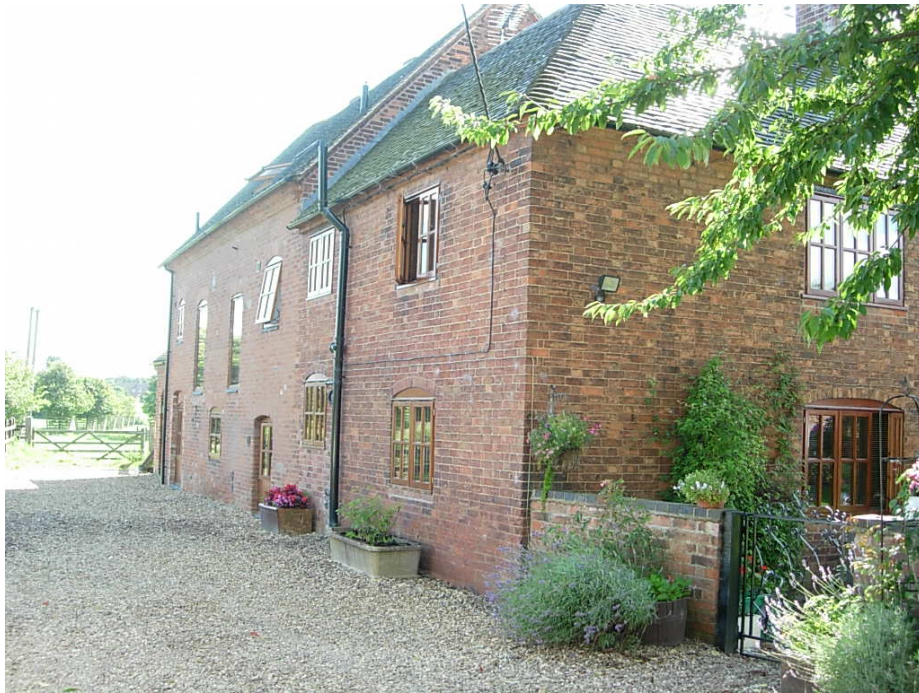
Mill House & Bilstone Corn Mill. The watermill is built on 3 floors and before it closed was converted into a dwelling in 1962. The ground floor was the corn store and an adjoining wheel house; the first floor was the grinding floor and the second floor fitted with garner. The adjoining Mill House was relatively large with 4 bedrooms.

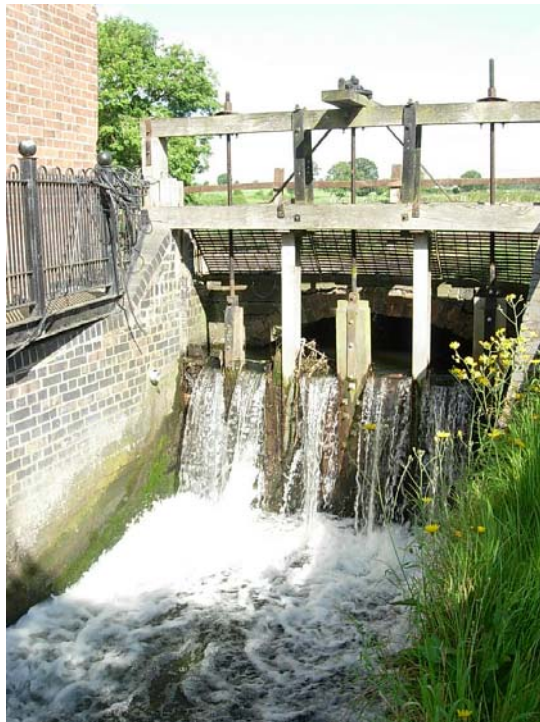
The sluice-gate on the River Sence adjacent Bilstone Watermill is of considerable interest to ramblers using the field footpath to Congestone.

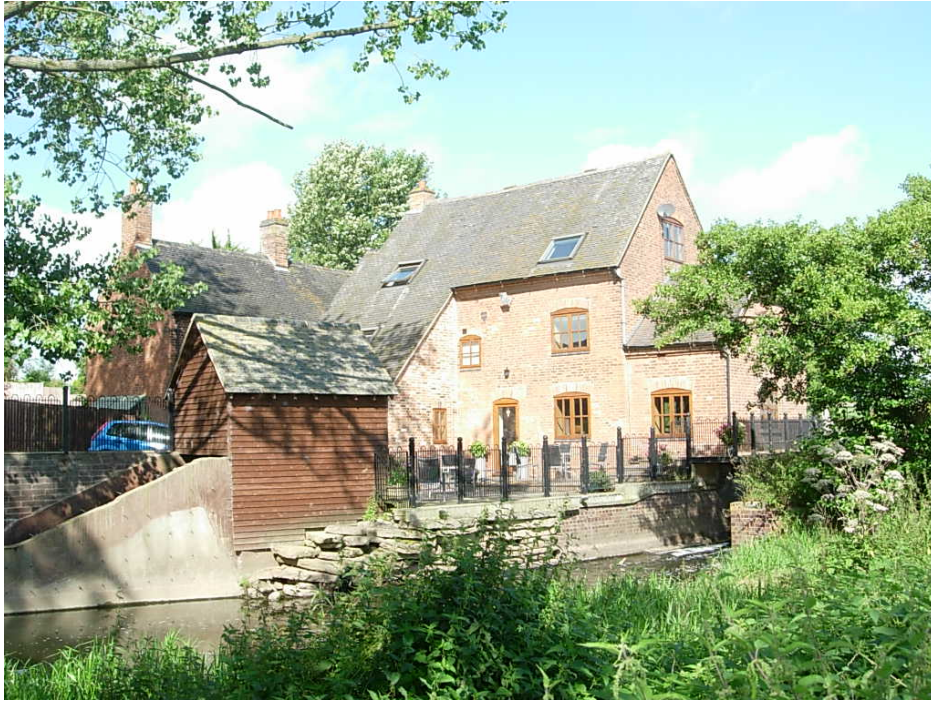
The rear elevation of Bilstone Watermill with the River Sence in the foreground. It is unfortunate that loose irregular slabs have been used to form the edge of the mill race.

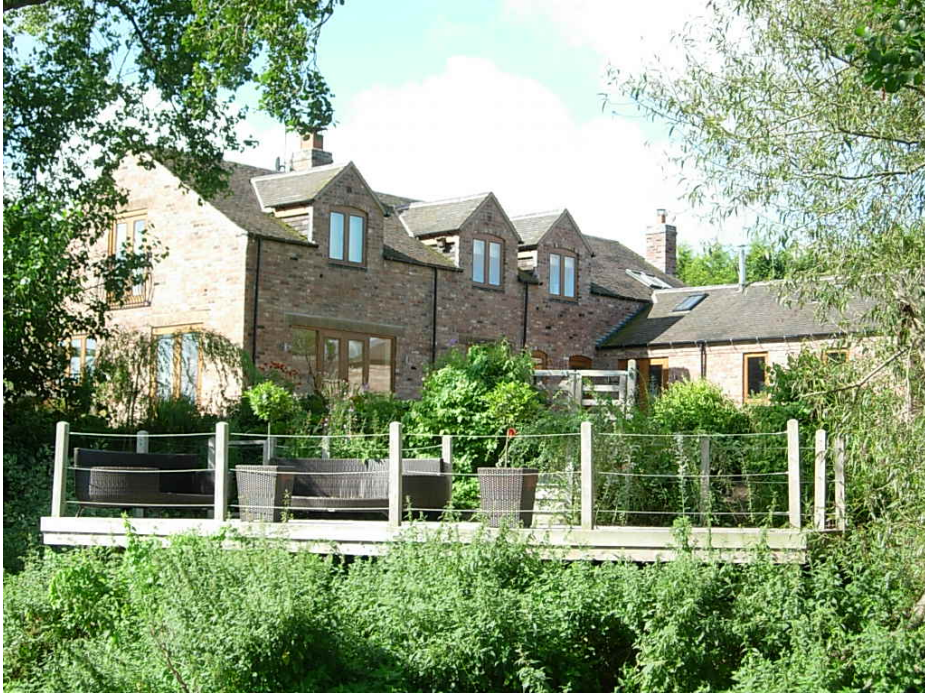
The rear elevation of Mill Wheel Lodge, one of two modern properties built in Bilstone. Built with modern materials and design, such dwellings stand out, being suburban in appearance.

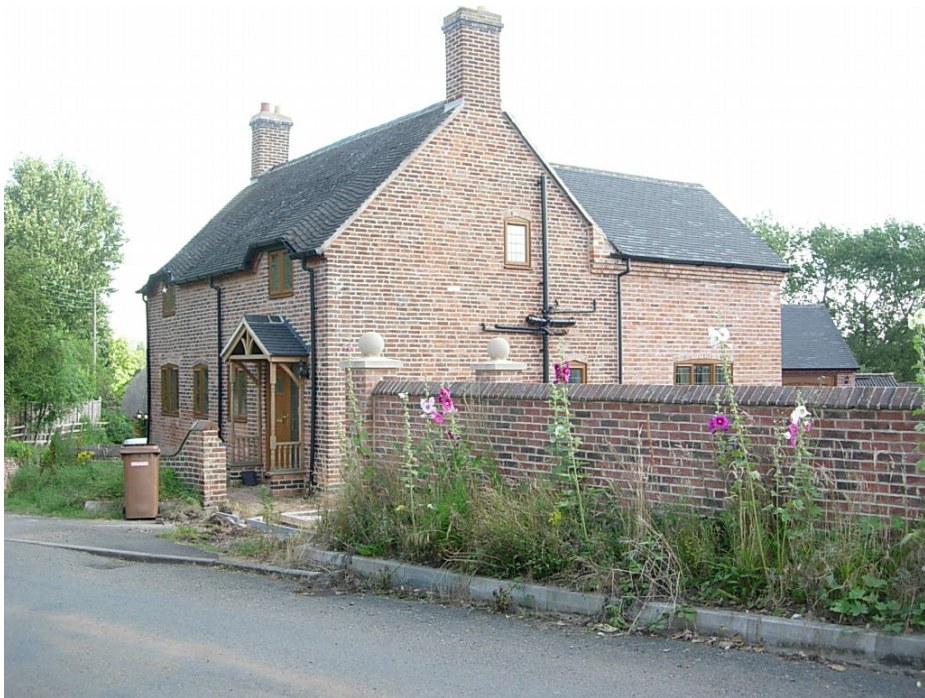
30 Main Road was originally two cottages although at the turn of the 20<sup>th</sup> century, one was used as a police station. The property has been substantially renovated and unusually is the only eyebrow dormer building in the village as eyebrow windows are a feature of Gopsall estate villages. The boundary wall has been re-built using traditional saddleback copings

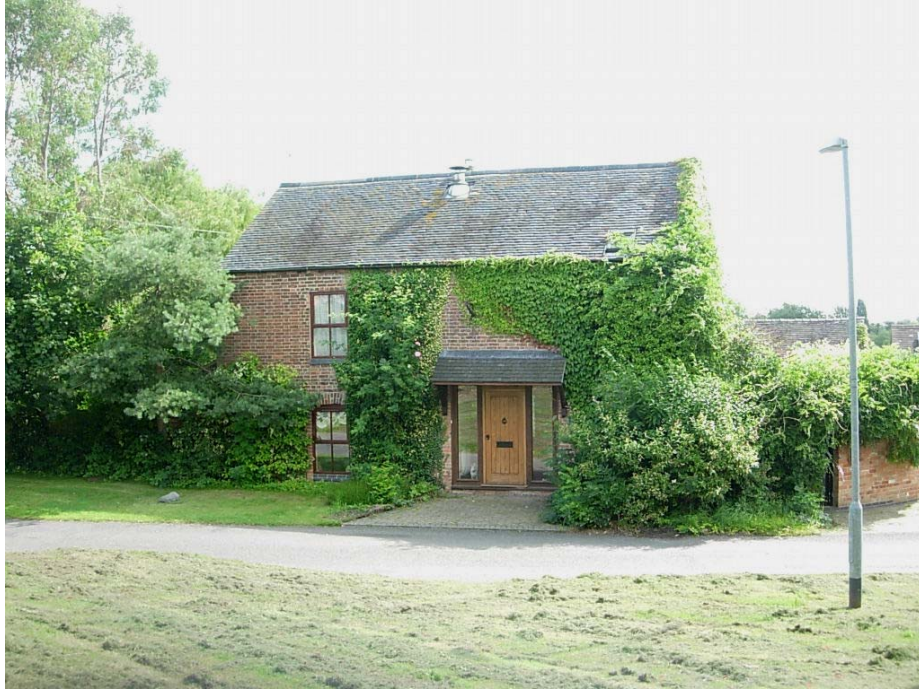
The Smithy was formerly a barn with granaries above that until recently was used as a piggery before being converted into a dwelling. The street light on the green needs to be replaced with a heritage street light.

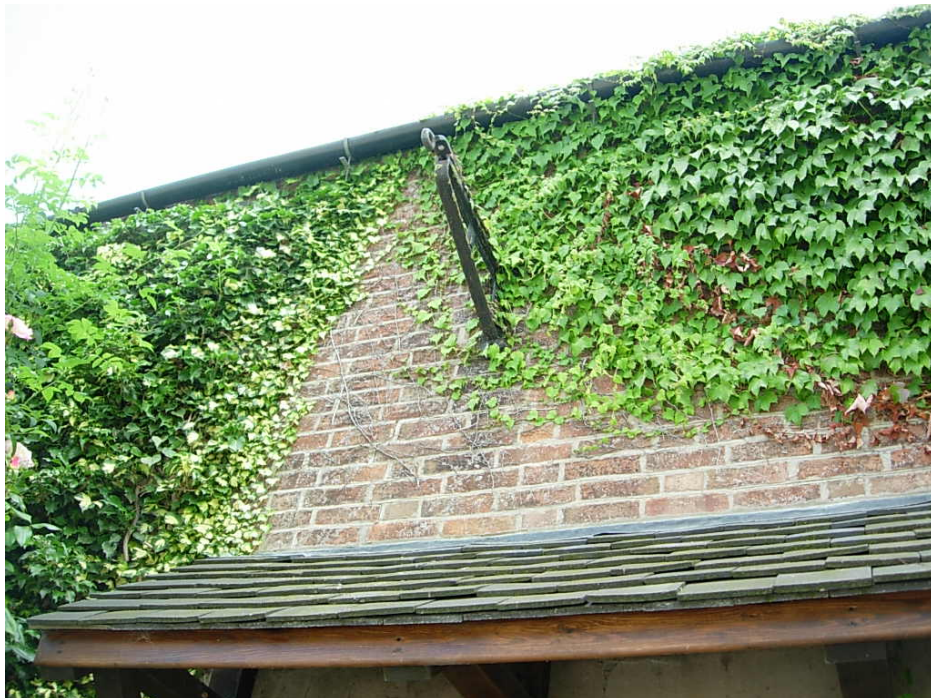
A lifting beam on the street elevation of The Smithy helps to highlight the use of the premise's first floor as a granary.

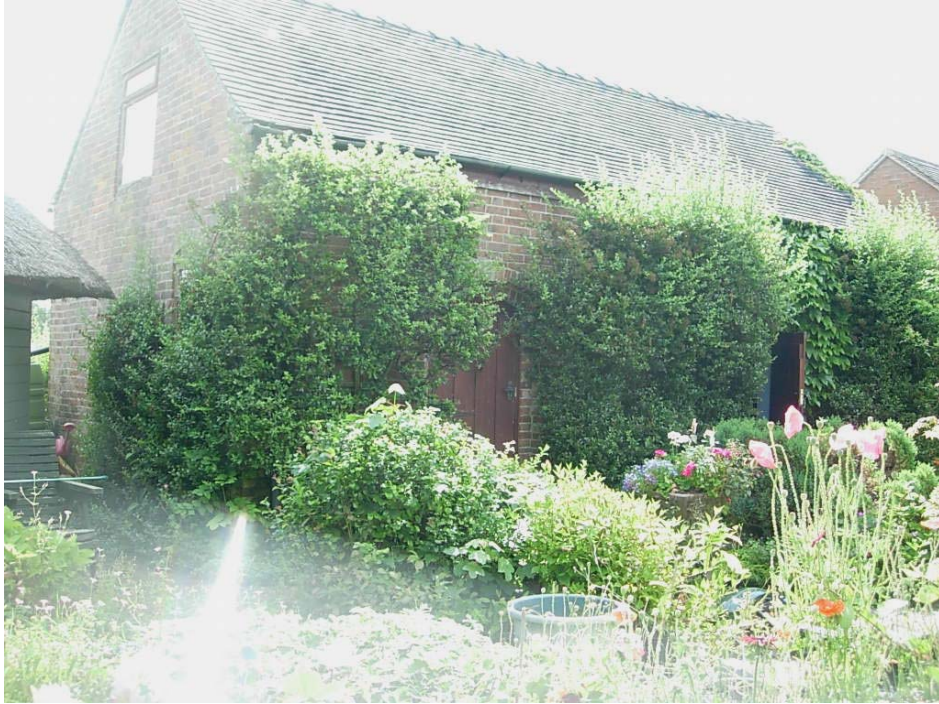
This building sited to the rear of The Smithy was formerly a blacksmith's workshop. Until recently it was used as a poultry house but has now been converted into a games room. Such small outbuildings buildings are important to the historic fabric of the settlement.

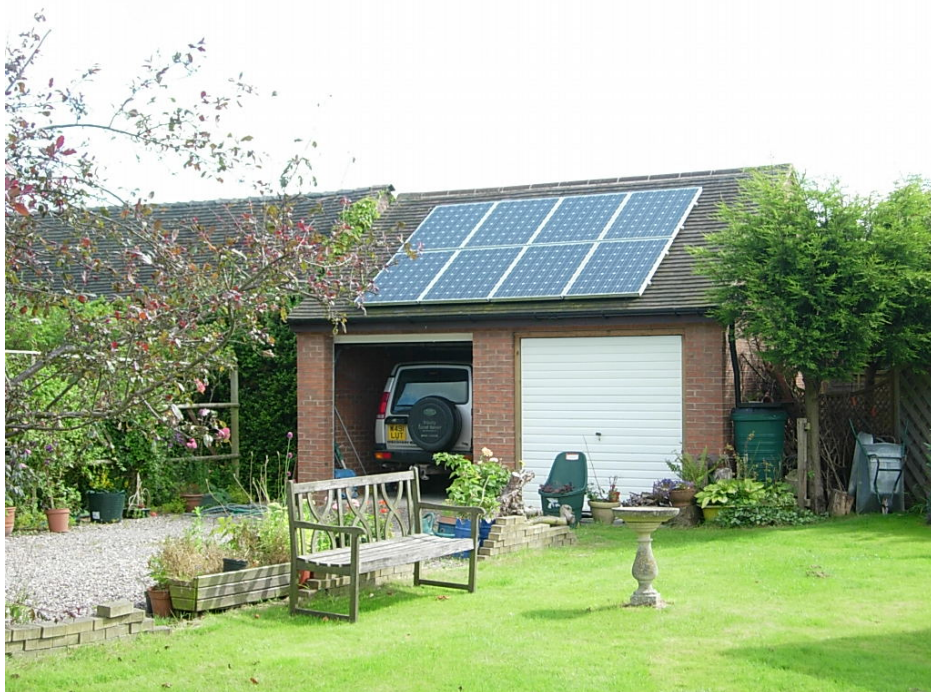
Although green initiatives should be encouraged, new technology doesn't always sit comfortably in conservation areas, as the photograph shows. The use of solar panels and wind turbines should be sited in less prominent places out of the public domain.

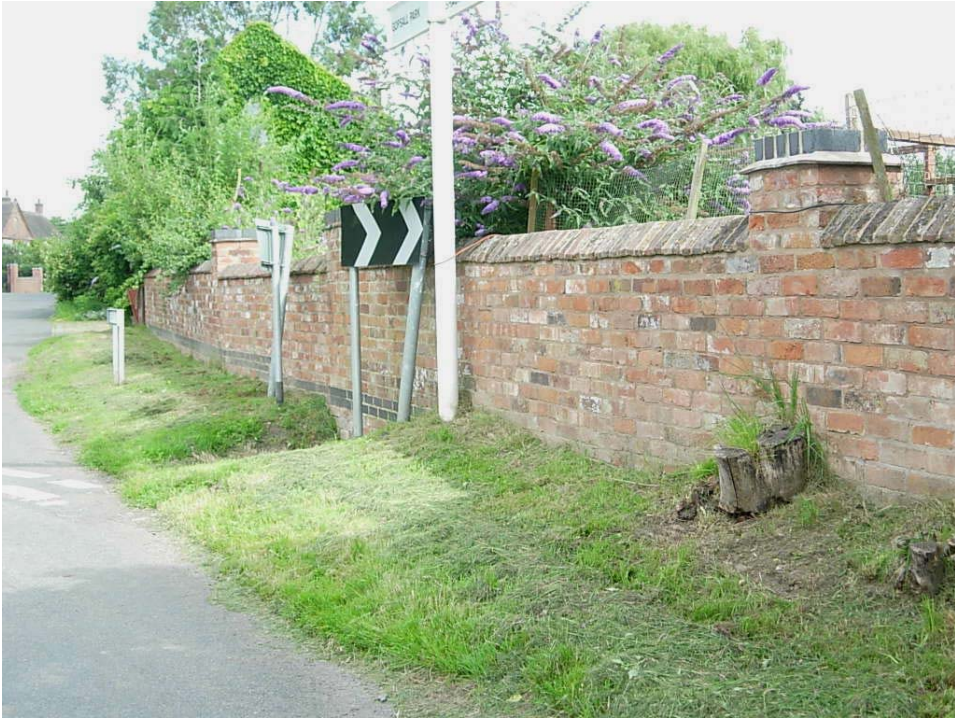
Traditional brick walls with saddleback copings are a common feature throughout Bilstone that enhance the rural character of the village. Every effort should be given to retaining and re-instating these important features.

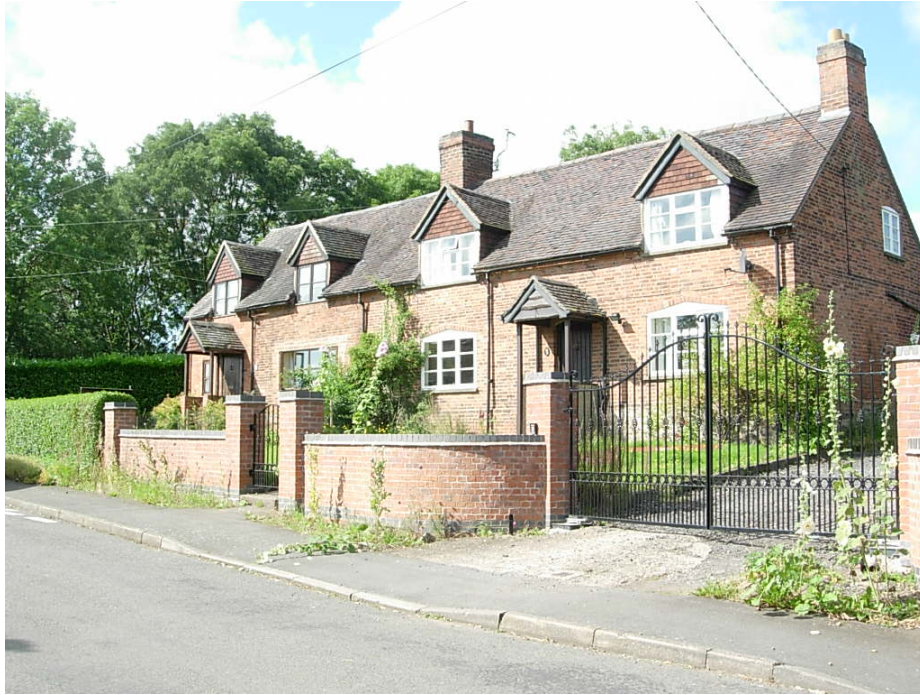
28/29 Main Road originally comprised a terrace of three brick and tiled cottages with V brick lintols over the ground floor windows. It has since been converted into two dwellings.

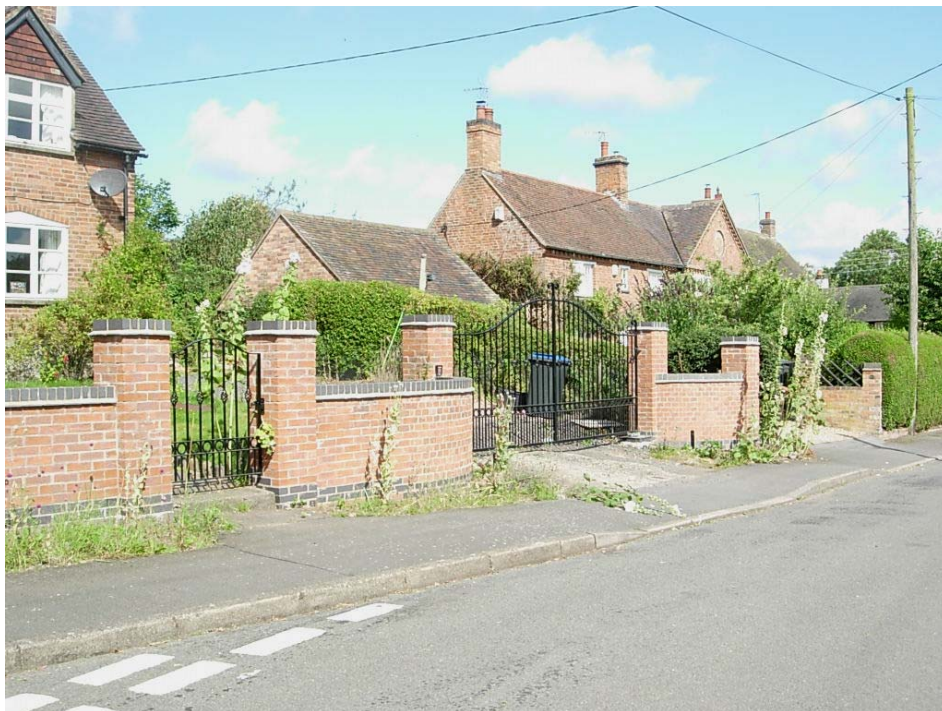
The modern brick wall and gates at 28 Main Road are suburban in character and do little to enhance the rural character of Bilstone.

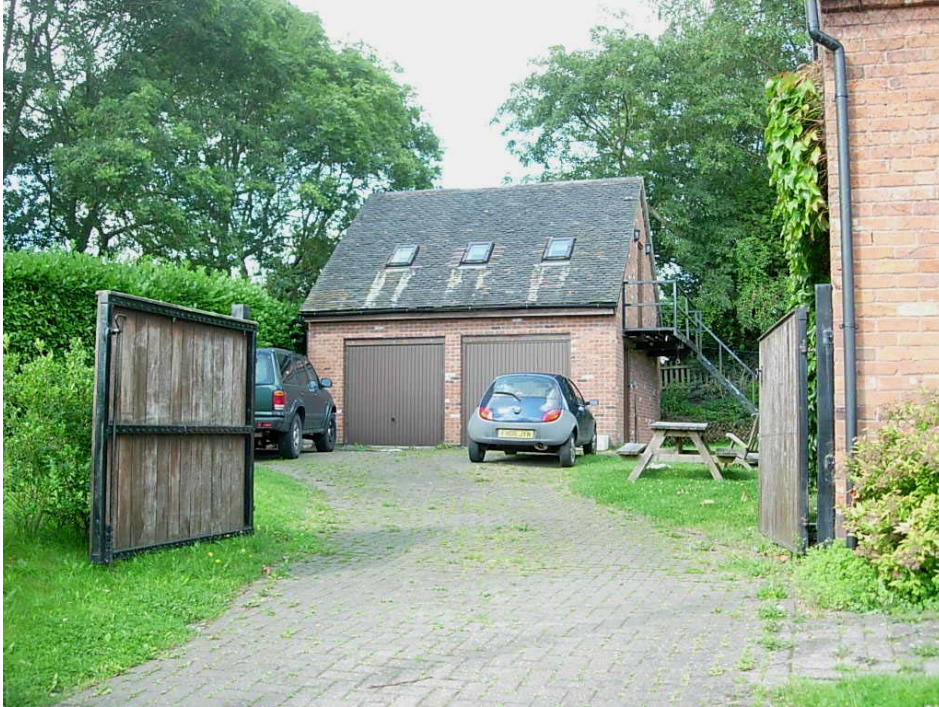
This double garage at 29 Main Road is acceptable with 2 timber doors although it would have been preferable if the roof lights were confined to the rear elevation only.

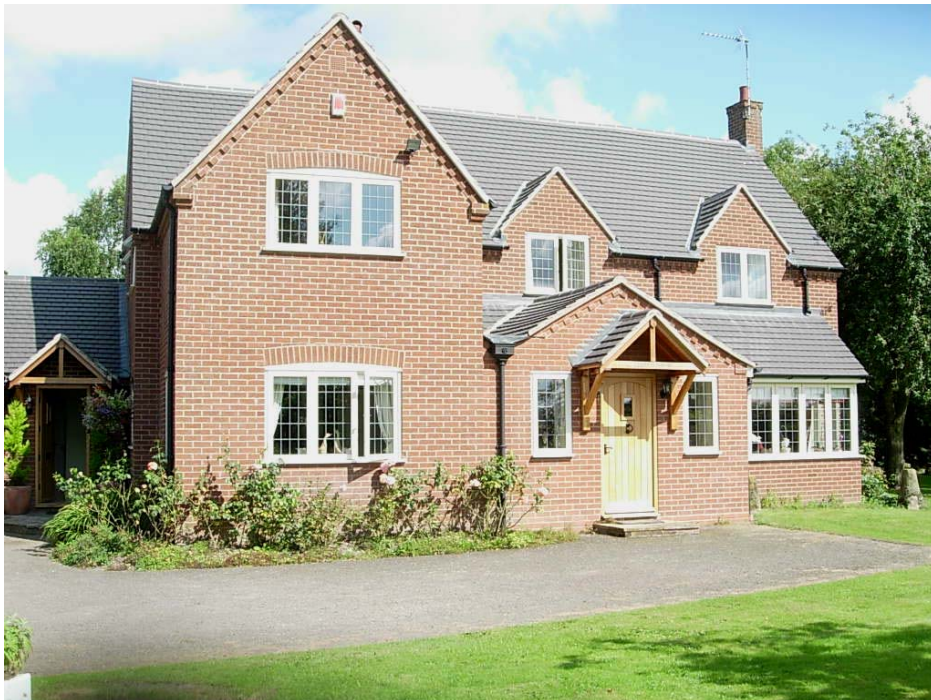
The Gables is a large modern detached property fronting Twycross Road. Unfortunately, the dwelling is of sub-urban design and therefore in the wrong setting. Any new dwellings in Bilstone should follow traditional guidelines of a rural village.

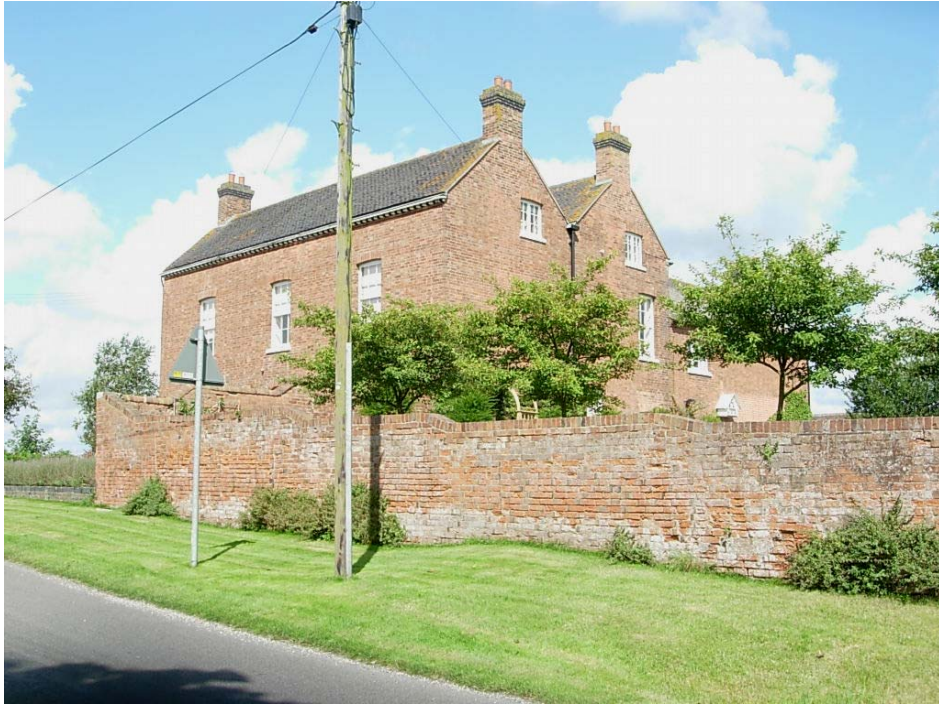
Bilstone Hill Farmhouse is a large imposing early C19 Grade 2 Listed Building built in red brick with a plain tiled roof and end chimney stacks. The 2 storey property has twin end gables and gable-lit attic. The side garden is enclosed by a high traditional brick wall.

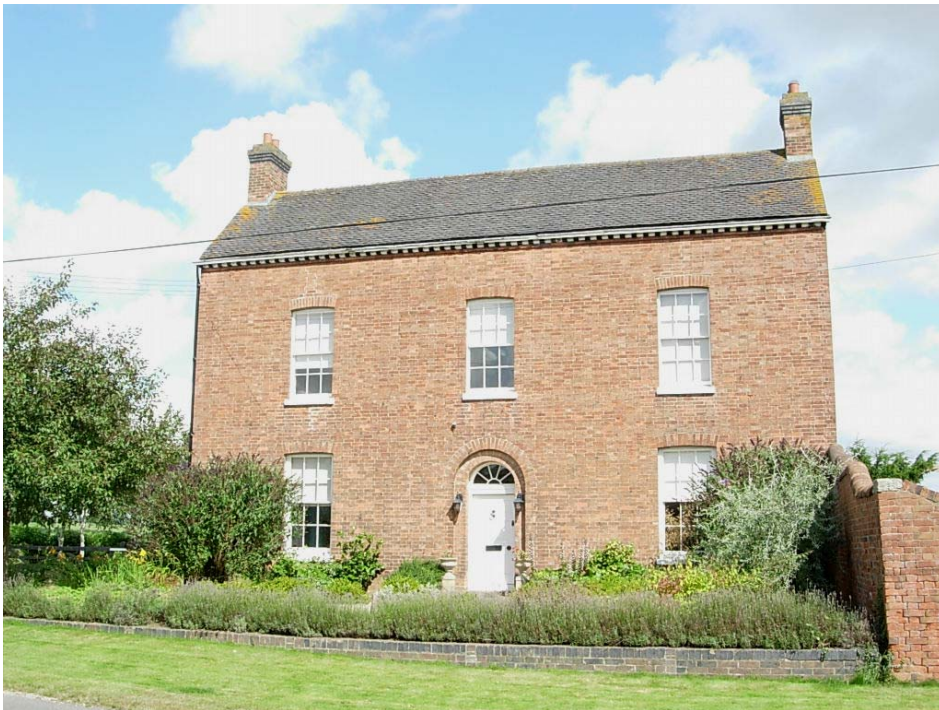
Bilstone Hill Farmhouse showing its regular 3-window frontage and central paneled door and fanlight.

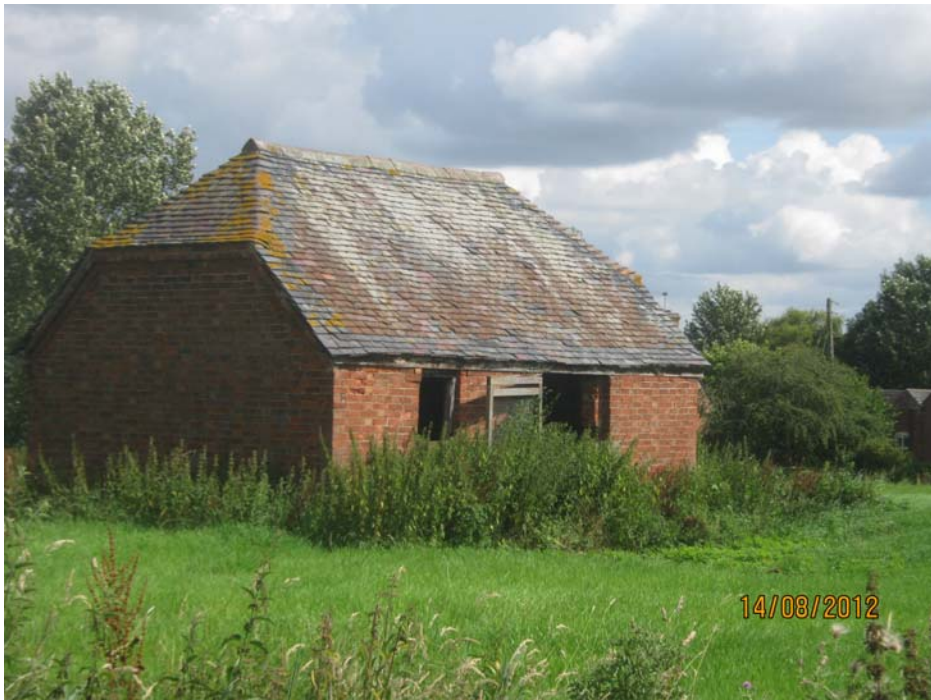
This quaint derelict half hipped building is sited in a large paddock to the west of Main Road. Such buildings add significantly to the village's rural character and their loss should be avoided.

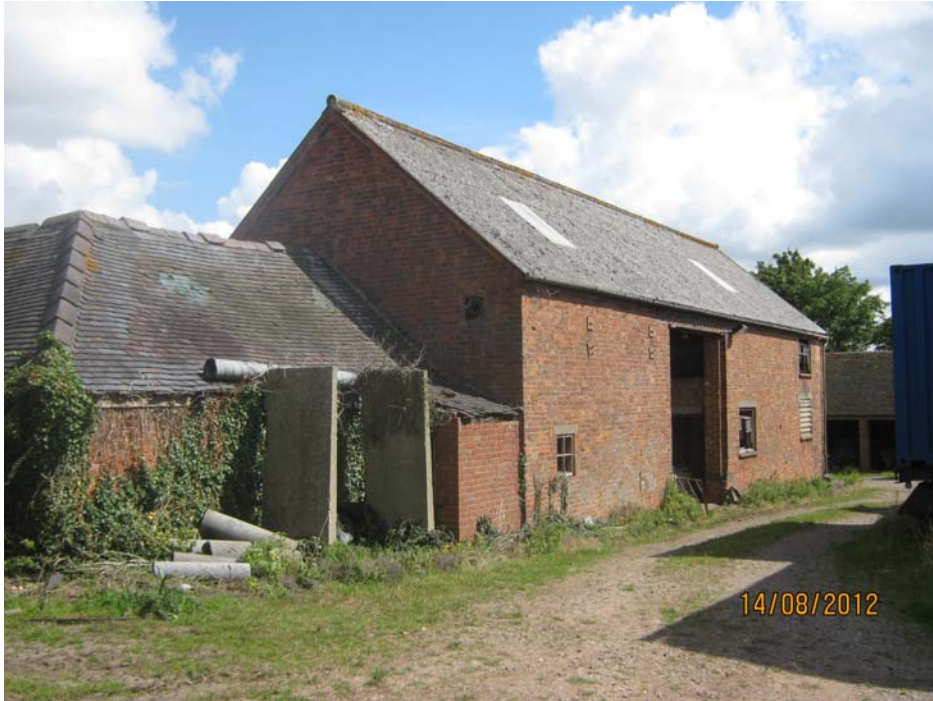
One of the large imposing buildings sited at the former Bilstone Hill Farm complex. The Farmstead has a number of fine traditional buildings, however, several are in need of urgent restoration.
