Hinckley & Bosworth  
Borough Council

**Bilstone Conservation Area Appraisal and Management  
Plan**

**Photographic Record**

**October 2012**

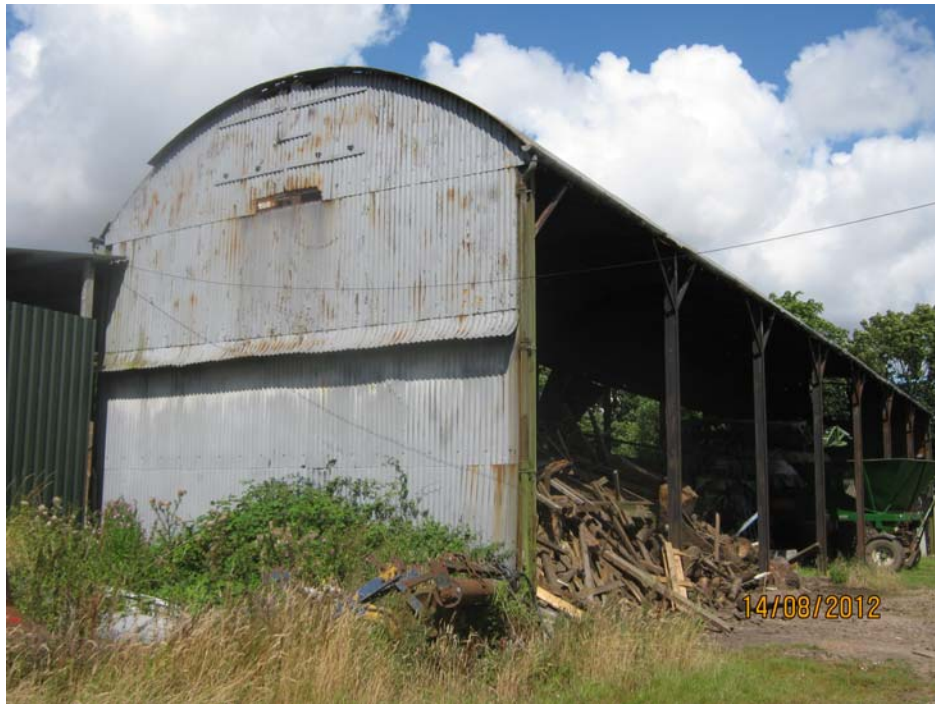
This large imposing Dutch Barn is an excellent prominent feature sited on the Bilstone Hill Farm complex, unfortunately, it is in need of some repairs.

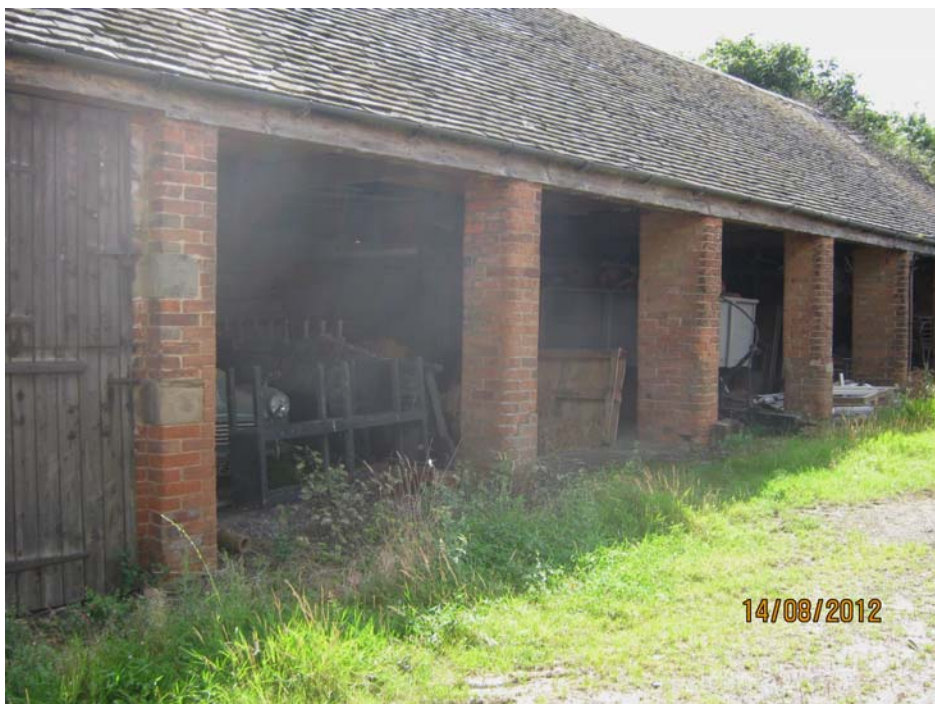
One of the open cart sheds at Bilstone Hill Farm

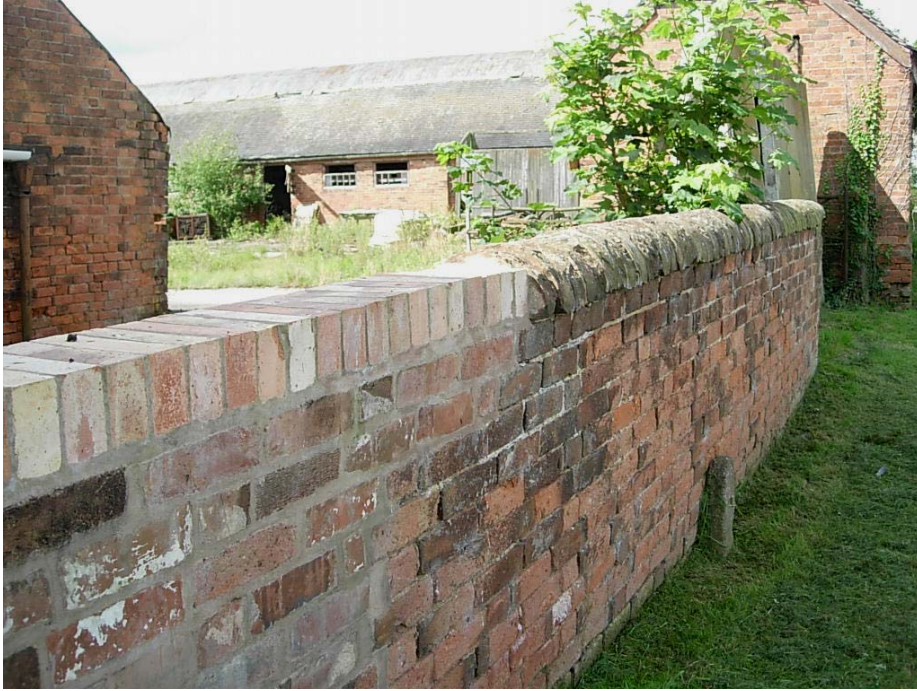
Unfortunately, the boundary wall running along Twycross Road, fronting the former Bilstone Hill Farmstead, has been repaired unsympathetically using a modern brick coping instead of traditional saddleback copings.

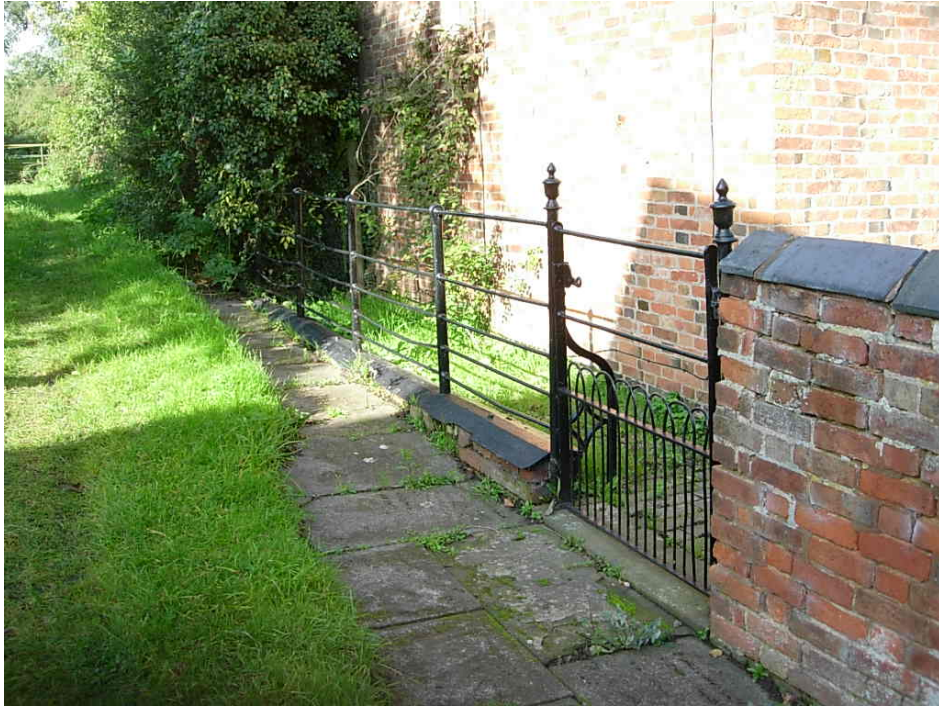
This small length of agricultural fencing, side gate and metal coping is a delightful feature at Dean's Farm.

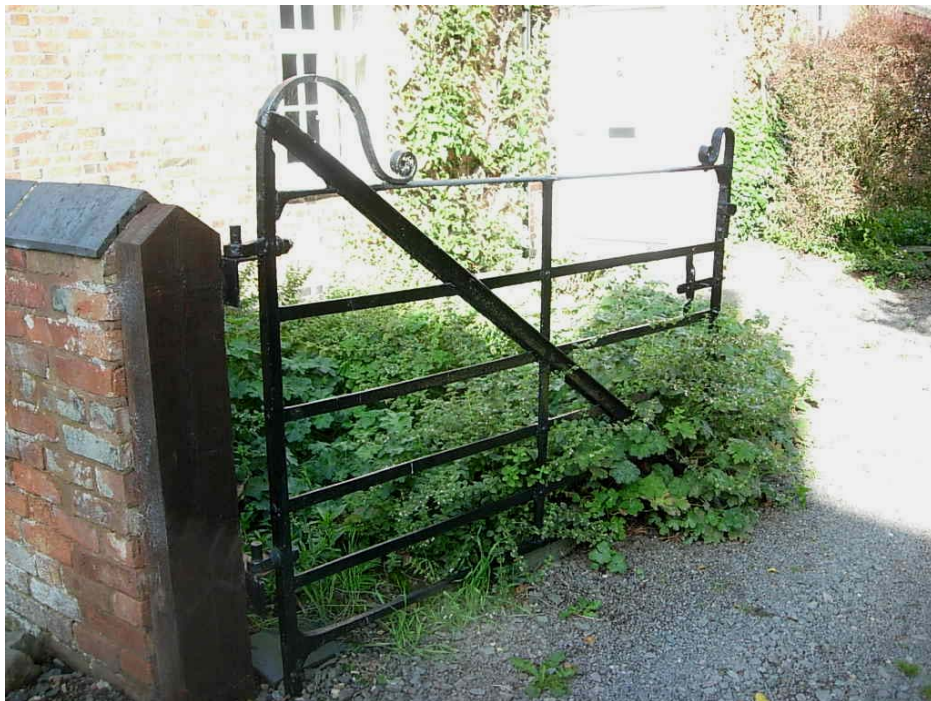
Similarly, the two large side gates at Dean's Farm help to enhance the rural character of the village

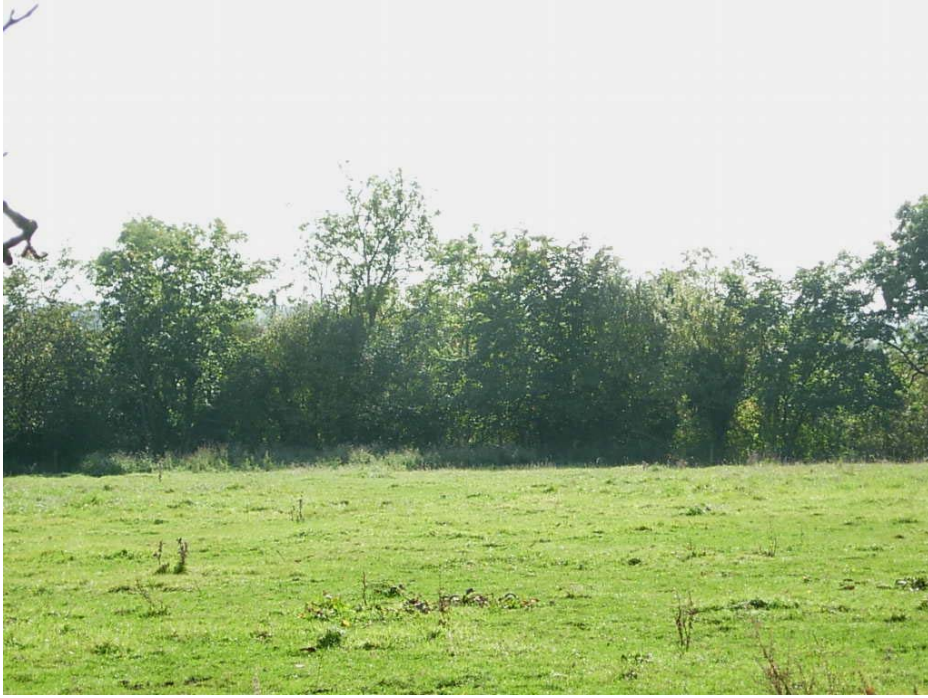
There is uncertainty as to whether the water feature sited in the field to the south of the proposed conservation area was constructed as a moat or ornamental pond. The 1849 Tithe Map shows it formed once formed part of the garden of a farmhouse.

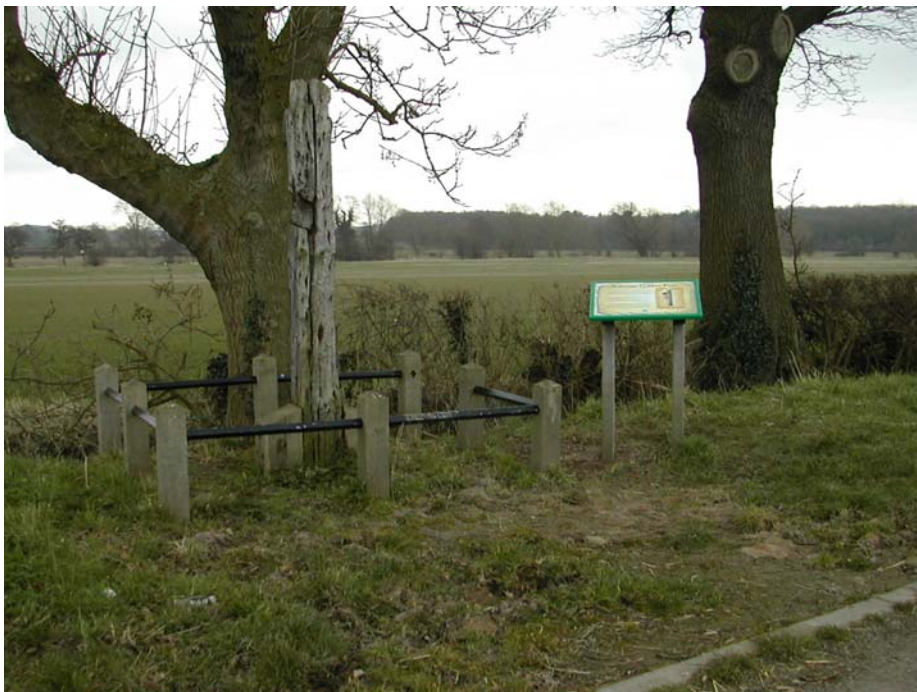
Although sited some half a mile to the south of Bilstone in the highway verge, this Gibbet post has a strong connection with the village. It was erected in 1801 when a local man, John Massey battered his wife and threw her into the mill pond. She later died of her injuries. Massey was subsequently hanged at Birstall, and as was the custom of the day, hung on the gibbet post close to where he committed the crime.
